SB-220
2 KW Linear Amplifier

Bulletin No:
SB-220-1

SBM-220-1 Modification Kit

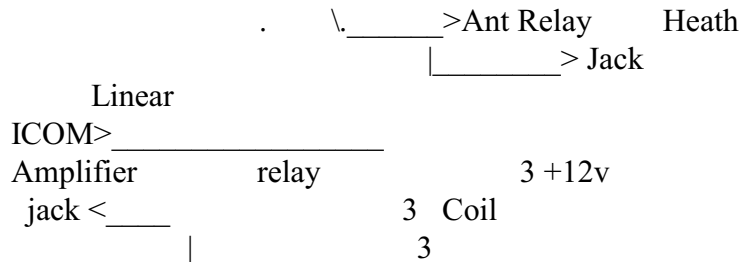
ICOM Transmitter Antenna Relay Contacts Fail When Connected To Antenna Relay Jack On Heath Linear Amplifiers

The 120 VDC at the Linear Amplifier antenna jack exceeds the 24 VDC maximum rating of the antenna relay contacts in the ICOM transmitter. This excess voltage causes the relay contacts in the ICOM transmitter to weld together. To prevent this, connect the ICOM transmitter to the Linear Amplifier using a 12 VDC as shown in the drawing below.

A relay box for this purpose is available for ICOM America, Inc.
