Repairing the Traps on our Hygain TH7 Beam

Our tri-band beam, the venerable Hygain TH7, has served us well over the years.

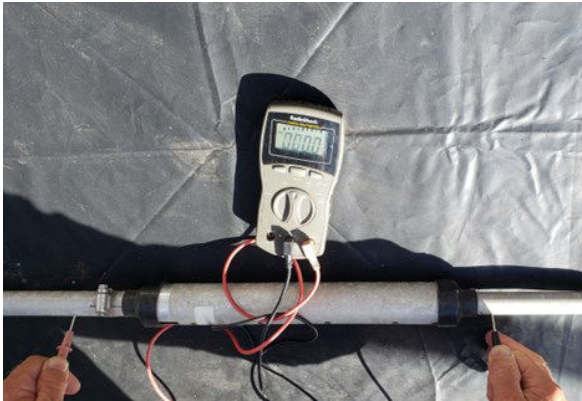
6 Measuring R across the trap - should be <1 ohm

Normally, R should be below 1 ohm in both instances. If R is above 1 ohm, removal of the plastic boot from the inner end of the trap and inspection of the connection is warranted. A loose or corroded sheet metal screw will likely be found at this point. Tightening the screw is one option, but the more permanent solution is to replace the existing 1/2" or 3/8" #8 screw

with a larger #10 stainless screw of the same length.

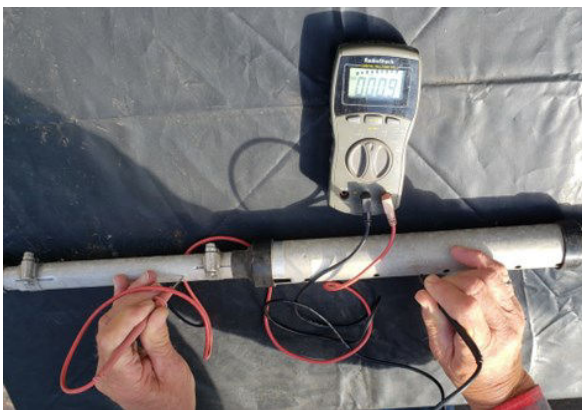
7 Measuring R between trap shield and element - should be <1 ohm

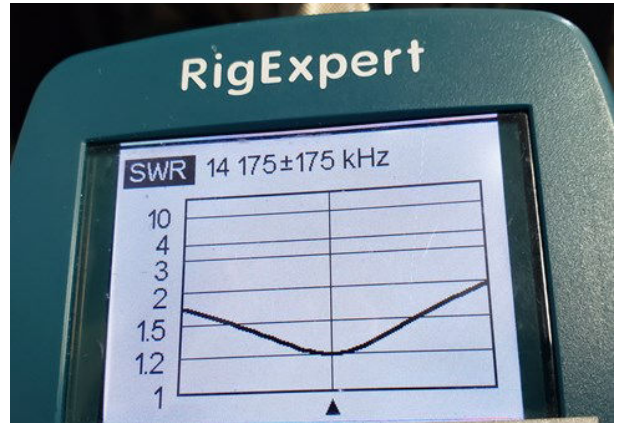
After repairs were completed and the tower raised, the expected swr was achieved as shown in Figures 8 and 9.

8 SWR as it should be on 20m

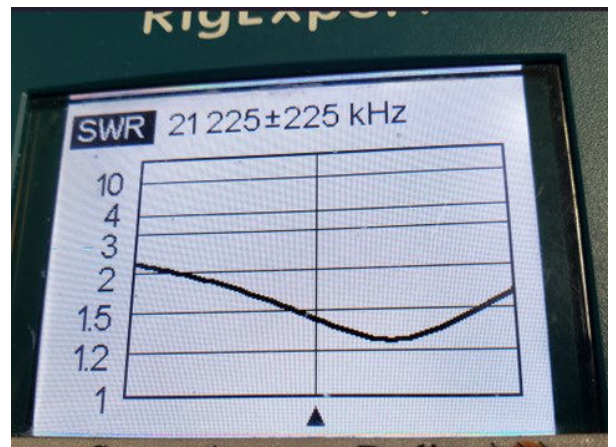
9 SWR as it should be on 15m
