## HM56/56A

### Electrolytic Capacitor replacement

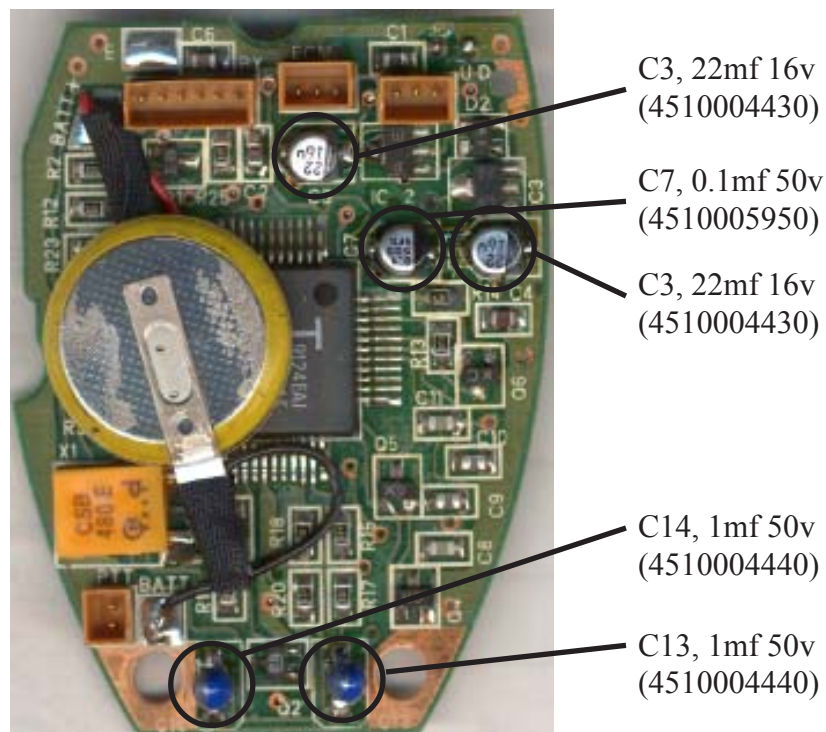
A common failure of the HM56/56A microphone, causing the radio to remain in TX mode when the mic is connected, is failure of the electrolytic capacitors on the microphone circuit board. Generally, replacing all 5 capacitors on the board repairs the problem and allows the microphone to work properly again. This repair is not a guarantee, simply a common failure point and reference for repair.

The 5 capacitors on the board are labeled as C3, C4, C7, C13 and C14. They can be ordered from the Icom parts department using the following part numbers:
