## Some technical and maintenance issues regarding the IC-781 and IC-R9000

*by Traian Belinas, YO9FZS*

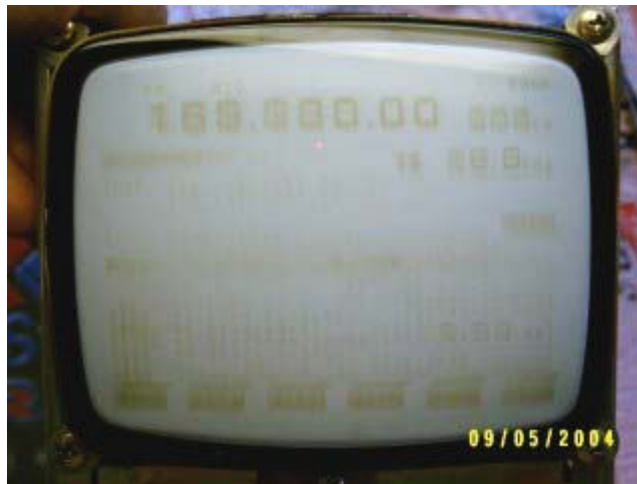
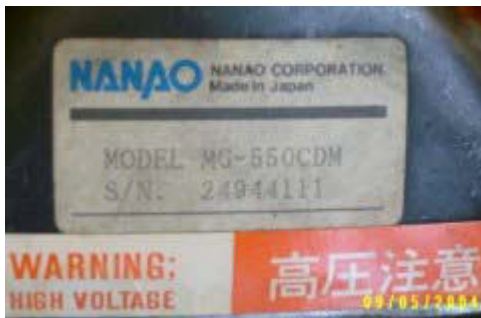
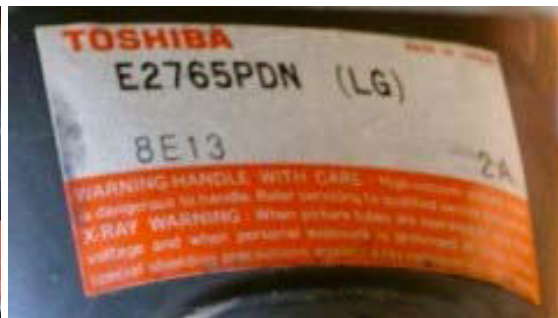
It is as if the picture pattern has been "imprinted" on the CRT screen. For the affected areas, the picture brightness and CRT phosphor efficiency is lower.

**This is permanent damage and cannot be corrected or avoided, but fortunately this kind of problem is not really catastrophic – this type of CRT may still function for many years after the first visible appearance of the burns, even if it may be uncomfortable to some. If needed, an external video monitor accepting NTSC CVBS input may be also used (or NTSC TV).**

You may see below how these burns may look; this example is from an IC-R9000.

The CRT below had maybe 10 years of use, most at a government agency before I got it (so it may had intensive use), and even now after I have sold it, it is still functioning at the new owner's QTH without these burns causing much trouble. This is also because the CRT itself is a relatively good quality one made by Toshiba. The CRT module is made by Nanao.

The CRTs are vacuum tubes, so they are actually “consumables”. This is true not only for the cathode system (regarding its electron emission capability) but also for the CRT’s screen surface phosphor. The burns are the result of the “consumable” phosphor. As the sum of these two characteristics, the CRT’s brightness, contrast and focus quality may get low after extended use. This is why the allowed CRT brightness and contrast will be reduced after extended use.

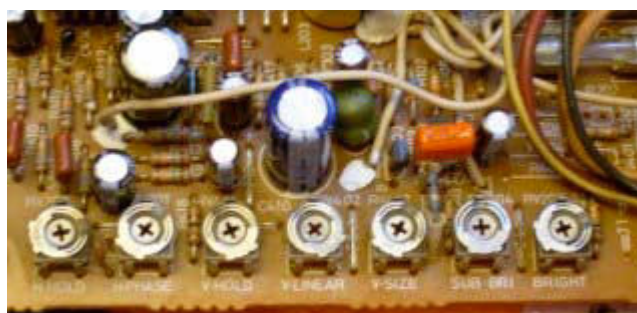
The low brightness of the old used CRT’s may be improved by using the internal adjustments of the CRT module. You have to open the CRT module top cover to gain access to them. To do this, you need to open the transceiver case, then to take out the six screws holding the CRT module top cover. The ATU preset pots PCB must also be removed. These adjustments are located on the CRT module PCB, close to its right side:

**SUB-BRI and BRIGHT** are the ones adjusting the brightness of the picture; adjusting them CW will increase the brightness of the CRT displayed picture.

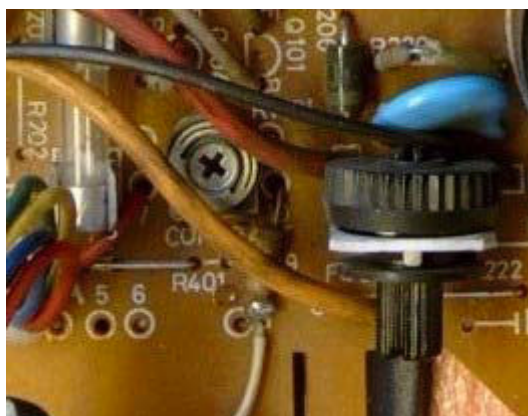
Contrast and Focus adjustments

There are another two but less obvious adjustments, one is the same type of small pot which adjusts the **Contrast (CONT)**, the other one is a larger pot including its shaft which adjusts the focus of the picture; they are located on the same PCB, just between the fuse and the CRT flyback transformer.

**If the CRT picture is dim**, try to adjust the Contrast pot first, and then the Brightness pots. When adjusting them, do not exaggerate. Don't set so high that the background (normally black) becomes very bright/amber, because using it in this way for a long time will shorten the CRT life (as explained previously), and the very high contrast may tend to a faster appearance of the burns on the screen.

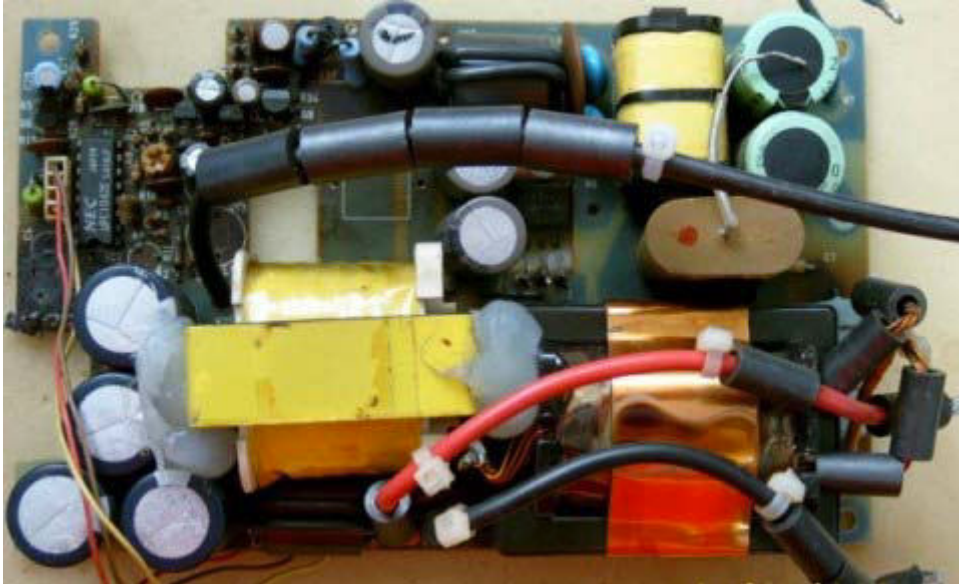
This is why overheating may damage the REG PCB, and the PCB itself may present burned areas and/or burned PCB traces, especially in the area close to R32 and Q7. Power resistor R32 can dissipate its rated power at 25°C, but not at 70°C... This overheating may also affect the electrolytic capacitors and even other small parts close to them. Special attention needs to be paid to potentiometer R2, which is included in the switching supply feedback loop. If R2 goes open or is damaged, it may cause output overvoltage, with possibly harmful consequences.

The REG PCB with most of the original parts on it;  
A few of the overheated parts near R32 area were already removed.

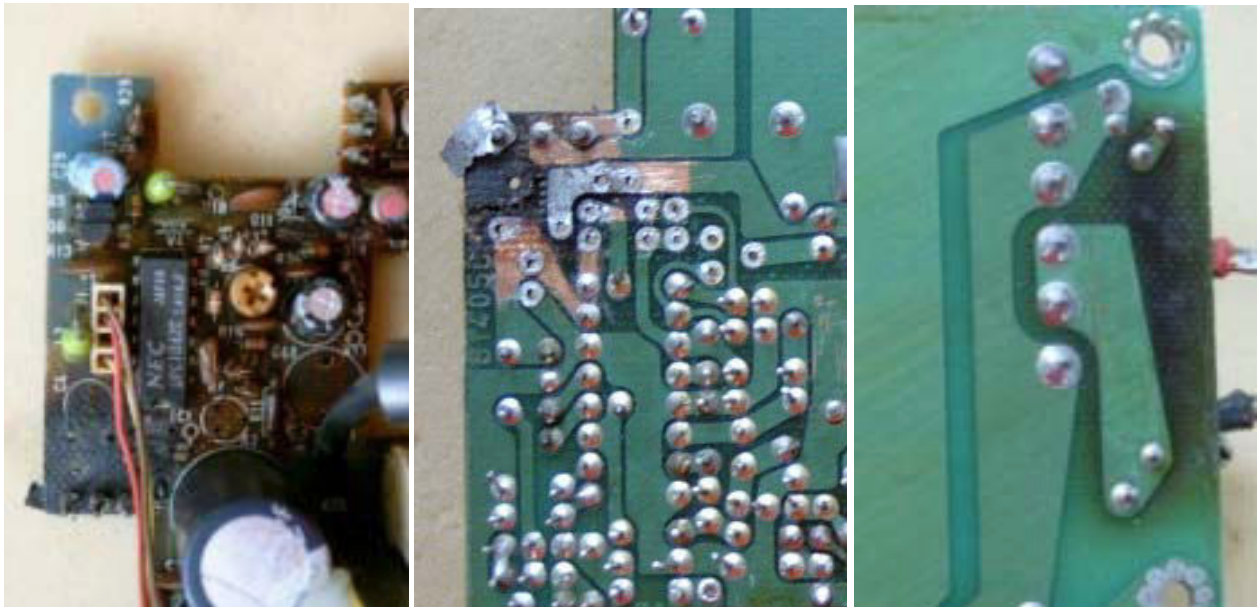
Burned PCB and copper traces near the R32, Q7 and R26; some parts are missing here.

Don't hesitate to make use of better and more trustworthy spare parts, it is not necessary to look for the 20-year-old “authentic originals”. I have found Q7 shorted and R32 interrupted and overheated. The 2SD1406 used for Q7 has 20W dissipation and maximum collector current 3A. I have used a 70W 8A TIP132 Darlington and insulating mica foil instead of the 2SD1906. [Don't use much higher current/power bipolar transistors as they usually have very low amplification (beta) and D5 may not withstand the higher base current required]. Don't forget to use thermal compound, insulating washers and mica foil where needed (D2, D3, Q2, Q3). Before assembling the PCB you may check the uPC1042 IC (it has to start oscillating) and verify the +9V and +5V regulator functionality after connecting an external current-limited 15V PS at C13 (observe polarity). Re-install the PCB inside its compartment only if all of these are OK. As a precaution, you may insert a 3.15A fuse in the 280V line (you may also leave it in circuit).

- Restore the PCB's circuit connections as needed, using the terminals of the newly installed parts if required;
- Check and if needed replace Q7, R32, D5, R2;
- Replace the small electrolytics with new high-quality parts; these must be rated for 105°C;
- If any sign of damage is visible at the C8, C9, C13, C15, C16, C20 to C23 (electrolytics), these may be replaced if spares are available - use the highest quality parts obtainable. Remember that the power supply must deliver 500W DC output and the caps must also be of 105°C type.

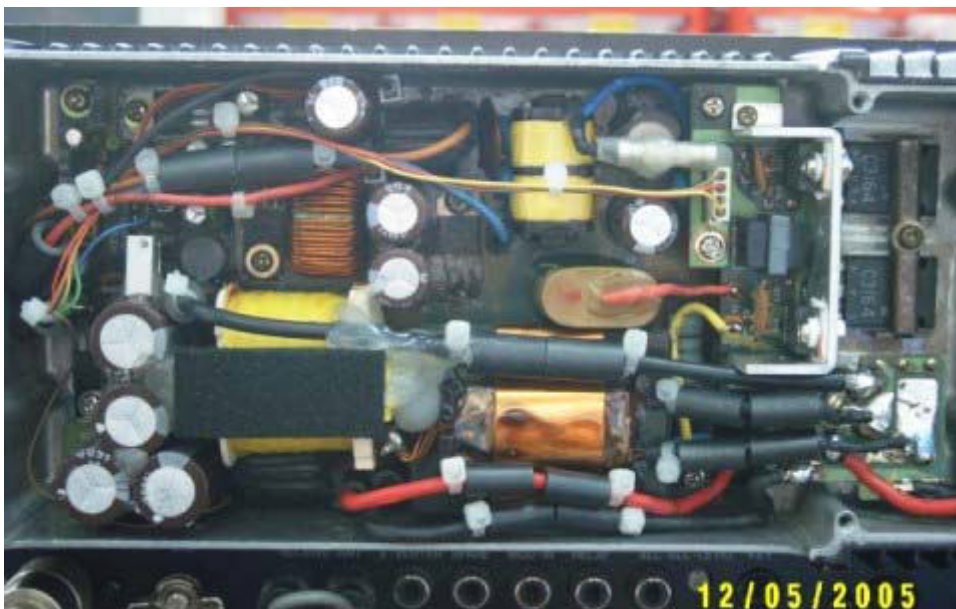
[The repaired and re-installed board; there is an added 3.15 amp fuse in the 280V input line; R2 was replaced with a high quality sealed multi-turn pot mounted on one of the 33V line electrolytics].

After finishing the work, if everything checks out, then proceed to the REG adjustments as described in the Service Manual (page 6-40, OUTPUT VOLTAGE and CURRENT PROTECTOR); include a check of the APC circuit and PA current limiting (APC SET, page 6-26) and finally check for all the output voltages (page 6-1).

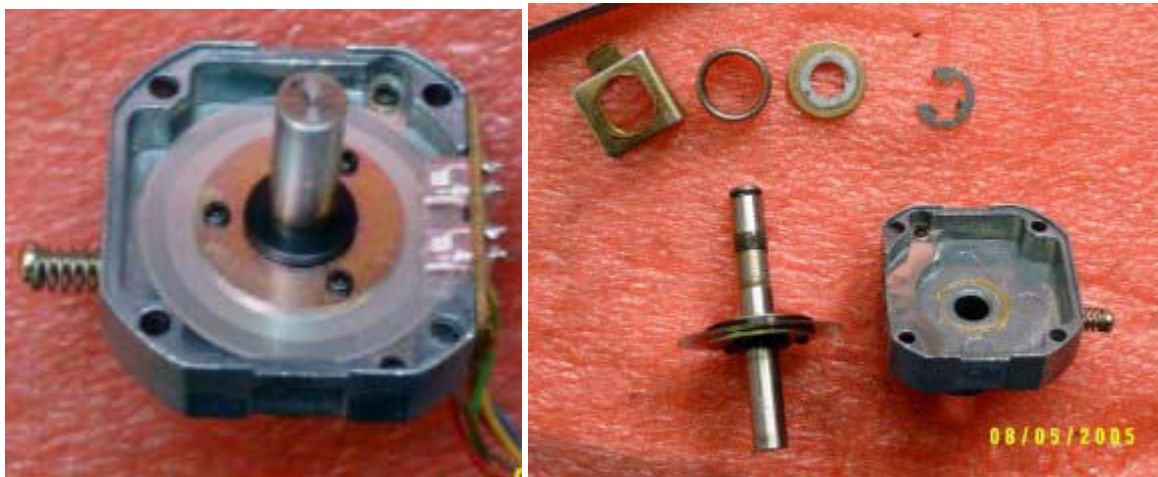
For both radios the VFO encoder knob had been rotating with some difficulty, even when its adjustable brake was released. This was caused by the old grease used in the shaft bearing. This grease has solidified because of age. It is inadvisable to use the radio with a stiff encoder shaft for any length of time, as this will cause a rapidly increasing backlash.

Clean the dirty shaft and the sleeve bearing remove the existing grease using isopropyl alcohol and then re-lubricate shaft and bearing. To reduce any backlash, lubricate with grease rather than oil. Don't use much grease; a small quantity will suffice. Avoid getting lubricant on the optical parts;

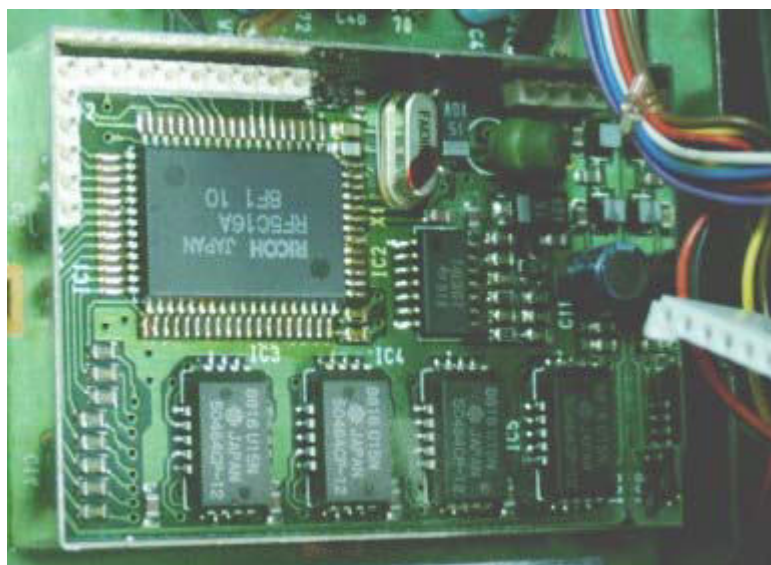
The opened CRTC module;  
C11 is the blue cap, to the right of the CRTC module.

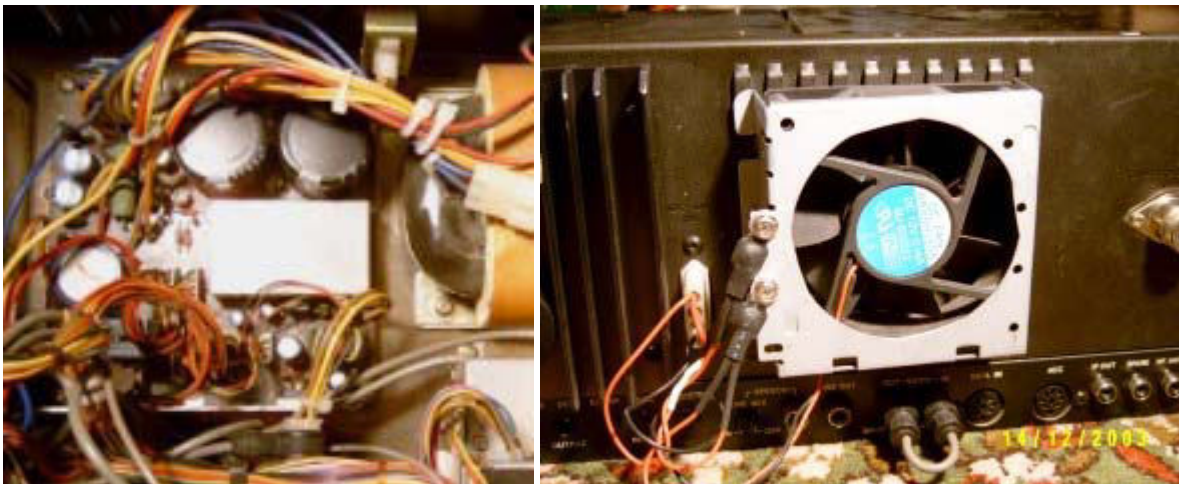
Because of this, and also because of their low quality, the electrolytic capacitors used in the DC-DC converter on the REG PCB board may fail. The usual symptom is no reception along with an abnormal S meter indication. It is caused by an incorrect value of the negative output voltage. C26, C29, C33 and possibly the other caps on the DC-DC converter in the REG Unit may be affected. They have to be replaced. If possible replace all of the converter's electrolytics. Use high quality 105 C ones.

After replacing the capacitors you may add a cooling fan so as to avoid any future problems. I have installed a temperature controlled 3" fan (using two 82 ohm NTC thermistors in series) and it's mounting device from an old computer case. The mounting I have found fitted exactly under the back panel fins near the REG Unit. There was not need to run wires inside the radio, nor even to open it; it can use the voltage available at the DC output connector on the back panel. While the airflow is not very high, it is adequate. The cooling improvement is still significant. The interior of the power supply is no longer hot, and the noise is very low as the fan speed is limited by the two NTC's. The fan can be removed in a few seconds if required (e.g. for shipping).

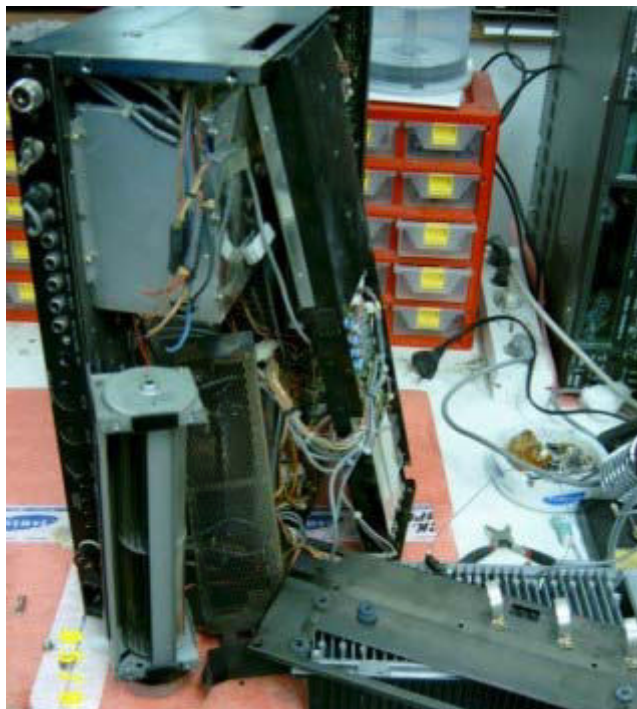
IC-781; heatsink and fan removed;

The fan is sitting on its motor side, and the sleeve bearing is at the top part of the fan's case

It is located under the RF/Filter Units module at the rear left side of the radio, and is attached to the big heatsink with screws. This fan may need lubrication. Its motor may have ball bearings (not requiring lubrication) - but the other end of the squirrel cage, at the right side looking from the front, it uses a sleeve bearing. The RF/Filter module has to be removed to gain access to the fan. Putting the radio on its left side may help to apply a small drop of oil to the sleeve bearing using a syringe.

If the fan and especially its squirrel cage (rotor) are very dirty and dusty, then the fan should be completely removed and dismantled and the rotor cleaned. Clean the heatsink fins as well.
