# SERVICE BULLETIN

from: TRIO-KENWOOD COMMUNICATIONS, INC.

TS-930 & other models

**SUBJECT:** Incorrect AC line voltage setting

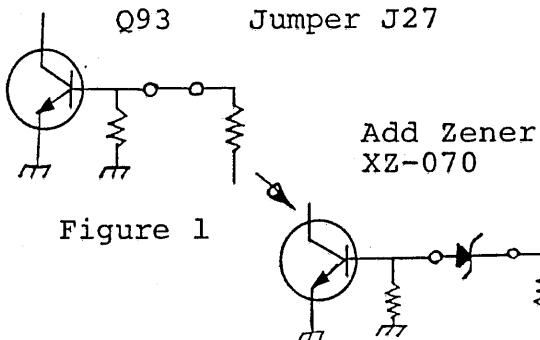
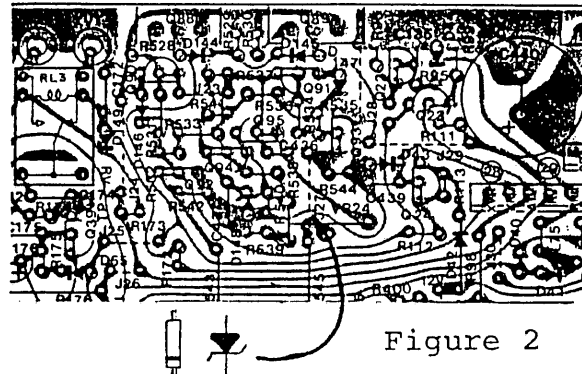
A loss of receiver sensitivity (6-30db) may be caused by shorted switching diodes in the Signal Unit (X57-1000-XX). The following procedure will increase the capability of the unit to withstand high RF voltage levels.

1. Replace Signal unit jumper J27 with an XZ-070 zener diode. (PCB coordinate C-1, see figure 2.)

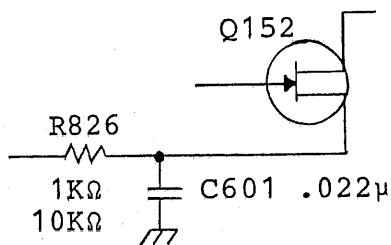
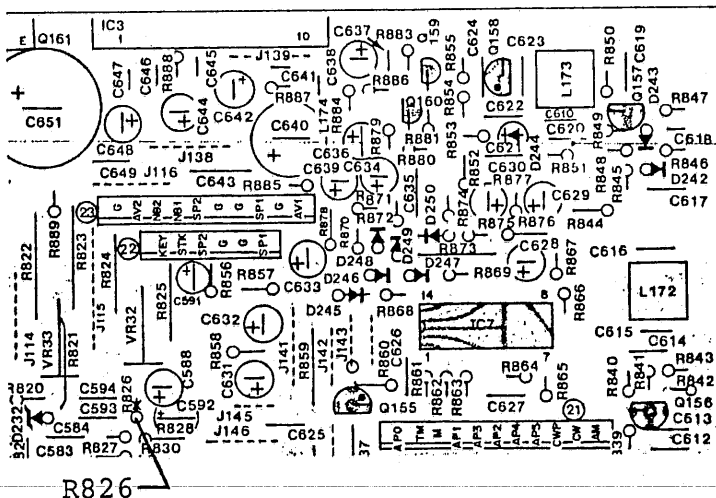
Schematic address: F,8

Some users of the TS-930S have reported a slight change in the CW pitch tone when the MONI switch is turned ON and OFF.

On the Signal Unit (X57-1000-XX) change R826 from a 1K ohm to a 10K ohm, part no. RD14CB2E103J and remove C601, a .022 $\mu$ F capacitor from the foil side of the circuit board.

Remove C601

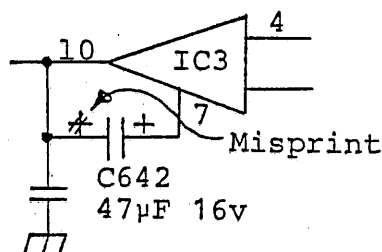
Some users have reported an audio oscillation when the AF gain control is set between 10:00 and 12:00.

The cause may be that Signal Unit (X57-1000-XX) capacitor C642 is installed backwards. See figures below. Please change your service manual schematic to reflect the correct positioning when you check the board.

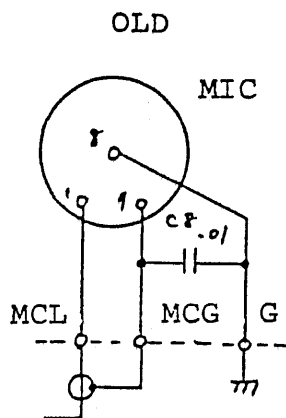
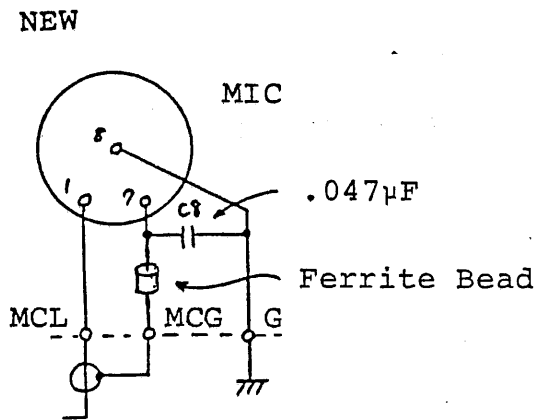
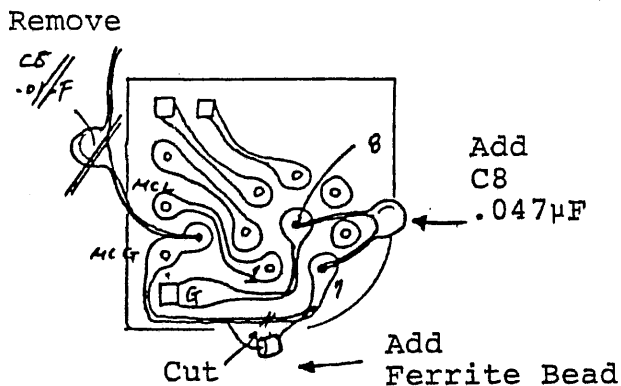
Some users may report RF feedback to the MIC at low frequencies, for example: 3.5 Mhz.

Make the following changes to SW unit (J) (X41-1410-00):

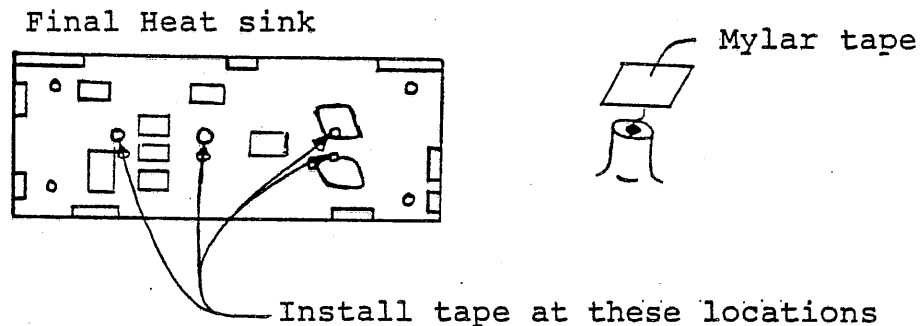
Some users have reported that the ALC meter indication occasionally jumps during long key down periods on the 28 Mhz portion of the bands. The symptom may be caused by the ground foil of the Final Unit (X56-1430-00) coming in contact with one or more of the projections on the final heat sink, due to expansion when the temperature rises.

Apply mylar insulating tape to the projections on the heat sink, to prevent reoccurrence of this symptom. See figures below.

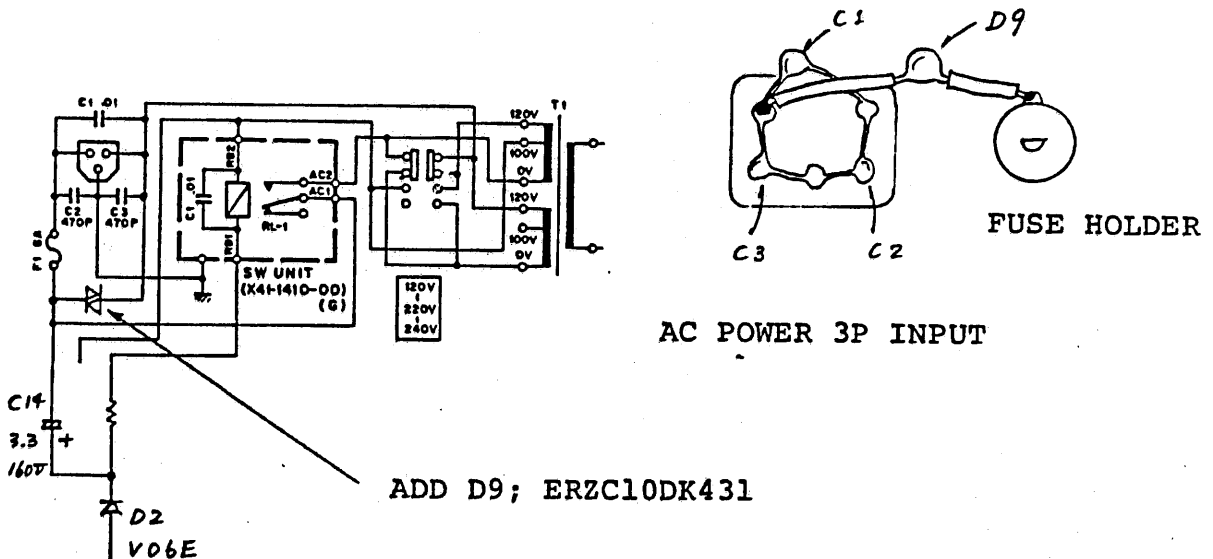
A line surge (exceeding approximately 4.5KV) due to static electricity or nearby lightning discharge may short power relay diode, D2 (V06E), and cause electrolytic capacitor C14 (3.3 uf) to break down. This results in relay chatter and the relay contacts may finally weld.

Addition of the surge absorber to the primary power supply input circuit, as shown below, should help avoid this type of failure.

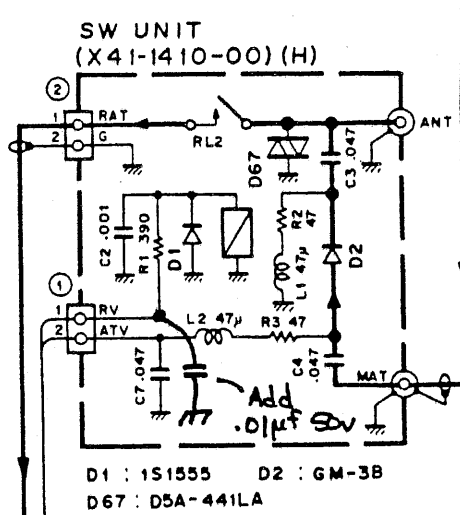
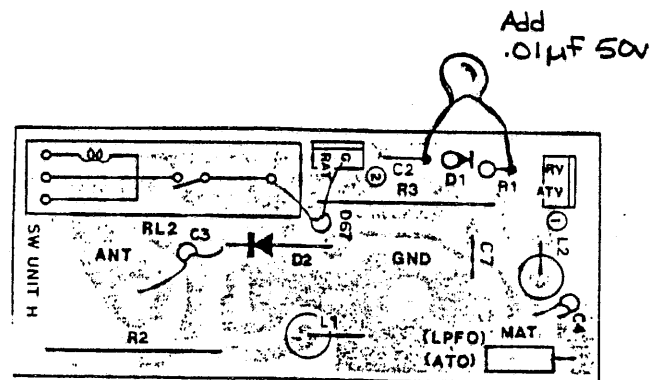
Some users have reported an internal beat tone that appears every 10 KHz, when operating in the range of 20-21.5 Mhz. Apparently the RV terminal of Switch Unit H is being affected by the 1st loop of the PLL unit. The cure is relatively simple. Add a .01 uf 50v disc ceramic capacitor on the RV line of Switch Unit H as shown below.

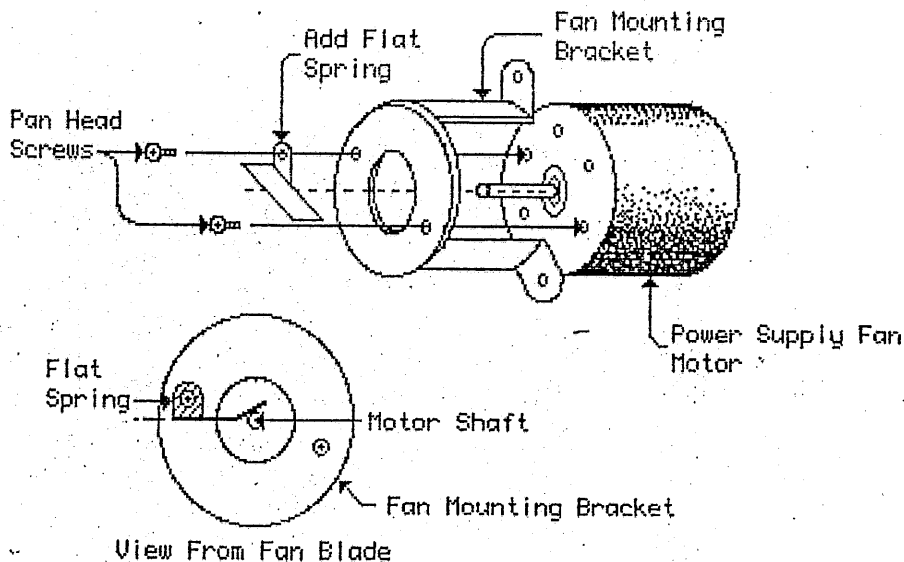
Some users of the TS-930S have reported that the Power Supply Fan motor makes excessive noise. This fan motor was originally designed to drive a pulley system. By adding a small amount of lateral tension to the motor shaft this noise is reduced or eliminated. The procedure listed below should correct any tendency of this motor to make noise.

Add the Flat Spring as shown in the figures below.
