## SERVICE BULLETIN

TS-940S LCD CLOCK DISPLAY ERRATIC OPERATION

TS-940S PLL UNLOCK

TS-940S ANTENNA TUNER RELAYS

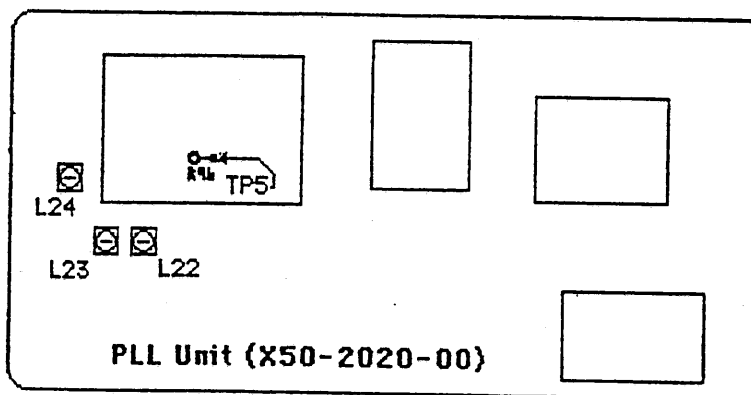
Some users of the TS-940S have reported a blanking of the display accompanied by a loss of transmit and receive. Readjustment of the PLL unit will correct this tendency.

On the PLL Unit (X50-2020-00)

1. Set the Dial frequency for approximately 1.8 Mhz (inside the band).
2. Using an RF probe at TP #5 adjust L22, L23 and L24 for a maximum reading on the meter. You should see approximately 250 mV.
3. Adjustment of L24 will produce the greatest change, which may be up to a 90° adjustment from its present position.

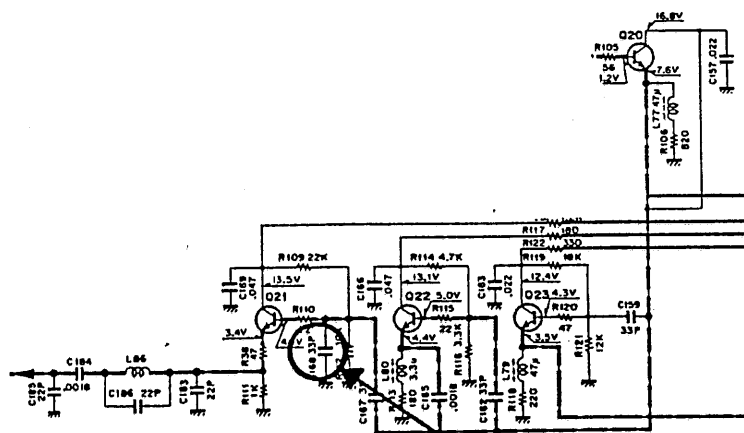
Reports of a PLL Unlock on the lower frequencies may be due to low VCO levels. The following change will increase the VCO level and should prevent reoccurrence of this symptom.

C168.....change to 15 pF 50 v (CC45SL1H150J)

1. On the RF Unit (X44-1660-00) change C168 from a 33 pF capacitor to a 15 pF 50 v capacitor.
2. Readjust the VCO BPF (RF unit L74-76) according to the instructions contained in the TS-940S service manual.

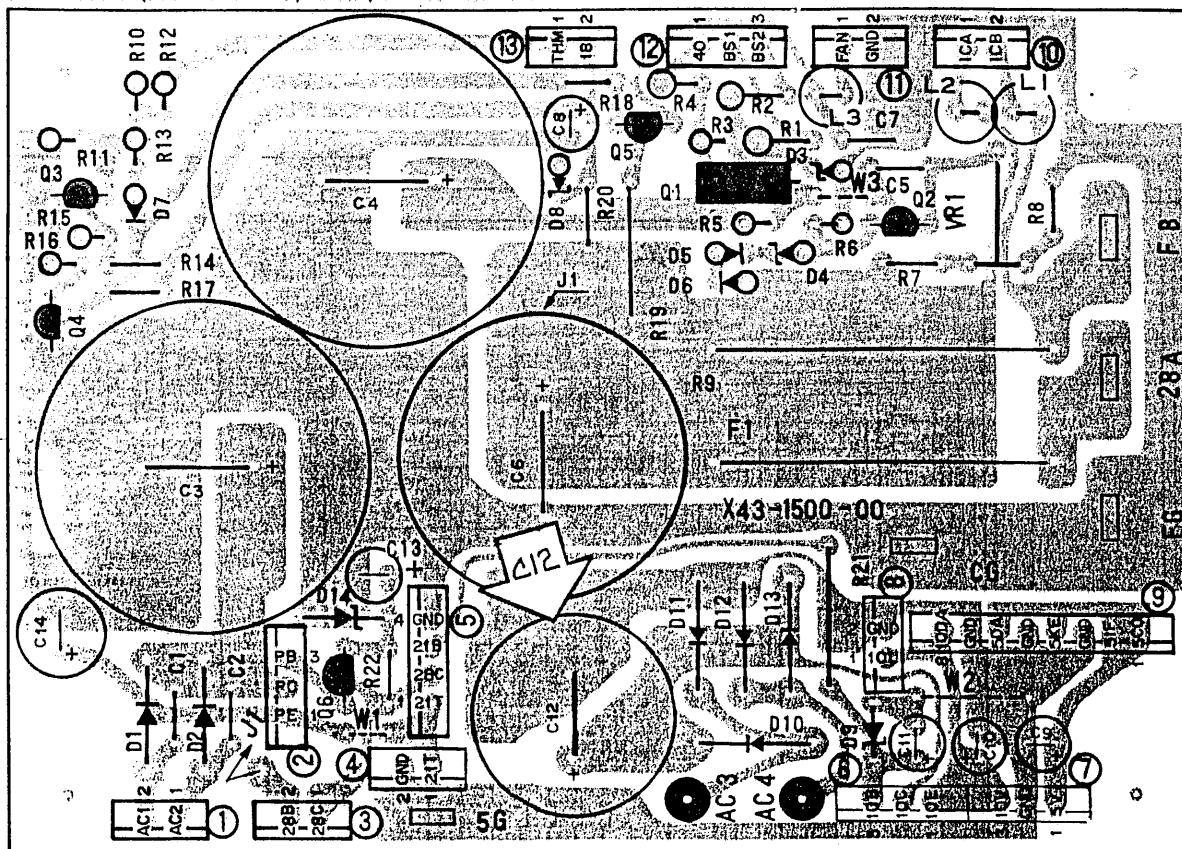
AVR UNIT (X43-1500-00) Component side view

In those areas of the country that are subject to large power line voltage fluctuations, excessive voltage may be applied to capacitor C12 on the AVR Unit (X43-1500-00). These voltage fluctuations might exceed the capacitor breakdown voltage. Replacing capacitor C12 with a capacitor having a higher breakdown voltage will help prevent this potential problem.

On the AVR Unit (X43-1500-00) change C12 from a 6800  $\mu$ F capacitor to a 5600  $\mu$ F 25 v capacitor (C90-2037-05).

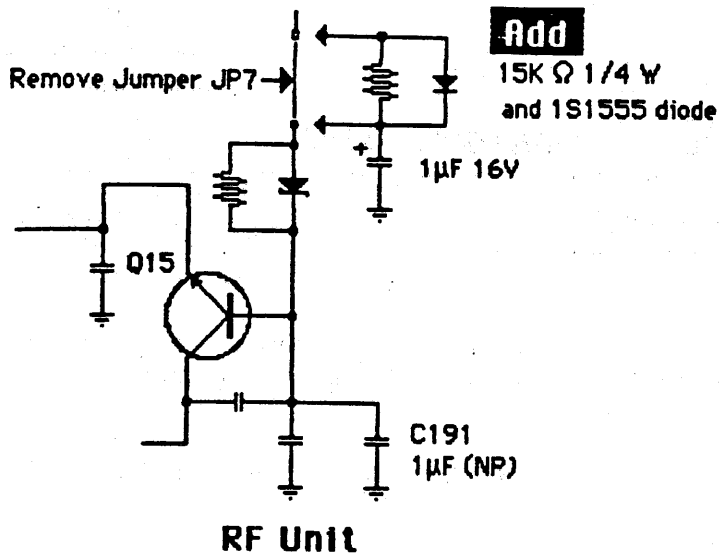
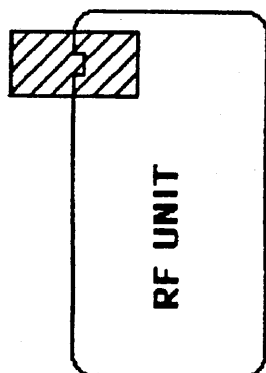
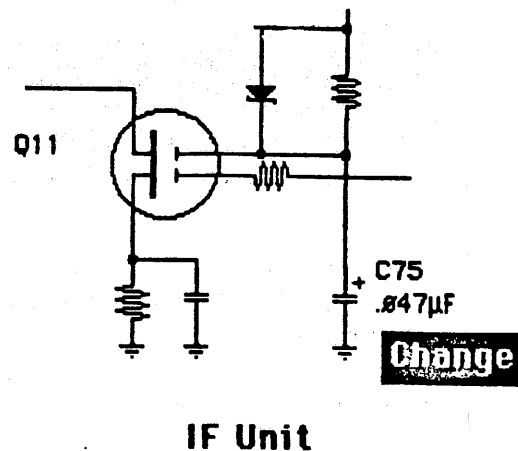
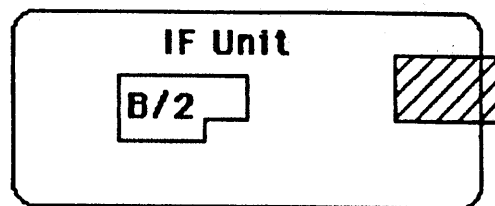
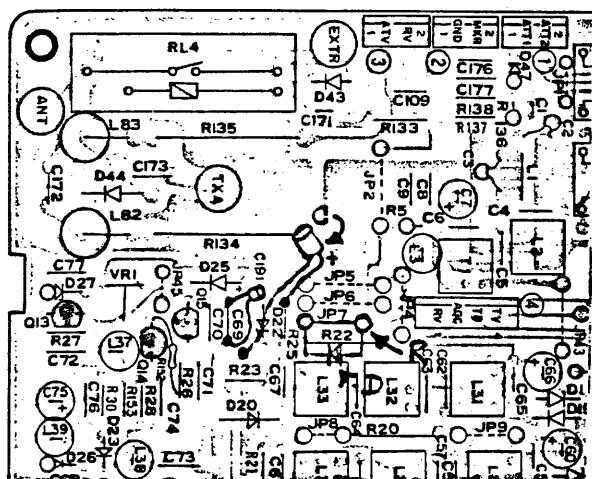
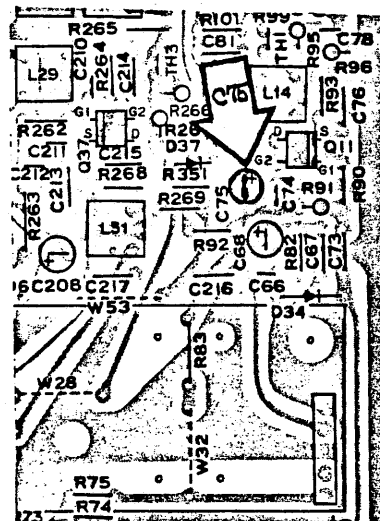
The following changes will improve the adjacent channel rejection of the TS-940S when a relatively strong nearby signal is present (S-4 or above).

1. Remove jumper wire JP7 and replace it with the parallel combination of the 15 k ohm resistor and the 1S1555 diode. Pay close attention to polarity.
2. Add the 1 uF capacitor as shown in the diagram.

Change capacitor C75 from a 1 uF 50 v capacitor to a .047 uF 50v capacitor.

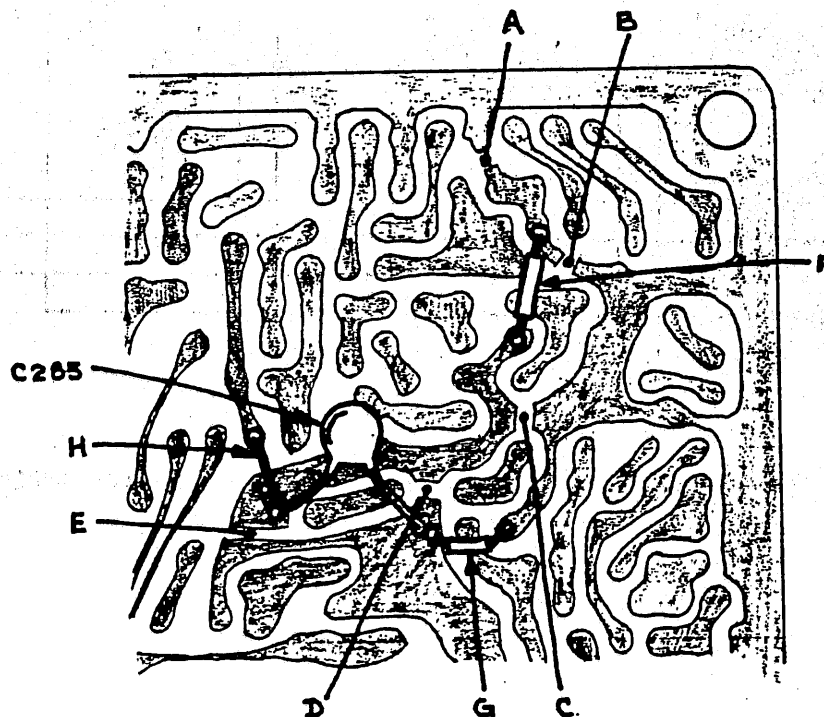
For reports of a low level audio hum superimposed on the normal transmitted audio, especially when the Speech Processor is used perform the following modification.

- Cut the foil patterns labeled A-E in figure 1.
- Add the jumpers wires labeled F-H in figure 1.
- Add capacitor C285 .01 uF 50 v as shown.

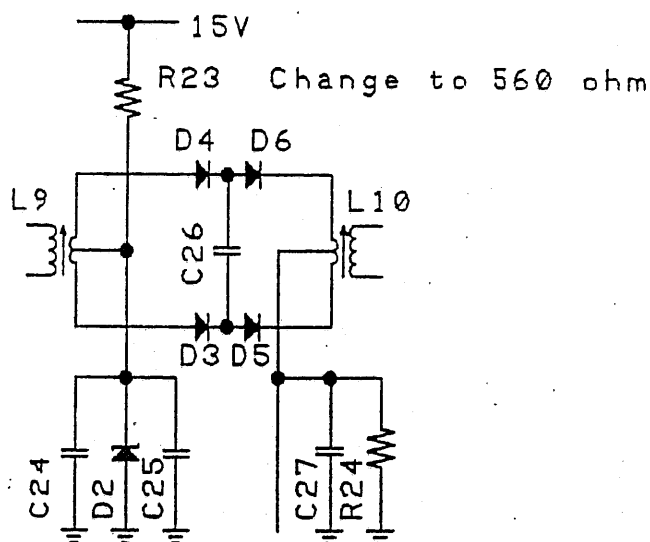
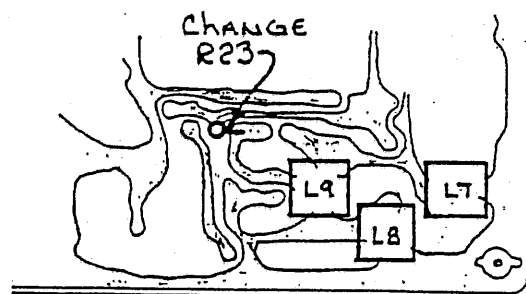
IF Unit (X48-1430-00)  
Foil Side

The following change will reduce the tendency of the Zener Diode in the Noise Blanker circuit to cause an increase in the ambient noise level. This change ensures that no current flows thru this diode in the normal receive position.

On the IF UNIT (X48-1430-00) change R23 from 330 ohms to 560 ohms.

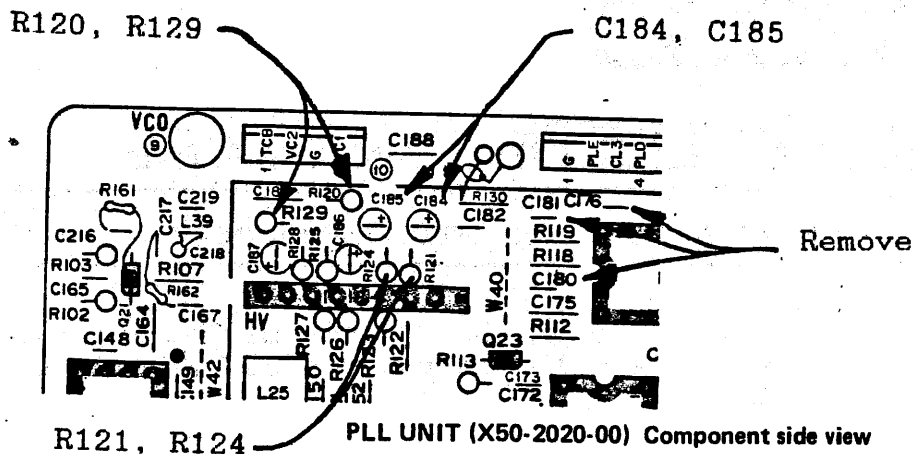
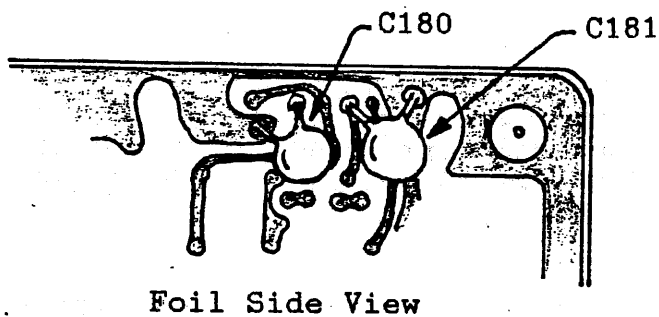
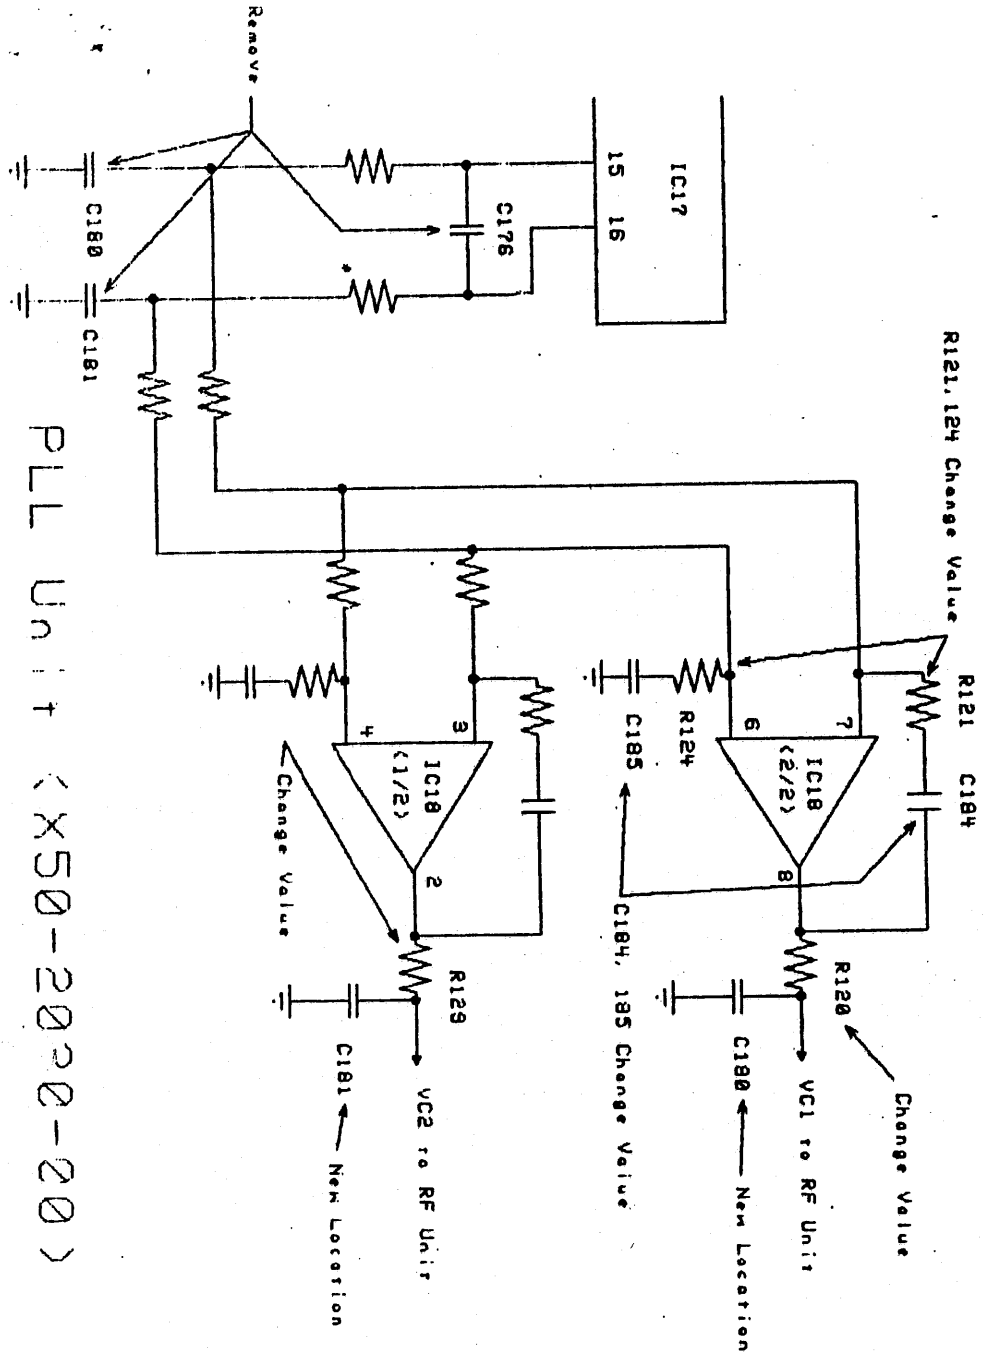
# PLL UNIT

The Carrier to Noise ratio of the TS-940S may be improved by the following changes. This bulletin supersedes bulletin number 911 dated September 15, 1986.

On the PLL UNIT (X50-2020-00) remove capacitors C176, C180, and C181. Change resistors R120 and R129 from 470 ohms to 3.3 K ohms. Change resistors R121 and R124 from 1 K ohm to 680 ohms. Change capacitors C184 and C185 from .22 uF to .33 uF 35V tantalum capacitors. Install C180 and C181 in the positions shown in the accompanying diagrams. The use of new capacitors is recommended to improve reliability, don't try to reuse the old capacitors! Capacitors C181 and C180 should be attached to the foil side of the PLL unit.

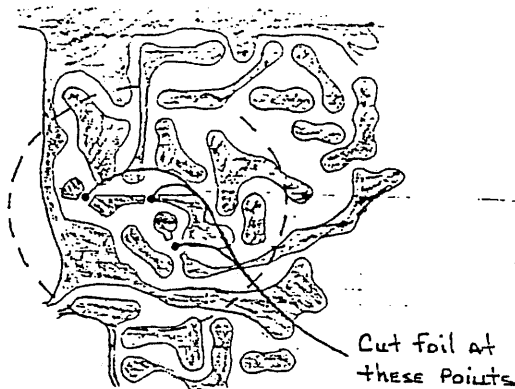
FIGURE 1

In some TS-940S below S/N 711xxxx, a "popping" or "clicking" noise may be heard when the squelch circuit is opened or closed. This may be more noticeable when an optional CW filter is installed. The following procedure will minimize the noise.

8. Using a small craft knife, cut the foil at the 3 points shown in figure 1 (top right corner of the board).
9. Unsolder and discard resistors R194 and R197. They are mounted on the component side of the board and soldered on the foil side.

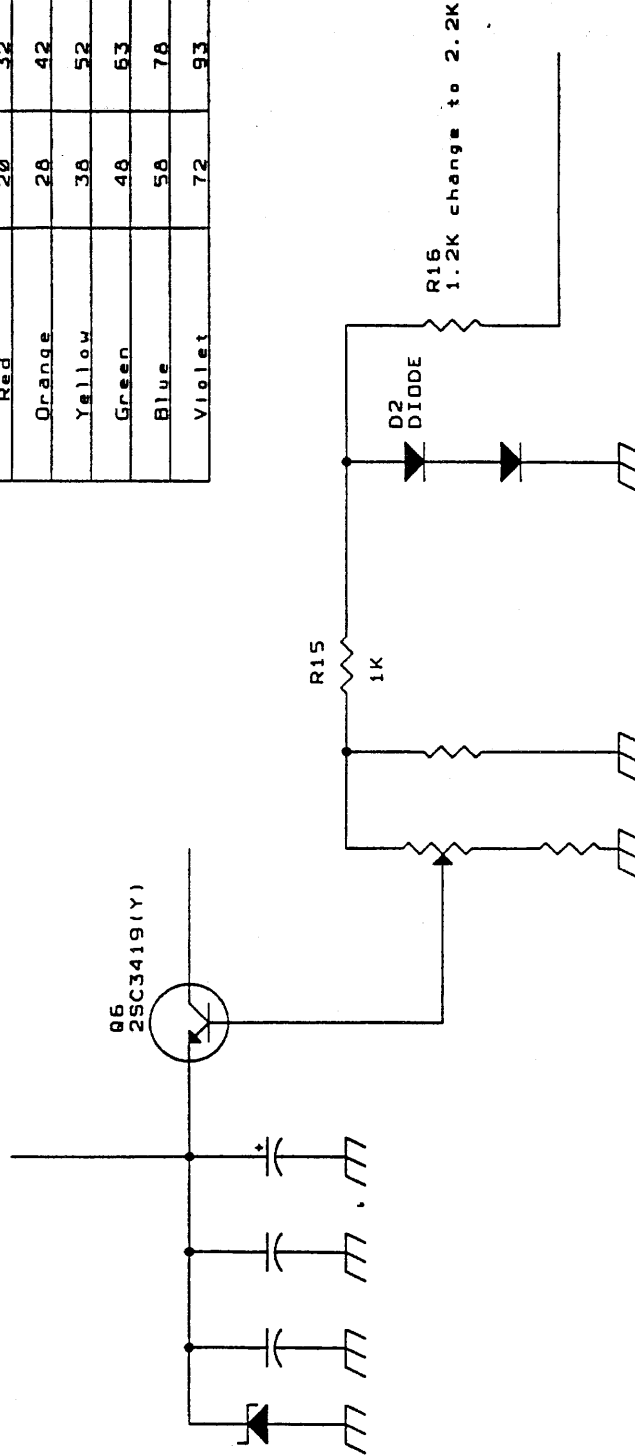
Some MRF-485 transistors are being supplied by Motorola with a Green or Blue color ranking. If these transistors are installed without modifying the driver bias circuit there is a very strong possibility that they will fail within a very short time frame.

These high gain transistors cause the circuit to become unstable which can cause the circuit to break into self oscillation, and therefore self-destruct.

Use of Red, Orange, or Yellow hfe color rankings is recommend. These lower gain transistors work just fine and do not suffer from the circuit instability problem. If you are only able to obtain the higher gain transistors you will need to modify the varistor/temperature compensation circuit on the final unit (X45-1400-00) by changing R16 from 1.2K to 2.2K ohms.

**Caution:** If using a Green or higher hfe rank one of the above countermeasures must be taken depending upon the serial number of the set. After replacing the drivers check the bias current. We recommend transmitting for 1 hour in the SSB mode with no modulation into a dummy load. After this time frame check the bias current. It must not exceed 300 mA on the original radio. If the current changes you must change R16 from 1.2K to 2.2K.
