# SERVICE BULLETIN

from: TRIO-KENWOOD COMMUNICATIONS, INC.

TR-9000

SUBJECT: TR-9000 CW, SSB TX INSTABILITY

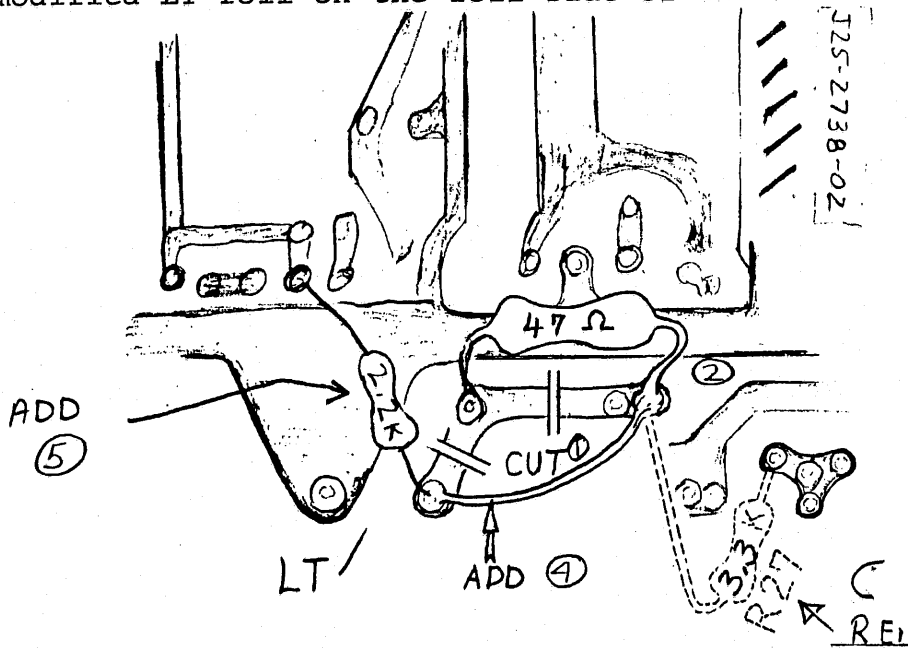
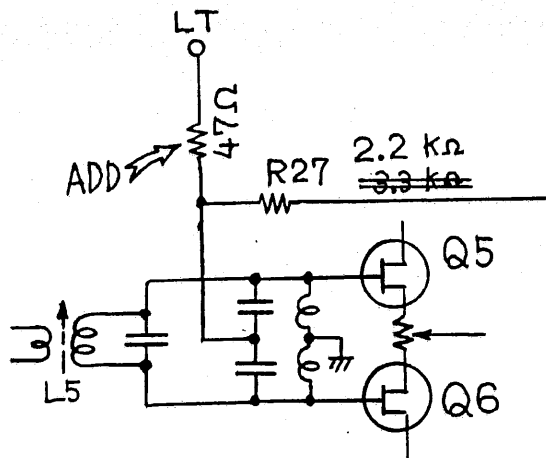
Complaints of FMing in SSB, or CW chirp may be eliminated by minor changes to the TX mixer circuit.

On the TX unit X56-1370-10, perform the following changes:

1. Cut the LT foil path.
2. Install a  $47\Omega$  resistor on the foil side of the PCB.
3. Remove R27,  $3.3K\Omega$  and delete.
4. Jumper the cut foil.
5. Install a  $2.2K\Omega$  resistor from Q12 collector to the modified LT foil on the foil side of the PCB.

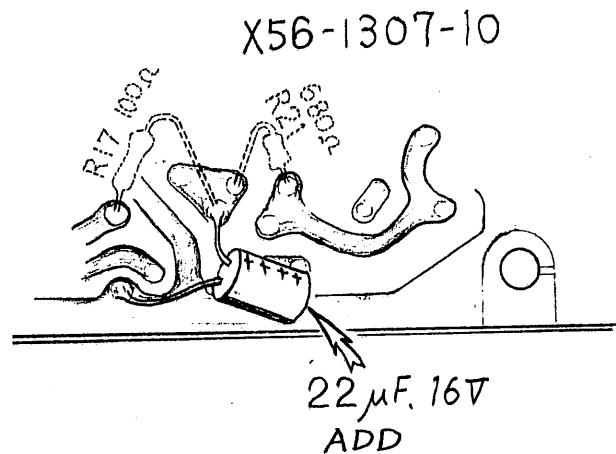
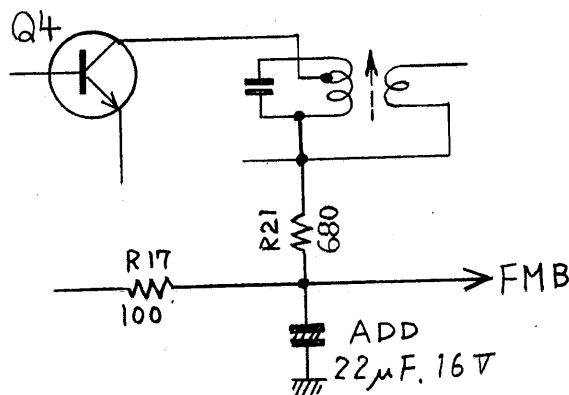
SUBJECT: TR-9000 TX PULSE NOISE IN SSB MODE

Pulse noise heard during SSB transmission may be reduced or eliminated by adding one capacitor to the TX unit.

On the TX unit X56-1307-10 add a 22 $\mu$ F 16V radial lead cap to the FMB line, as illustrated, on the foil side of the PCB. No adjustments are necessary.

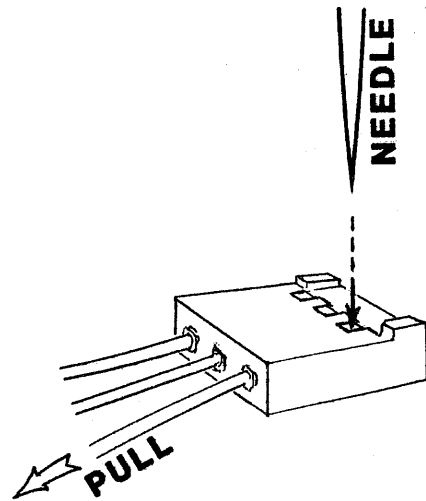
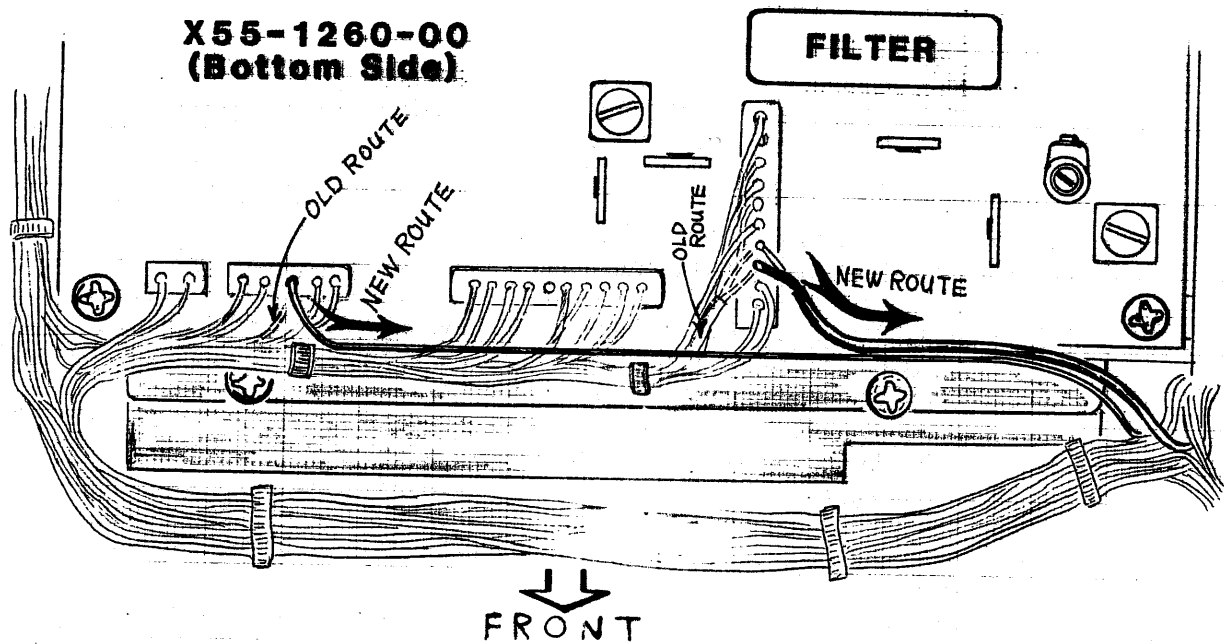
**SUBJECT:** TR-9000 Transmitter Sideband Carrier Balance

Distorted sideband transmission may have one of two causes. If normal alignment does not cure the problem, distortion or poor carrier suppression may be improved by rerouting two leads in the wire harness.

4. Carefully unplug each of these connectors by gripping the connector housing with a long-nosed plier.
5. Extract the terminal from the housing by depressing the locking tab and simultaneously withdrawing the lead with terminal. (see illustration on page 2).

6. Reroute these two lines from the behind the Mode switch, between the chassis and control unit, then left to their original connectors. Reinstall the terminals in their original positions in the connector housing.

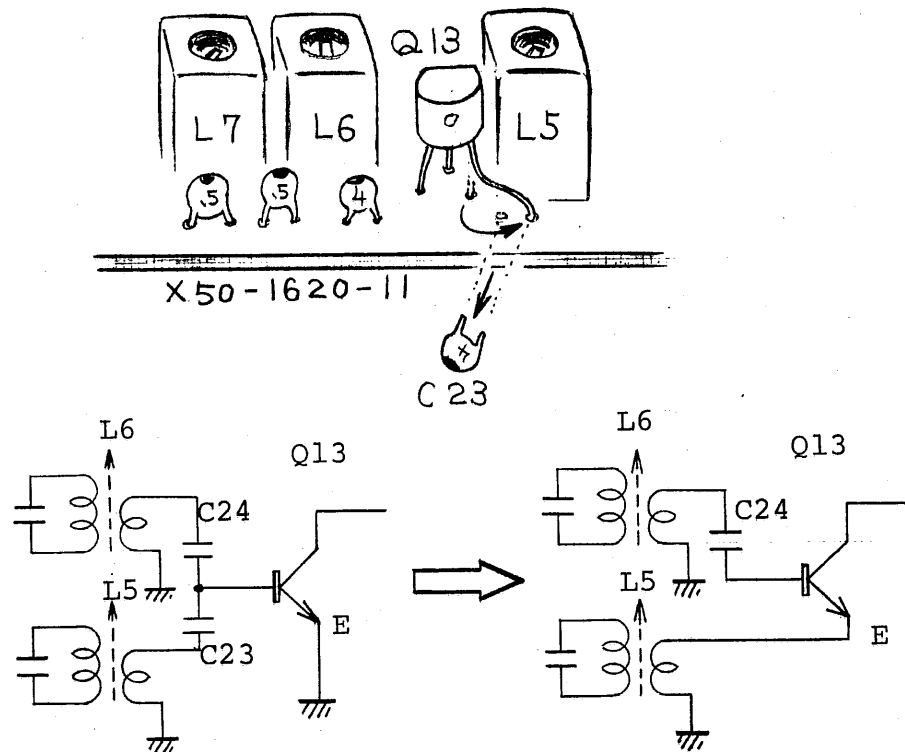
TP-3

SUBJECT: TR-9000 Temperature Stability Improvement

PLL noise or unlock at high temperature may be cured by changing a mixer feed point in the PLL.

Measure TP3 on the PLL unit. If greater than 0.5V RMS signal is available, this change will not be required. If less than this level is present, proceed.

On the PLL unit X50-1620-00 at Q13:

1. Remove and delete C23.
2. Connect Q13 emitter to L5 "hot" (original C23 take-off.)
3. Realign L5, 6, 7 for at least 0.5V RMS at TP3.

Alignment Note: To align L6 & 7, first position the slugs flush with the tops of the coils, then alternately adjust these two coils for maximum output at the first peak into the coil (fundamental frequency). Then align L5 for maximum.
