SERVICE NOTES

B&W MODEL 5100 TRANSMITTER

MODIFICATION TO REDUCE BACKWAVE

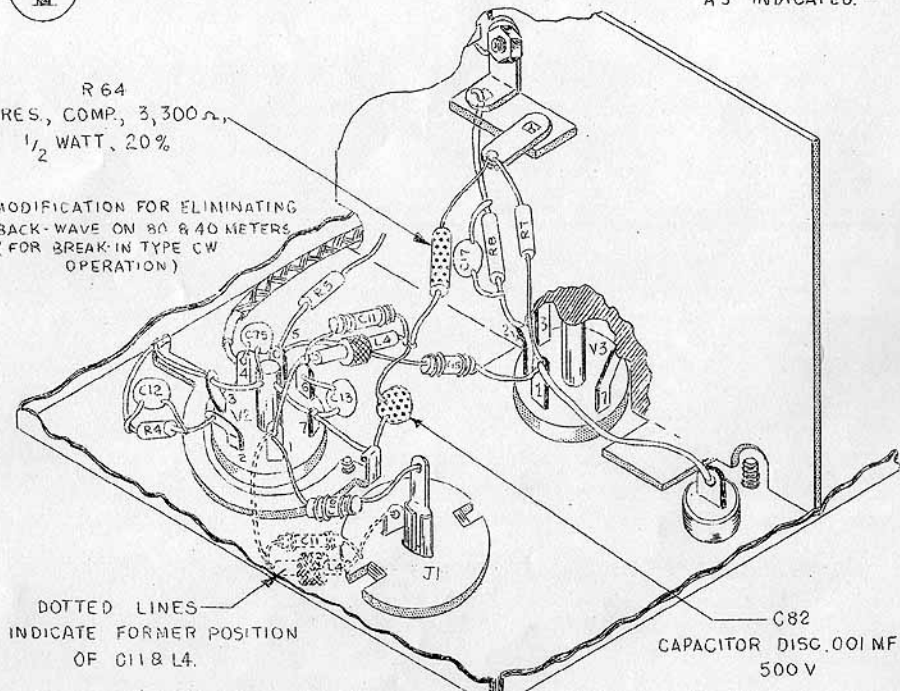
PARTIAL WIRING DIAGRAM
BUFFER-XTAL OSC.

R64 & C82 TO BE ADDED
CHANGE POSITION OF C11 & L4
AS INDICATED.

MODIFICATION FOR ELIMINATING
BACK-WAVE ON 80 & 40 METERS
(FOR BREAK-IN TYPE CW
OPERATION)

1. Remove the "Buffer-Xtal Osc." Unit from the Transmitter.
2. Remove bottom shield from the unit by removing the six screws on the sides.
3. Referring to the accompanying drawing, disconnect the parallel combination of L4 and C11 from the ground lug of J1, and connect and solder to junction of R64 and C82 as shown.
4. Connect and solder other end of C82 to ground lug as shown.
5. Connect and solder R64 and R7 as shown.

The Buffer Modification is now complete, and should be checked to make sure that this wiring agrees with that shown on the drawing. The shield may then be placed back on the Buffer Chassis, and the Unit reinstalled in the Transmitter.

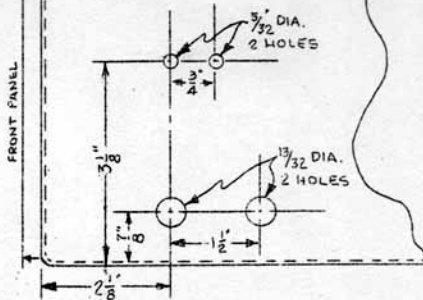
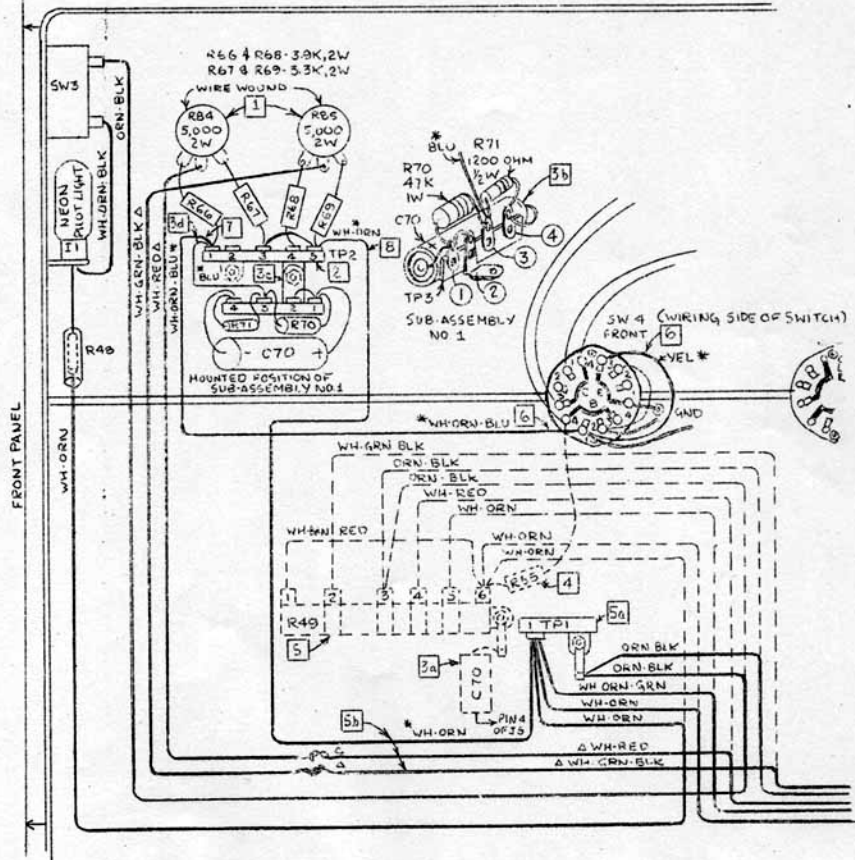
PARTIAL TOP VIEW OF CHASSIS

1. X - INDICATES 4 ADDITIONAL WIRES (WH-OR, WH-ORN, BLU, BLU #VEL)
2. A - INDICATES EXISTING WIRES WHICH ARE TO BE SPLICED FOR ADDITIONAL LENGTH (WH-RED & WH-GRN-BLK)
3. DASHED LINES (---) INDICATE FORMER ARRANGEMENT, SOLID LINES & HEAVY CONNECTIONS (—) SHOW MODIFICATION.

1. Place two 5,000 ohm pots. (R84 & R85) in 13/32" dia. holes, and secure in place.
2. Place five terminal tie point (TP2) in 5/32" dia. holes. Tighten the nut nearest the front panel, leave other nut loose for mounting of sub assembly #1. At this point connect and solder resistors R66, R67, R68, and R69 as shown, also connect jumper wire between 3 and 5 of TP2.

Bias modification is now complete. R84 adjusts the grid bias on the final R.F. tubes, while R85 adjusts the grid bias on the Modulator Tubes.

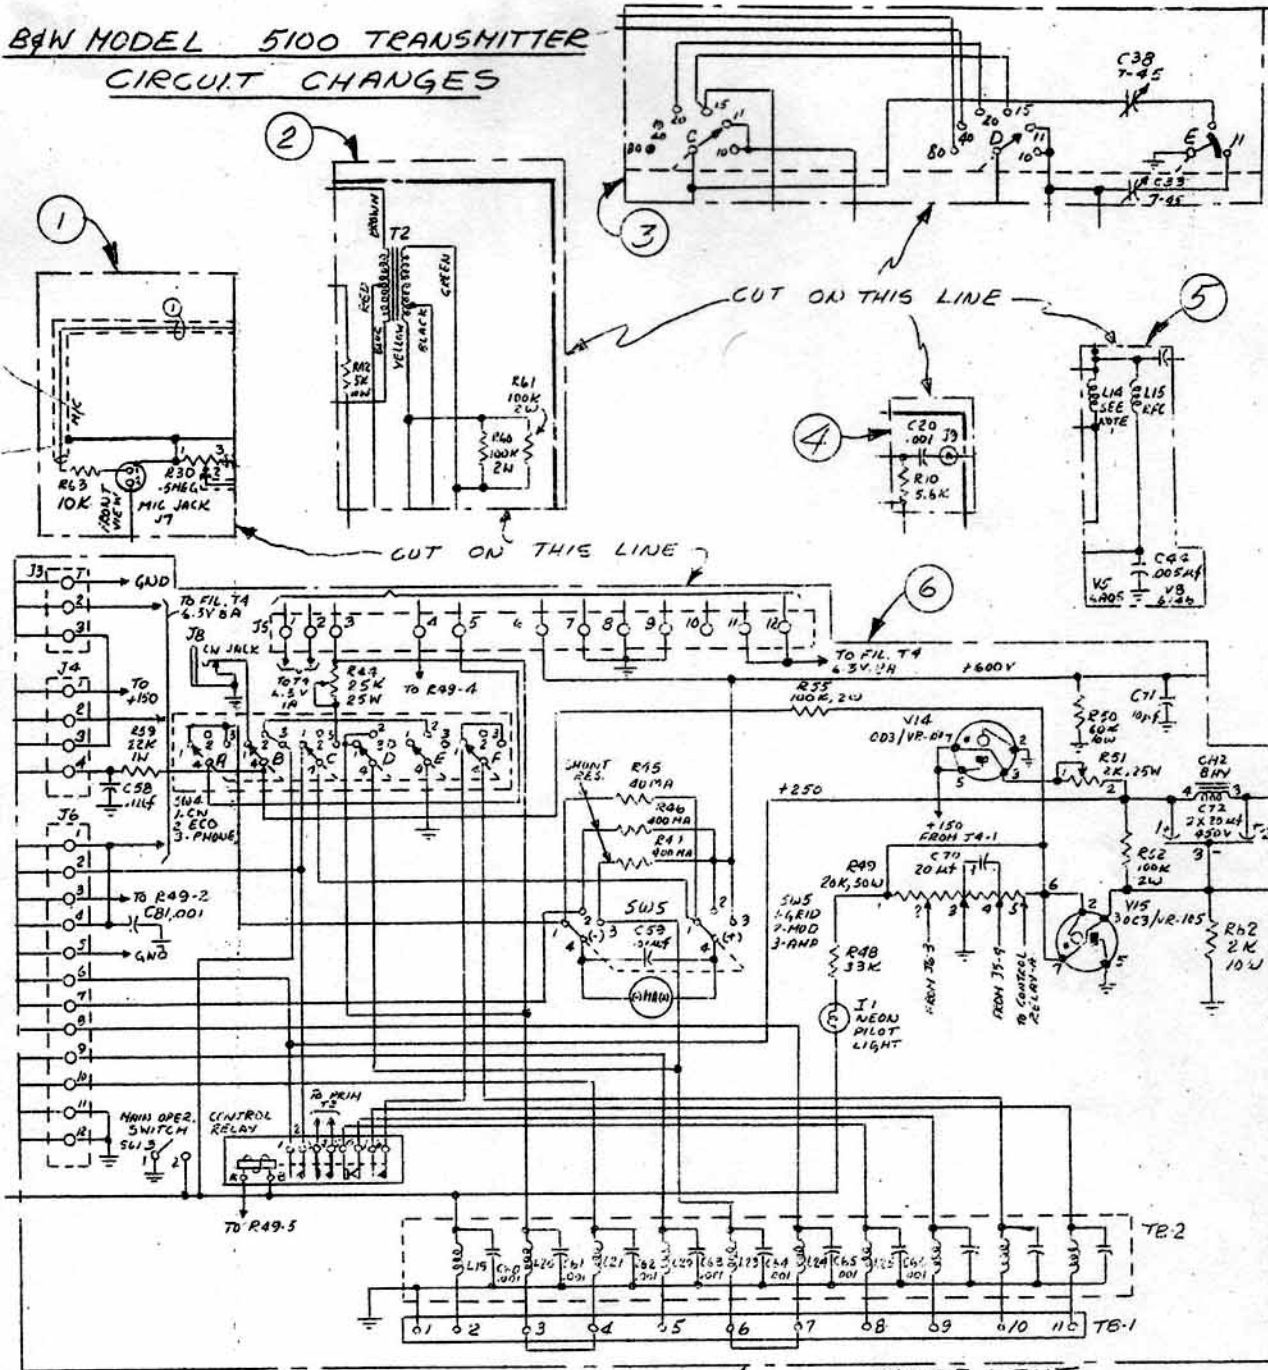
CIRCUIT CHANGES

NOTE:
 THESE CORRECTED CIRCUITS HAVE BEEN DRAWN TO SCALE, CUT OUT AS SHOWN AND PASTE ON INSTRUCTION MANUAL SCHEMATIC IN PROPER PLACES AS INDICATED BY CIRCLED NUMBERS ①②③④⑤⑥.

SCHEMATIC ERRORS - See corrected circuits attached to these Service Notes.
