# SERVICE NOTES

# National

Service Bulletin FSN-30

Subject: NC-300 Changes

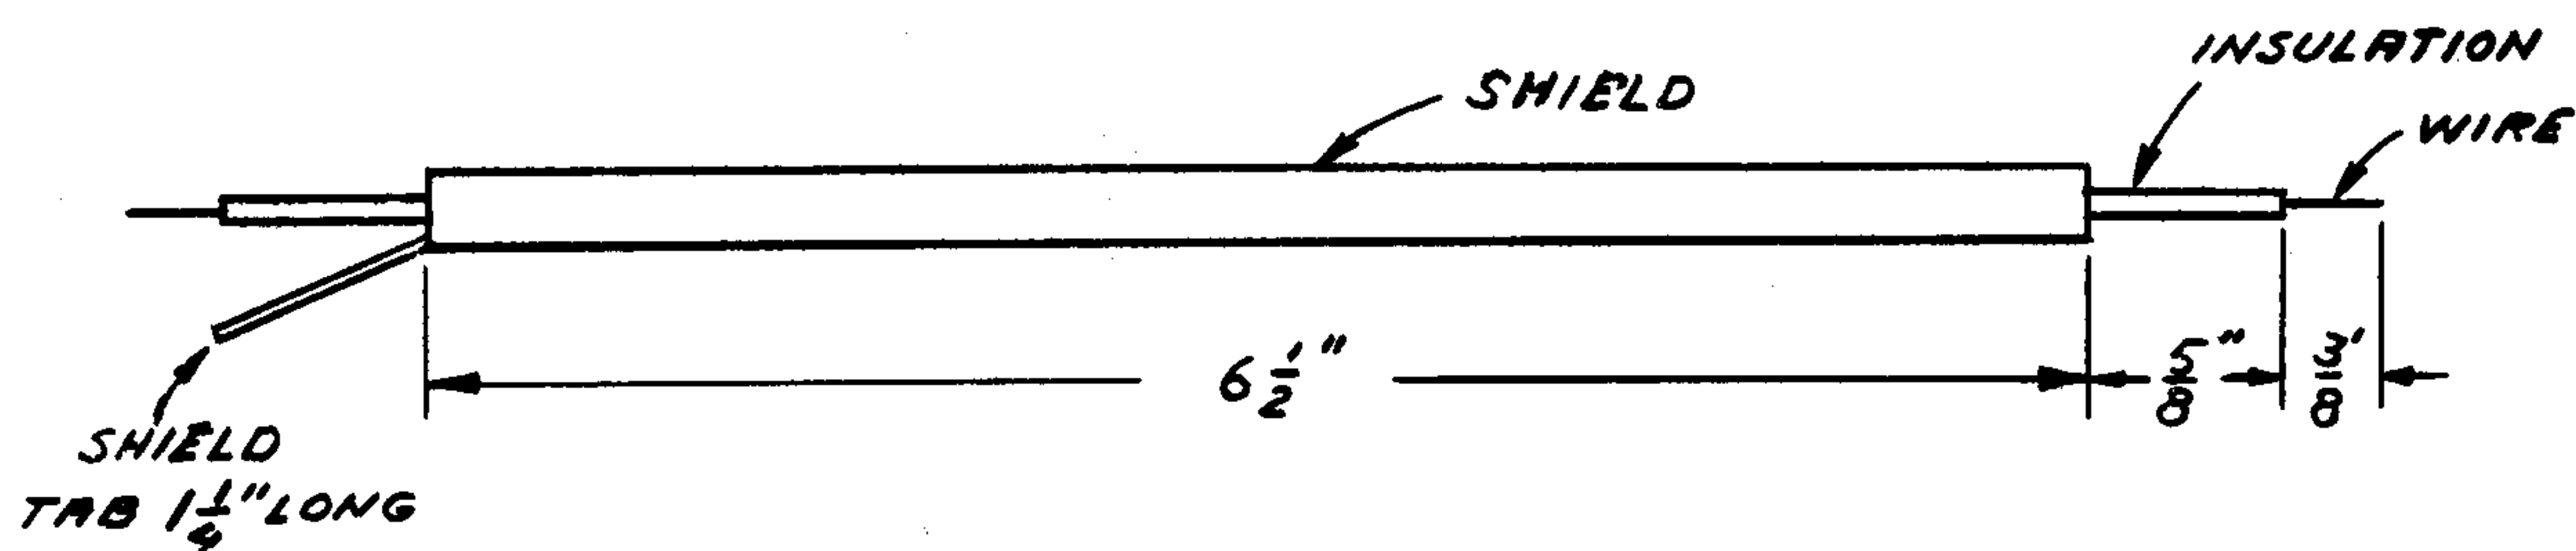
A shielded lead should be constructed as shown below:

- A. Replace shielded lead from L4 to grid of second converter, V3 with above lead, placing it under phasing control shaft as shown in the pictorial diagram below.

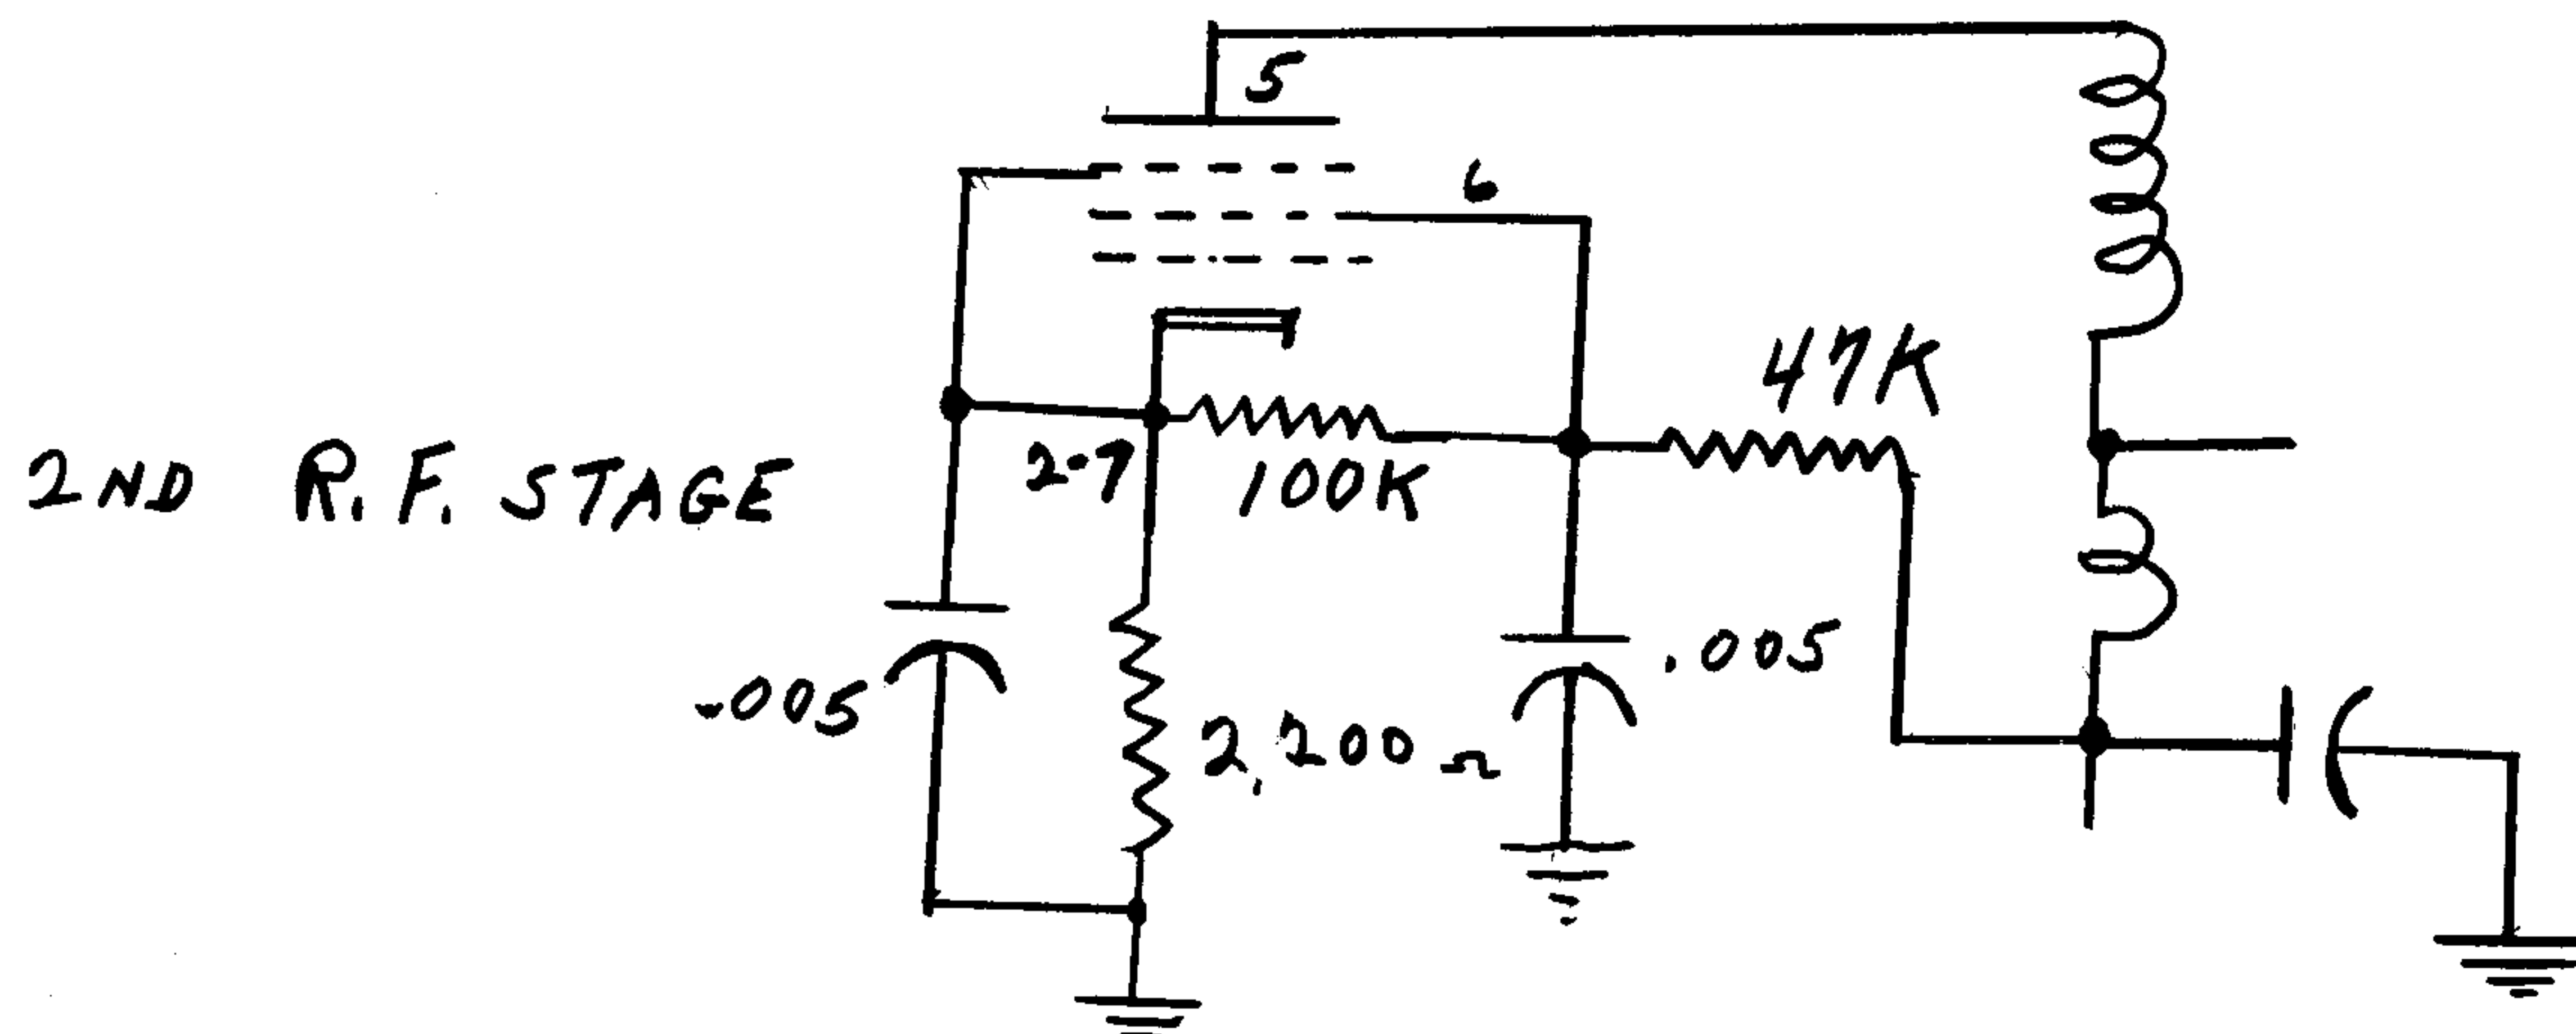
The following changes are recommended in the 6-meter converter to reduce cross-modulation:

Change cathode resistor in 6AK5 2nd R.F. amplifier stage from 470 ohms  $\frac{1}{2}$  watt to 2200 ohms  $\frac{1}{2}$  watt

A 100,000 ohm  $\frac{1}{2}$  watt resistor should be connected between Pin #6 and Pin #2 - 7 of the same 6AK5 2nd R.F. stage

Revised circuit below:

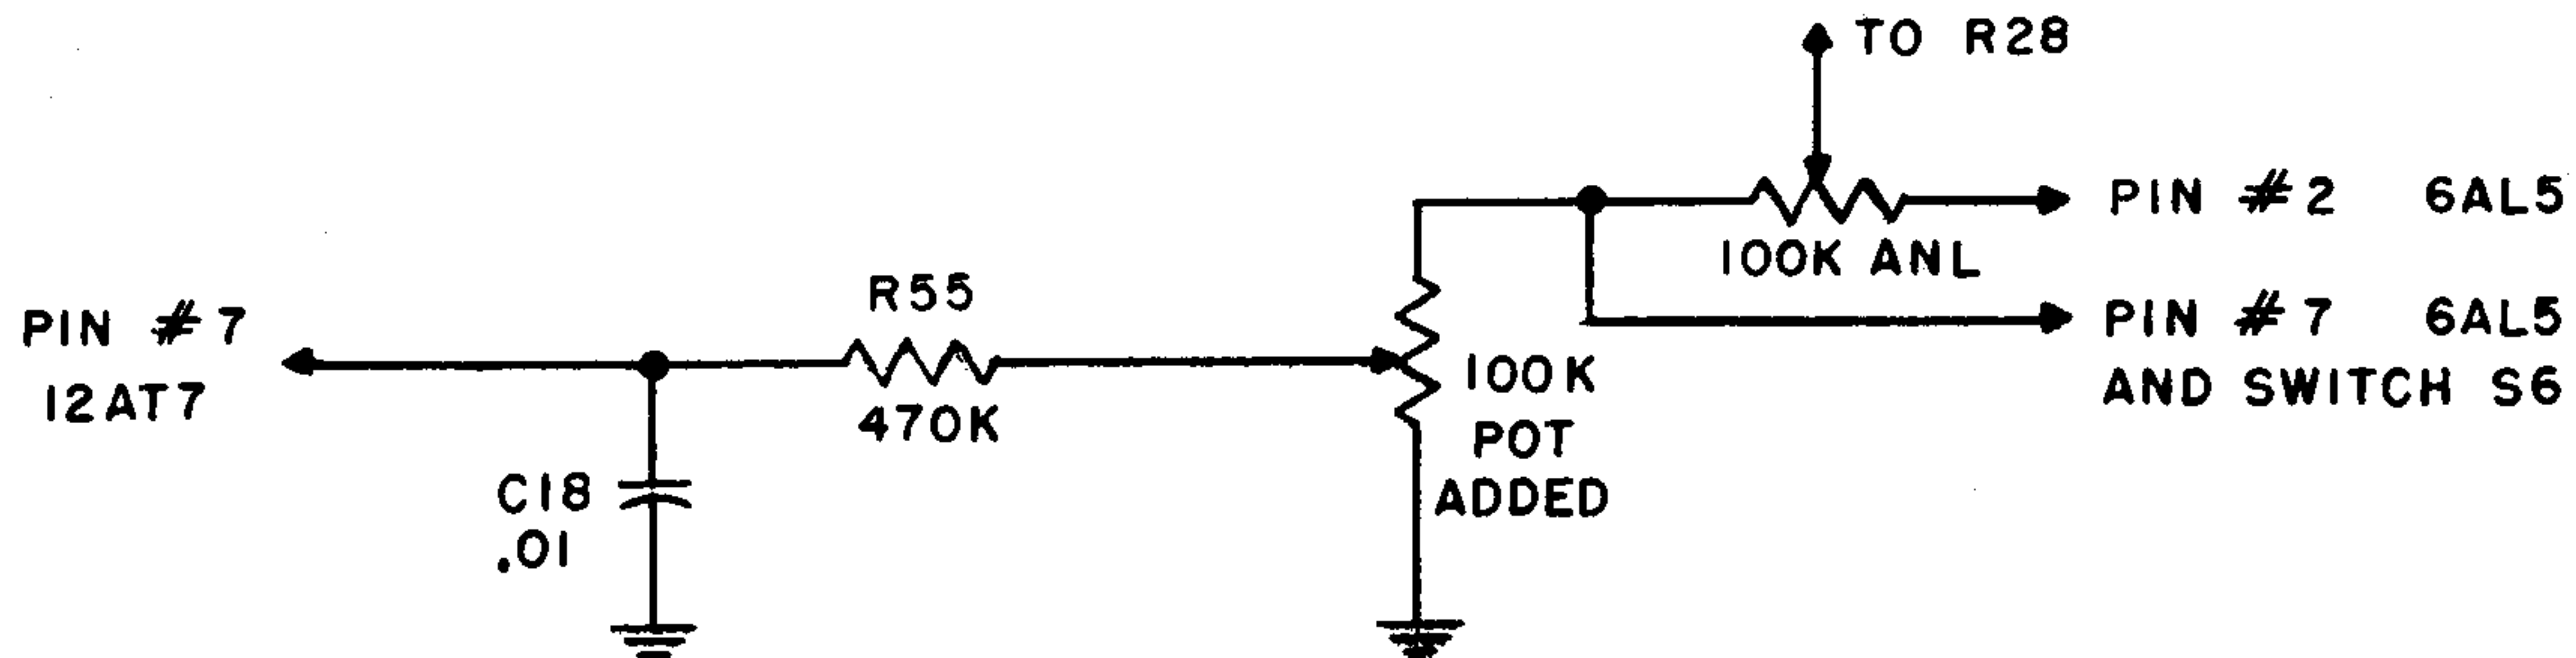
Some users of the NC-300 have complained about the fact that the "S" meter on the NC-300 seemed too sensitive. This may be adjusted in two ways to satisfy the individual user.

1. To decrease sensitivity of the "S" meter by a fixed amount, decrease the value of R-30 (68K 1/2 watt).
2. To decrease or increase the sensitivity of the "S" meter by a variable amount, replace R-43 (33K 1/2 watt) and R-30 (68K 1/2 watt) with 100 K potentiometer, connect arm of potentiometer to R-55 (47-0K 1/2 watt).

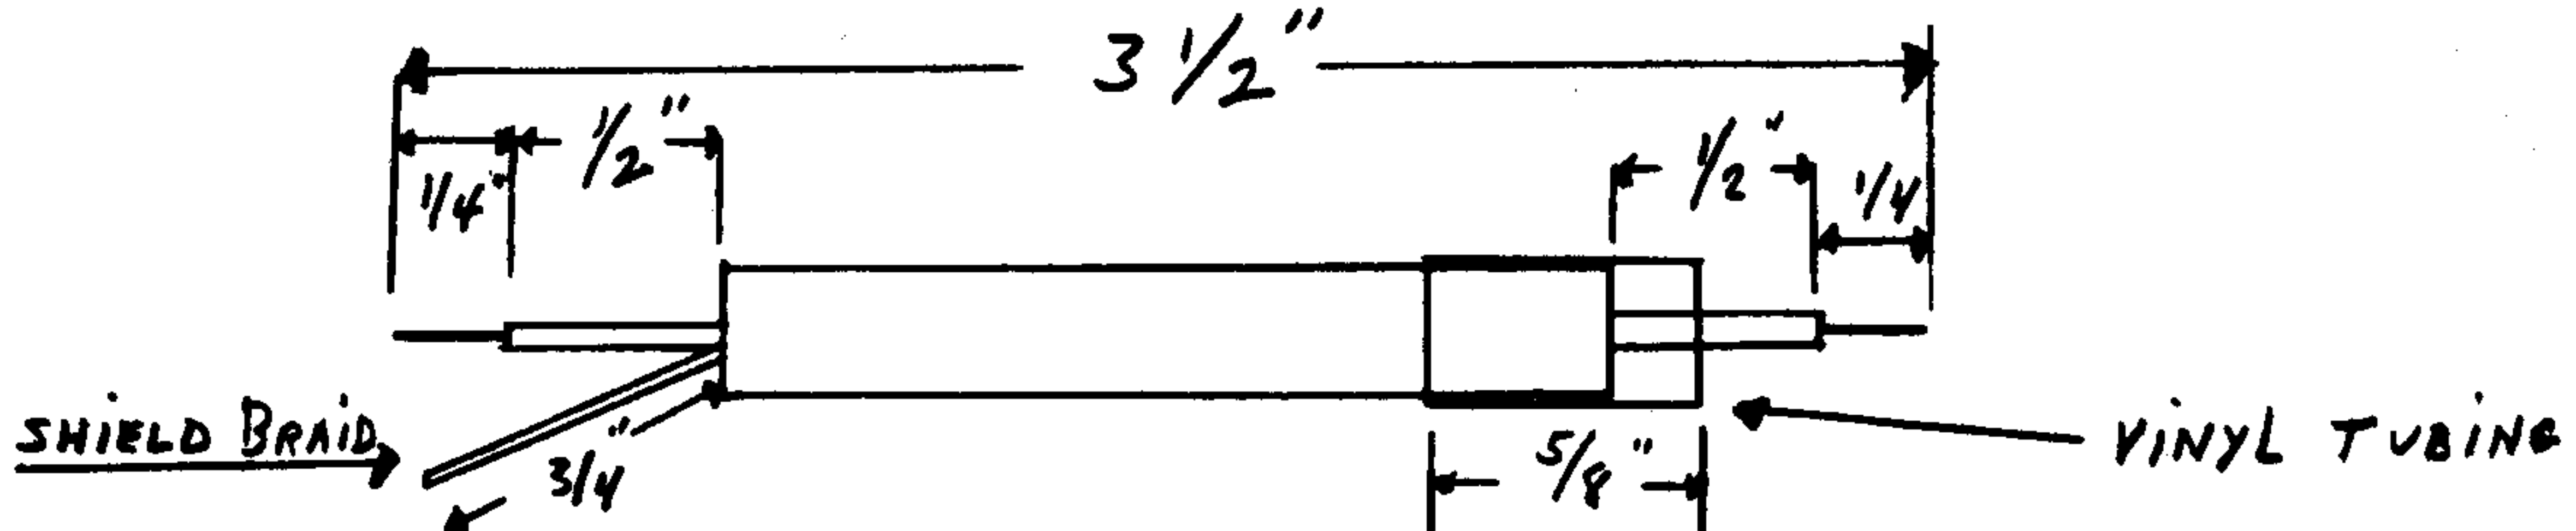
Subject: Additional Notes on Reduction of Spurious Responses  
and B.C.I. in NC-300 Receivers

1. One shielded cable should be substituted for the blue lead connecting the plate of the first mixer (V2 Pin No. 9) to T3 (B). Drawing of cable below. The vinyl tubing is used to prevent grounds to other sections of the circuitry. Shield tab can be connected to the slug cup of L2-A which should already be grounded in accordance with FSN-33. It may be necessary to repeak L2-A after installation of this shielded lead.

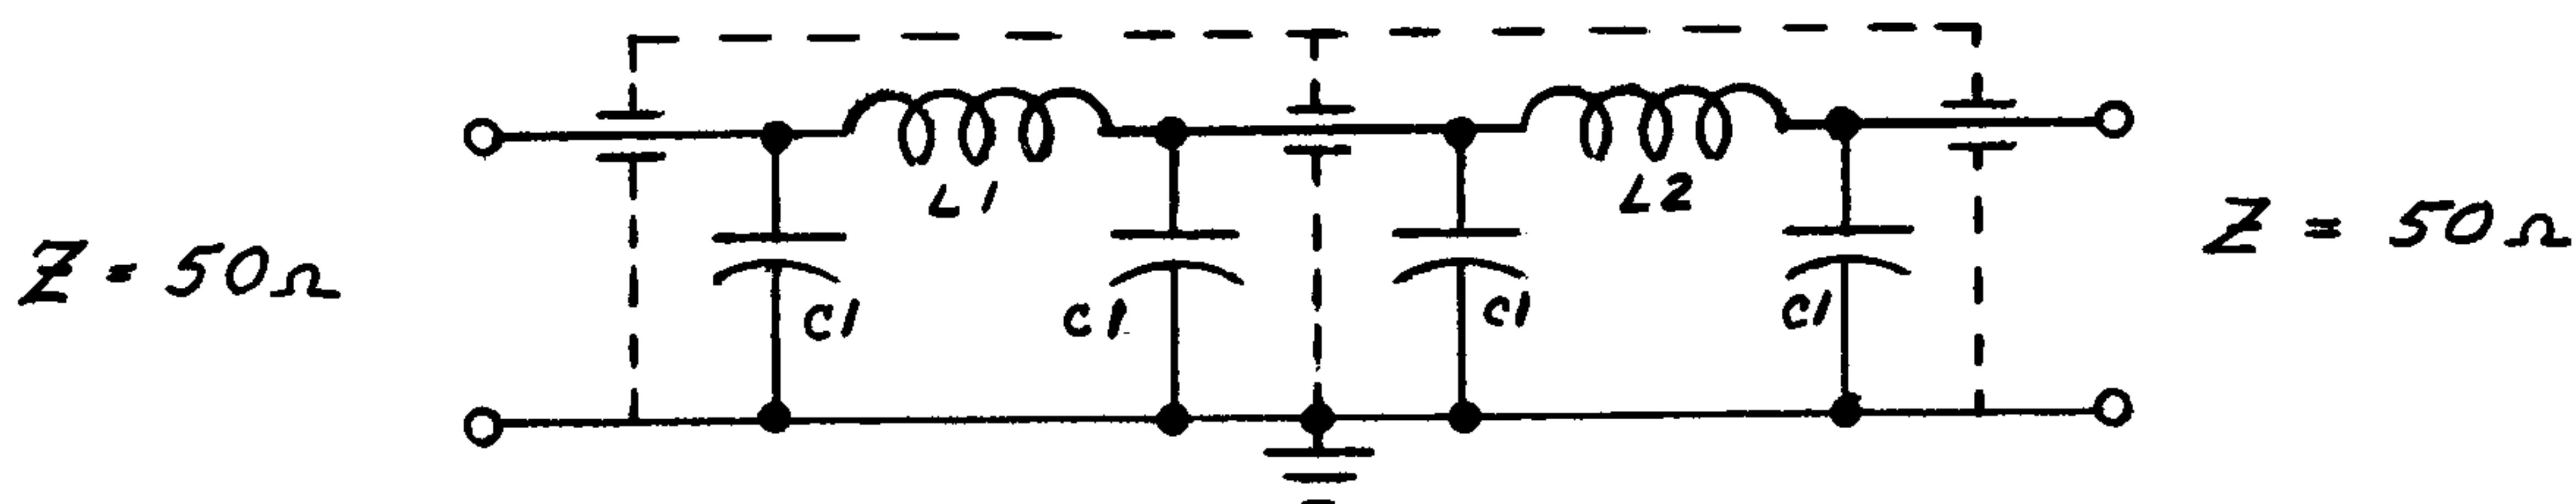
In certain metropolitan areas, I.T.V. is experienced on the 21 mc, 28 mc and X bands of the NC-300. This can be minimized by proper selection of antenna and the use of a low pass filter shown in the diagram below. This filter should be inserted in series with the antenna and located as close as practicable to the antenna terminals on the back of the chassis. A good earth ground helps considerably.

L1 = .4 uh      10 Turns #20 on 3/8" form spaced 1/2"  
L2 = .4 uh  
C1 = 80 uuf Ceramic

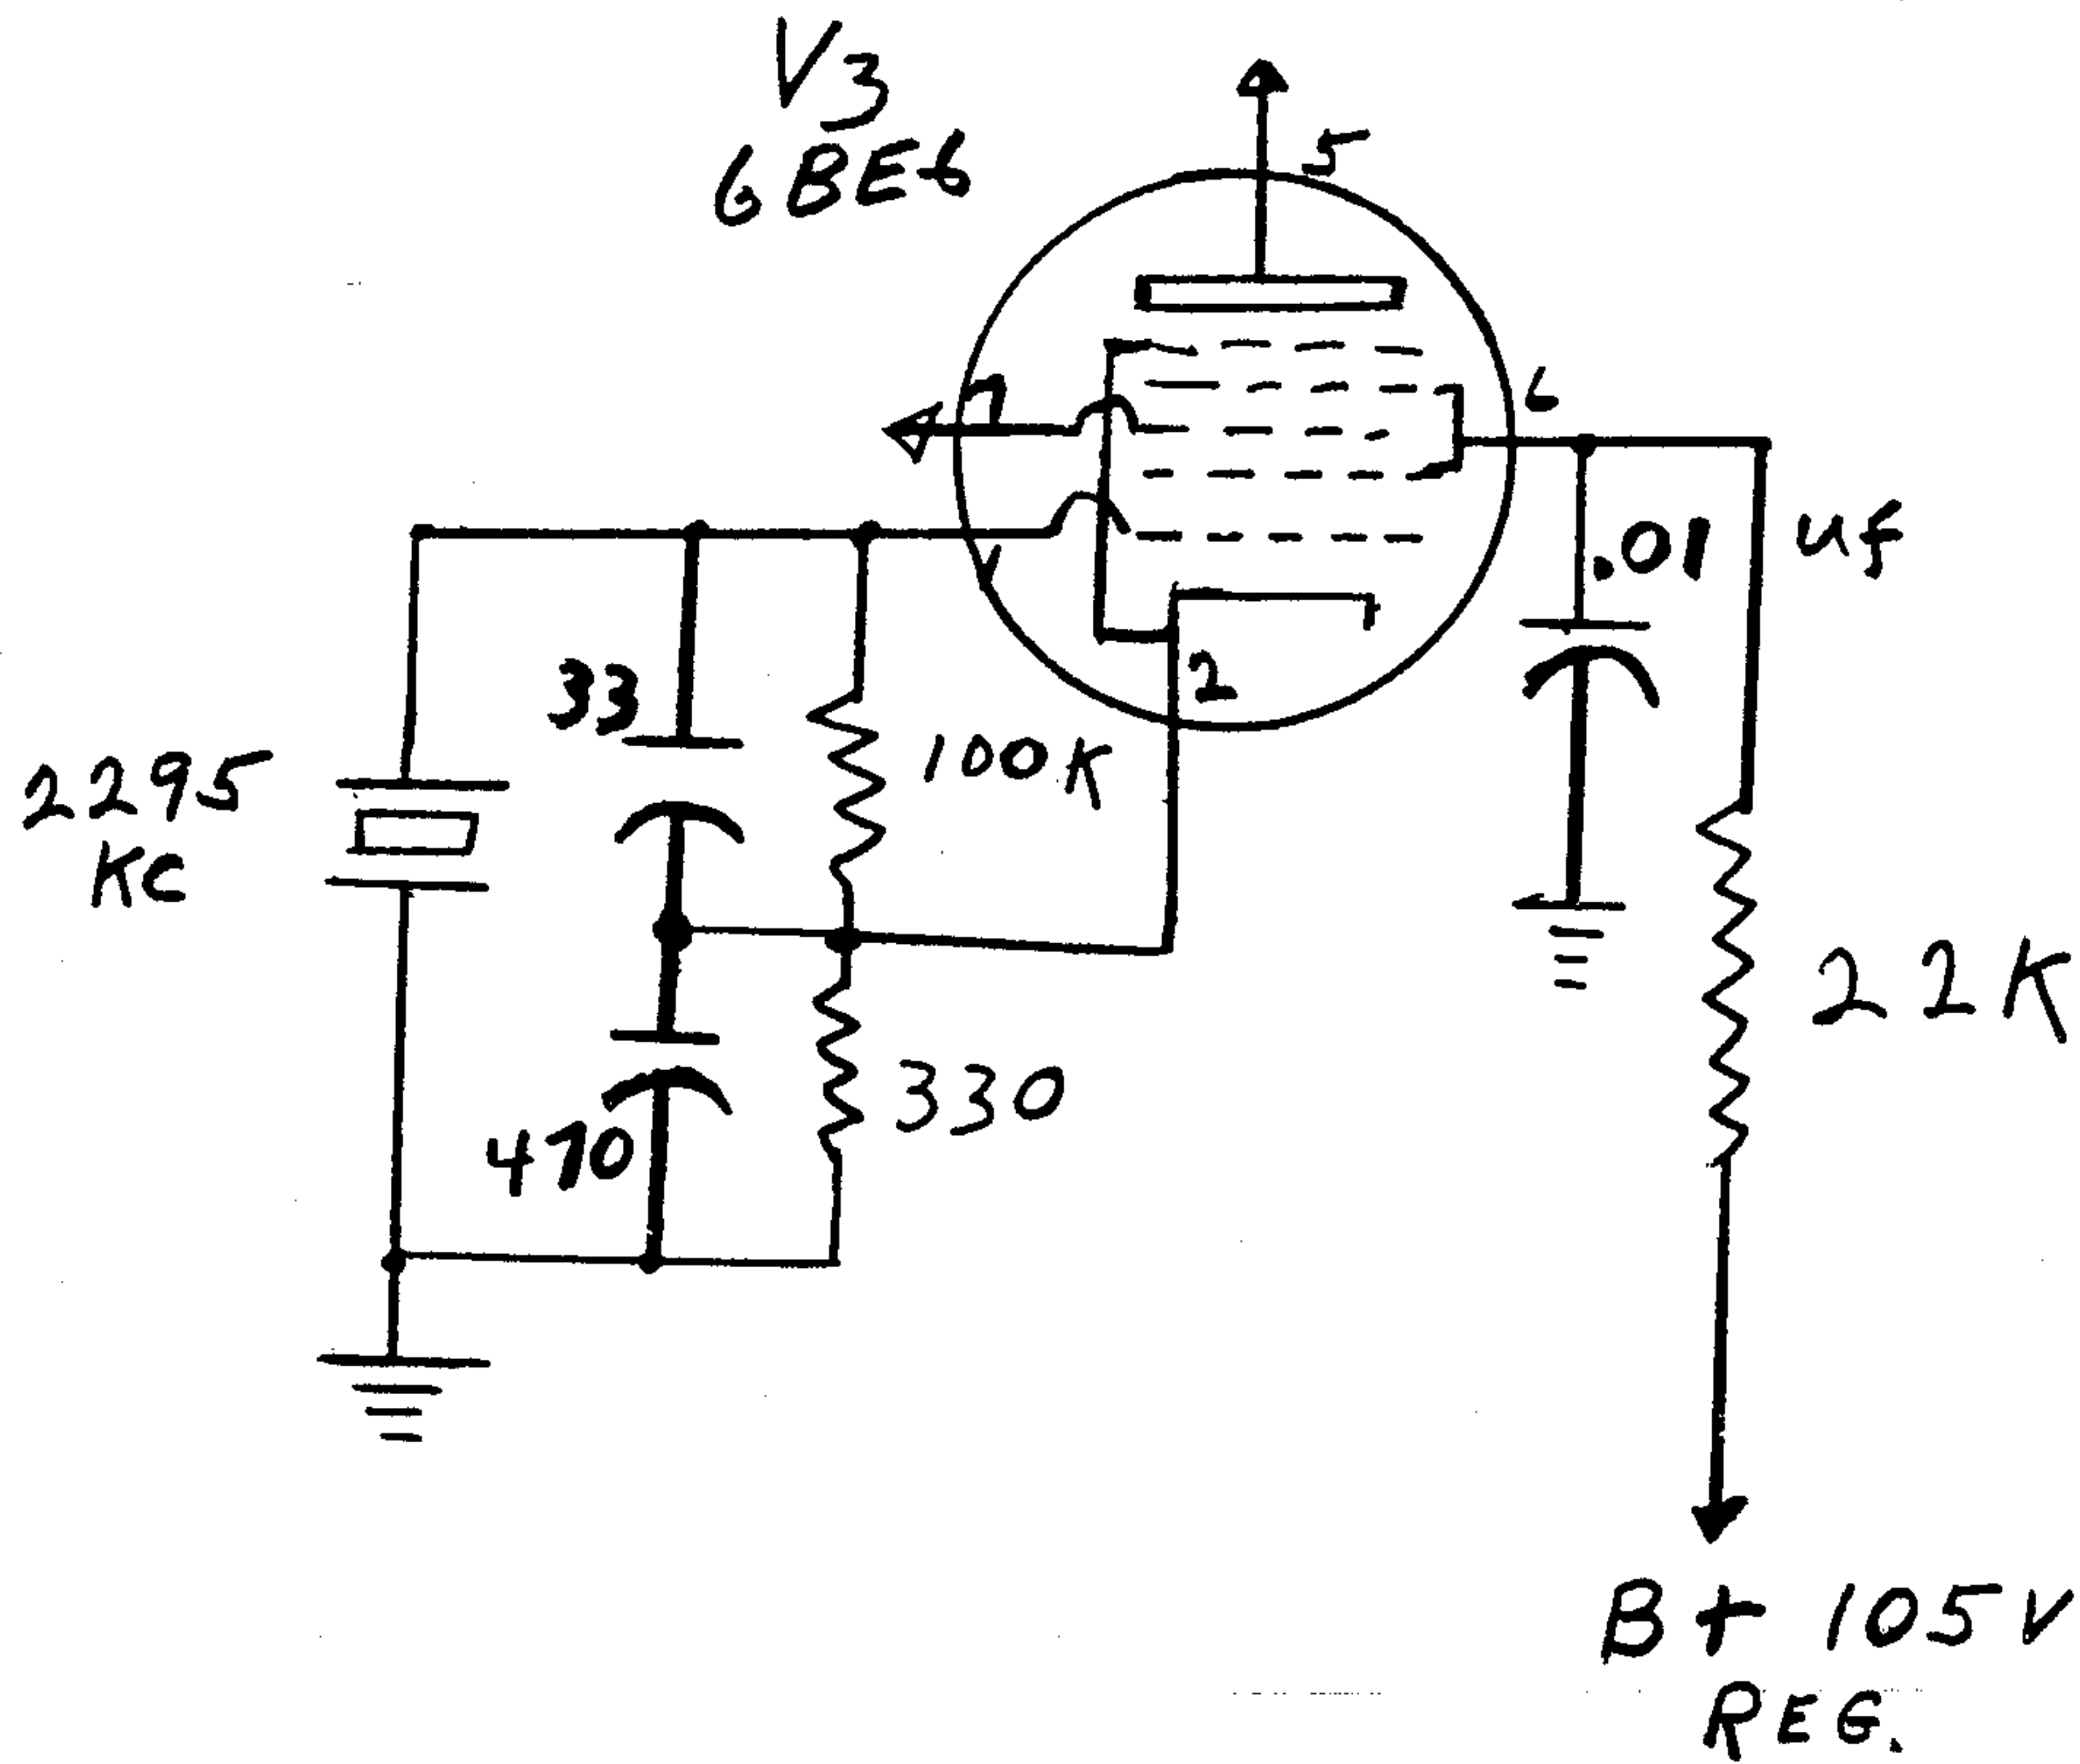
This time of year with relatively high heat and humidity usually brings sporadic reports of calibration errors and ineffective crystal filter action in the NC-300. This is due to the second conversion oscillator coil having drifted off its correct frequency of 2295 kc.

In most instances all that is necessary is that L6 in T5 be trimmed to the correct frequency by means of the slug in it. There are other rare cases where the second conversion oscillator will not maintain its frequency for more than a period of a month or so. These reports usually originate in areas of high humidity such as Florida and Louisiana and other localized areas.

In these instances we recommend crystal control of the second conversion oscillator as per the attached schematic. It should be remembered that there are now two crystals in the circuit which must be properly coordinated if the receiver is to work at maximum efficiency. Normal production tolerances in the grinding of the crystals may allow a situation to exist where the difference in frequency of the crystal in the crystal filter (2215 kc) and the crystal in the second conversion oscillator (2295 kc) is not exactly 80 kc (second IF).

If this is so the second IF strip must be adjusted accordingly either slightly higher or slightly lower to compensate.
