Technical Bulletin

Bulletin #: 201501-02
Issue Date: January 15th, 2015

Model Number: MH-75A8J with EVX-5300/5400 RF feedback problem

Subject: Improvement

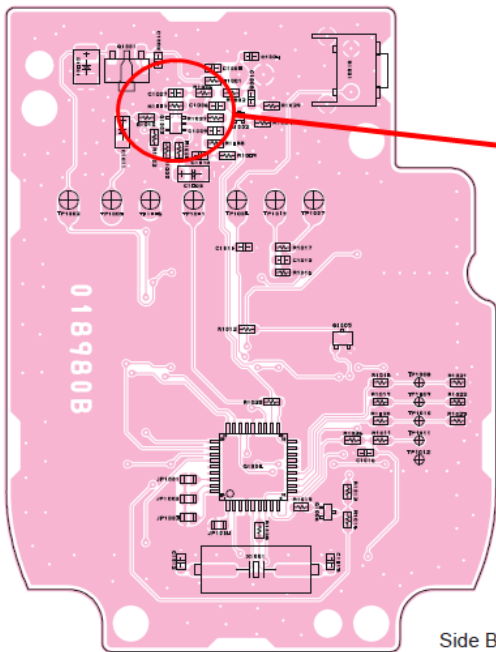
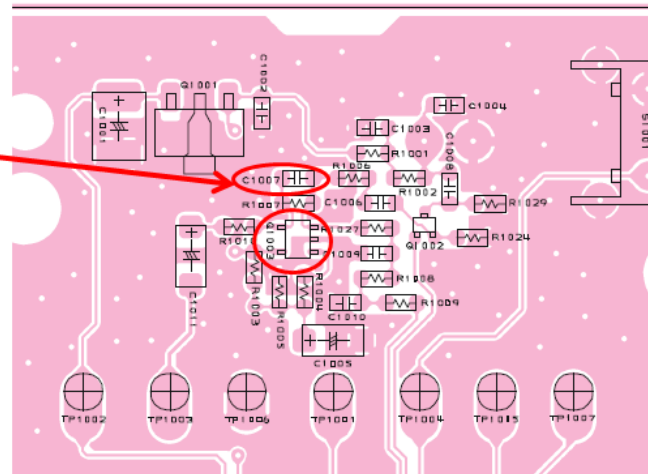
LOT 001

When the MH-75A8J DTMF microphone is used with the EVX-5300/5400 radio, some undesired noise (chopper noise) is transmitted in the digital mode.

This is caused by the RF feedback to the MH-75A8J. Please apply the following modification in that case. This problem is not observed in the analog mode.

- (1) Disassemble the MH-75A8J by removing screws.
- (2) Remove Q1003, and change R1007 to 0 (zero) ohm jumper.

Remove Q1003
Change R1007 to 0 ohm jumper
