Restoration of a Central Electronics 600L Amplifier

By Bob Sullivan, WØYVA
PO Box 579
Great Falls, VA 22066

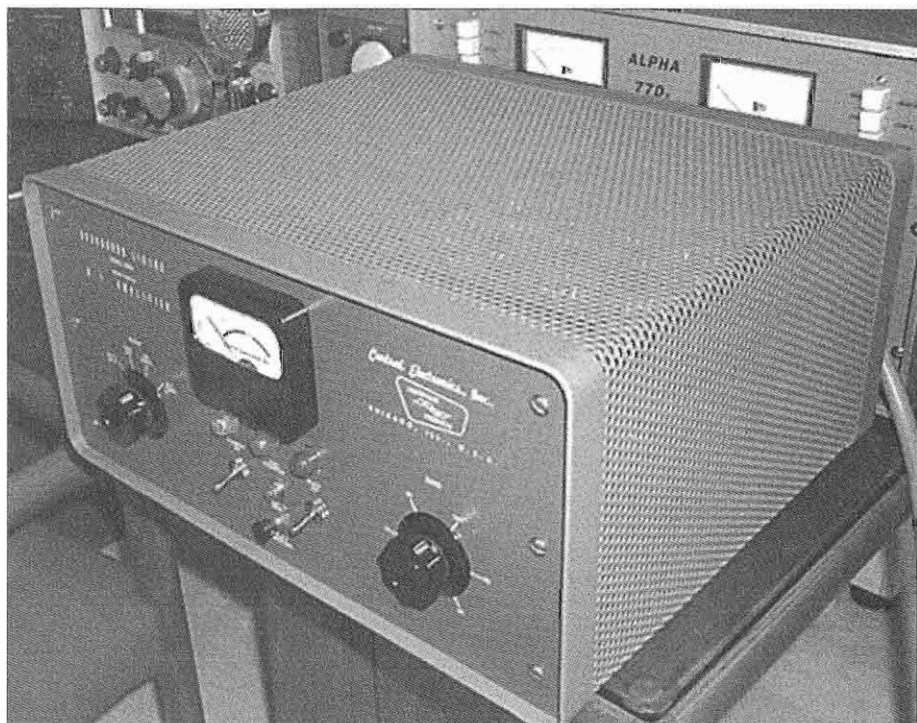
This oblique view of my completed 600L amplifier shows how nice the refinished cabinet came out, and the polished front panel.

During the restoration process I had the cabinet sent out to be blasted and repainted. Boy, did it look good – the original CE grey paint and texture is easy to match. Many custom auto-body shops can help you out with this.
