An ARTICLE on CARE OF YOUR 30L-1

The Care and Feeding of Your 30L-1 and Other Pertinent Trivia

de Bill Carns, N7OTQ/K0CXX

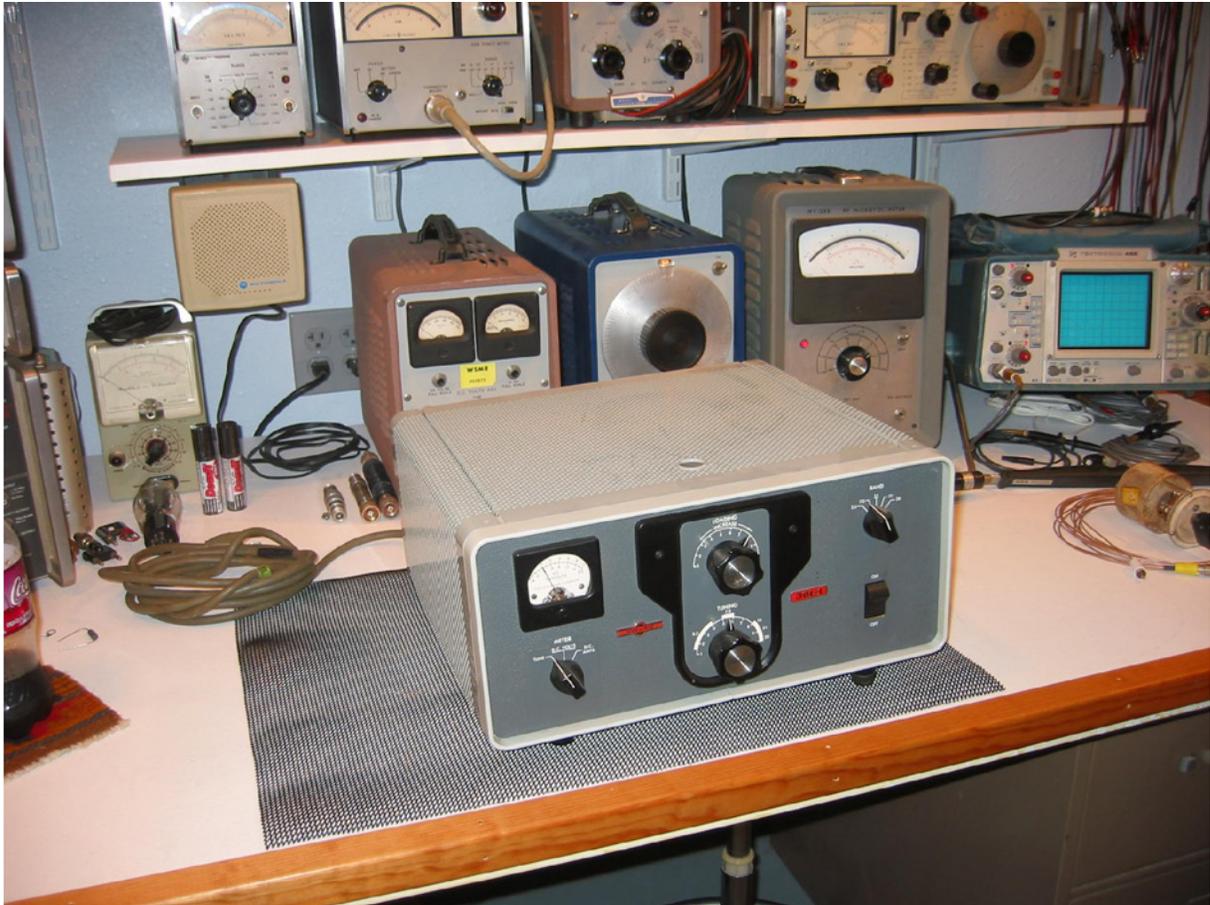
Figure 2. Oh Doctor, Serial Number 12770 is waiting in the exam room

Now, this is another long story that will have to wait for another day, but I almost left Arizona without most of my Collins gear. I was the almost victim of a 540,000 acre forest fire - the Rodeo Chedeski Fire - which, in 2004, was put out less than a quarter of a mile from my mountain retirement home. In the process of being evacuated, I had just enough time to grab some of my favorite and more mobile Collins gear and this included the 30L-1 that will be looked at here. The result was a very unceremonious trip in the unpadded bed of my ¾ ton pick-up truck and then out over a rough dirt road – in a big hurry.....e.g. Lots of shock for those poor 811As.....So, this is where we start.

But there seems to be something wrong with his foot - and he hasn't bathed for months.

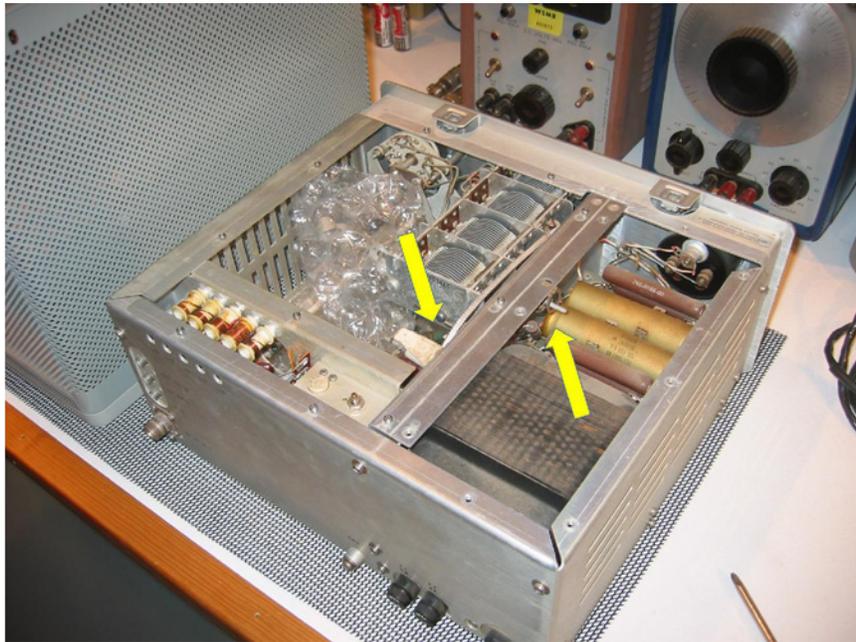
Remove the bottom and 2 top covers of the PA tube and HV compartments. Notice that there are spring loaded shorting interlocks that short the HV to ground when the covers are off. There are two on the top and one on the bottom. I say that because 30L-1s are often damaged by inexperienced repair efforts that involve running the RF amp with these covers off. First, try to never do that and if it is absolutely necessary and you are experienced at debugging HV equipment, then these shorting interlocks need to be defeated TEMPORARILY while the trouble shooting proceeds. This can be done by slipping a piece of heavy high voltage rated heat shrink over the screw in the center.

Figure 3. First surprise – No tubes. I forgot that Mister Thorough removed the tubes and padded the plate clips and braid before moving.....Hmmmmmm, Time Out! ... and it is tube hunting time. With the current cost of 811As, read that PANIC time!

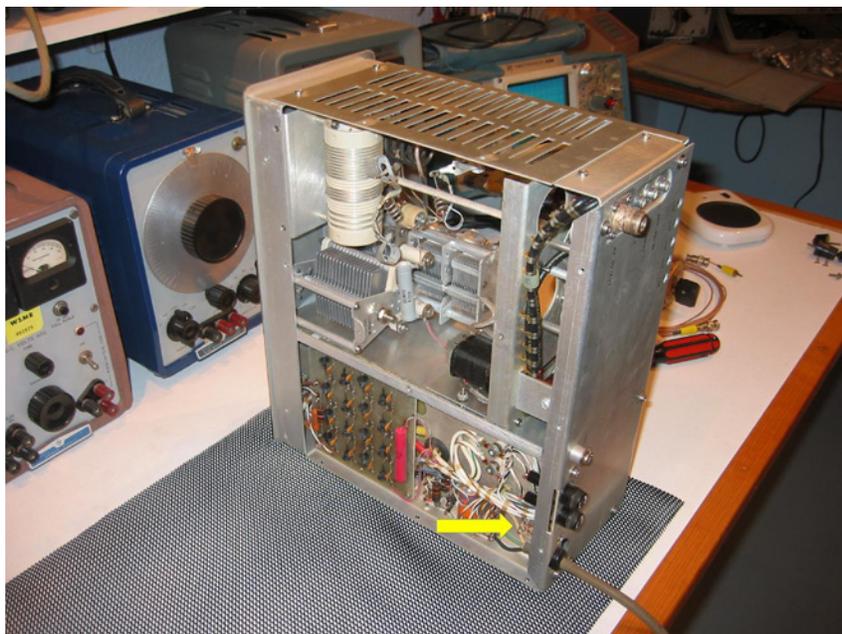
Figure 4. Bottom Cover off and note the bottom third high voltage interlock shown with the yellow arrow. (See the previous figure for the top two interlocks)

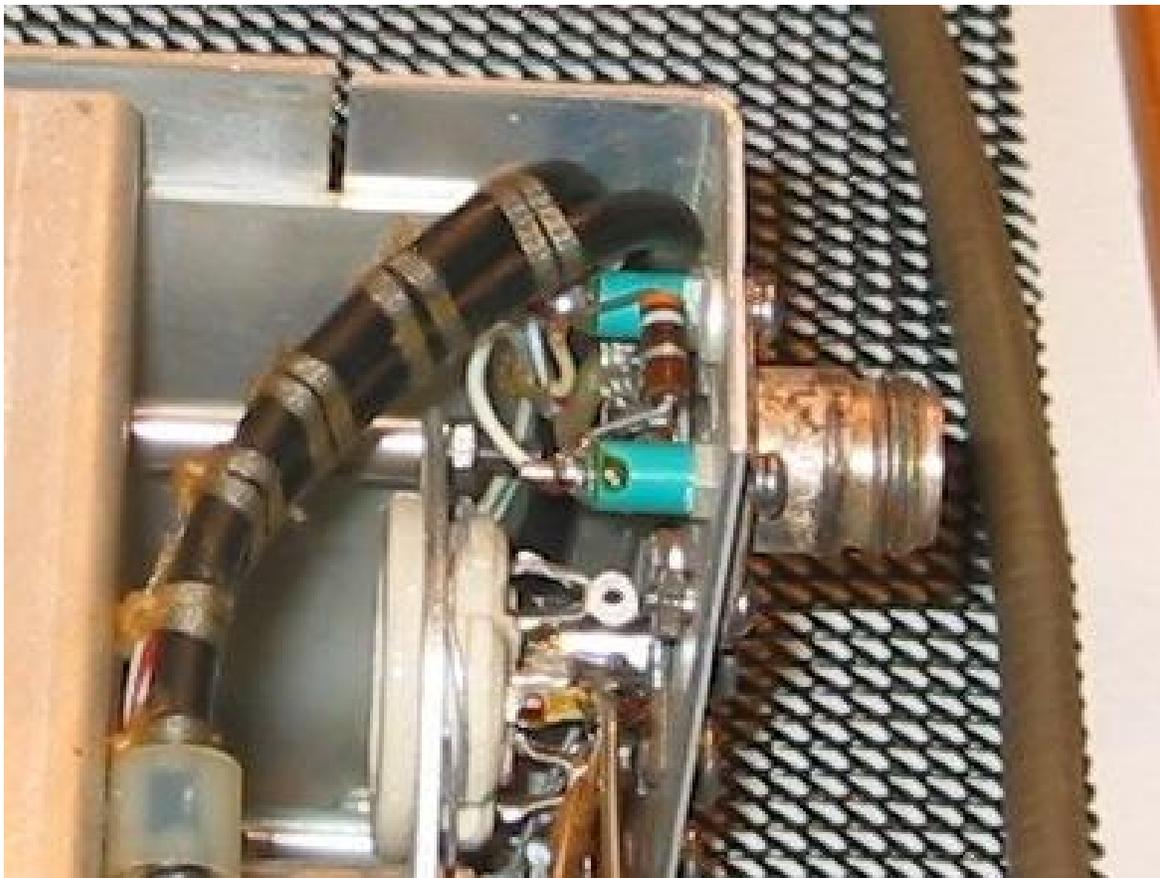
Part A of Service Bulletin #3 was issued, again very early, in April 1962, to reduce the resting current of the 4 811As to 110 mA from the original approximately 130 mA (the bias was increased to about 3.0 Vdc) . This change results in R12 being 2000 ohms 7 watts, R28 being 39 ohms @ ½ watt, and R9 changed to 47 ohms. Follow the service bulletin here to check and see if it has been done. NOTE: There are a lot of folks that will tell you to change R28 to at least a 1 watt resistor and that the original ½ watt specified in the SB3(A) is not big enough. The Grid Bias voltage should be around -3.0 volts when the antenna relay is pulled in (R28 grounded). A quick V^2/R power calculation will tell you that this resistor is only dissipating a quarter watt.

Figure 5. R28 Bias setting resistor (hiding behind the RF Antenna N Connector)

When the antenna relay is not pulled in, there is no current in R28.....So, why are folks upping the wattage when they find it blown? I think Collins engineers knew exactly what they were doing here and used a half watt because it was enough UNLESS the grid came up in voltage because of a tube short. In this case, what do you want to blow here? You can have damage to the relay and bias supply, or you can let R28 blow under this stress

and protect the relay. In fact, with the Bidirectional Clamp Diode protection mod recommended in this article, R28 will never see more than a half watt of dissipation. I leave this resistor at ½ watt. Now, finish this part by checking to see that R9 is 47 ohms and not 82 ohms. You may have to tweak this 47 ohm value (usually to a bit higher) to get the correct 110 (+/- 5) mA idle current with today's higher line voltage.

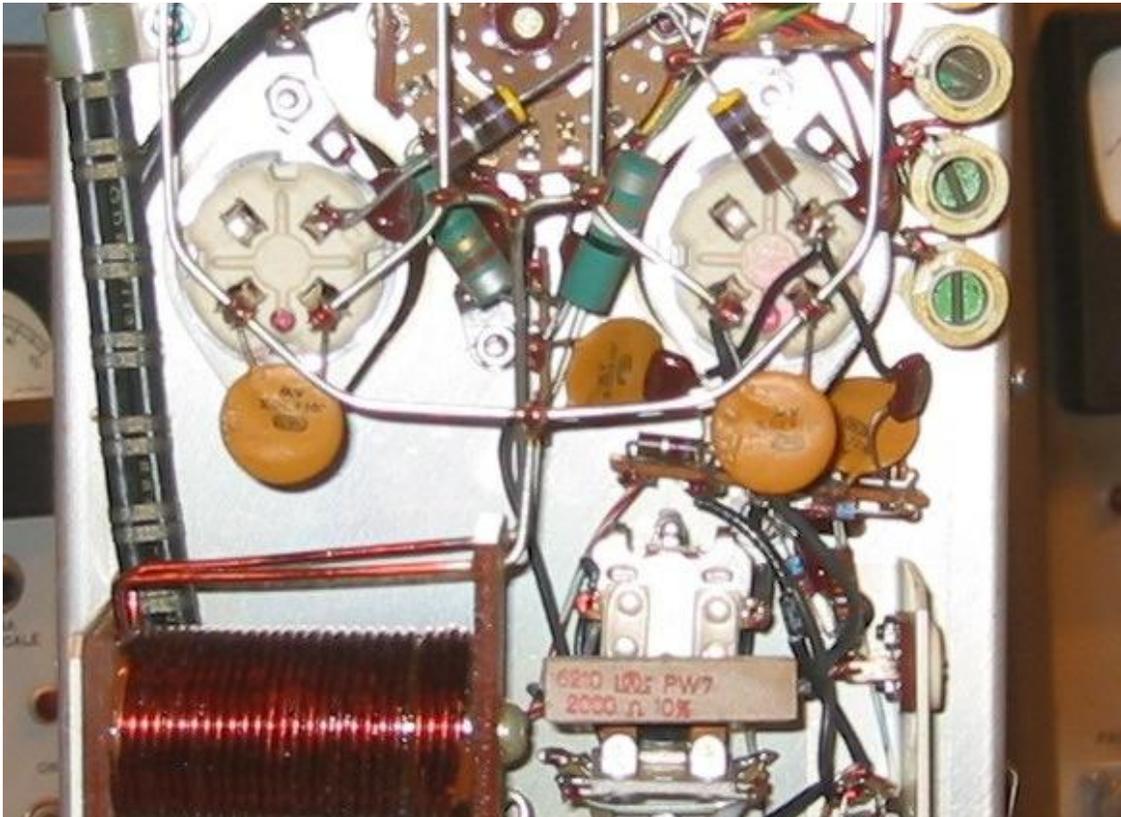
Now for “The exception that makes the rule!” While we are in the back end of the amp, I am going to make the one and only (non-destructive, completely reversible) mod that I recommend (No, insist on) in a 30L-1. Locate C2, a disc ceramic 0.01 mfd cap that is just to the right of the 47 ohm star connection of grid bias through the RF choke L3. Physically, C2 is on a three lug (center ground) terminal strip that is located just to the right of the tube sockets looking at the back of the amp while it is lying on its side. C2 lies flat against the chassis going from the right outside terminal to the center ground.

Figure 6. C2 shown to the right bottom of the terminal strip before Bidirectional Clamp Diode Install

Install a bidirectional Clamp Diode rated at 20 amps 180 volts (min). It will install in the lower position on the terminal strip flat to the chassis. It should be carefully non-destructively tacked across the terminals supporting C2. Position it in that open space to the left of the terminal strip and just below the green choke in Figure 6 shown above. Now, in case of a plate to grid short in one of the 811As (not uncommon), the Transzorb (or surge suppressor) will shunt the plate voltage to ground and save the bias supply - including the transformer winding - and also save the relay. Good Job! It will possibly die in the process and will short to ground which hurts nothing and then can be easily and non-destructively replaced. As they say at Am Ex, Don't leave home without it.

Note: This mod is also highly recommended by Dennis Brothers - who is still an authorized Collins repair station. Dennis used to run the internal repair facility at Collins Radio in Cedar Rapids. Obtain **Part # 625-1.5KE180CA-E3, Mouser pg. 596, Cat. # 643**

Note: The Bi-Directional clamp, or TransZorb, that is currently recommended for installation in the 30L-1 is much different in appearance than the original MOV shown in the earlier version of this article, but installation is the same and is not sensitive to polarity since it is "Bi-Directional". This Vishay part looks more like a diode.
