## Notes on Rebuilding an SB-220 Linear Amplifier (Updated Jul/13)

Brad Rehm, KV5V  
Salado, Texas

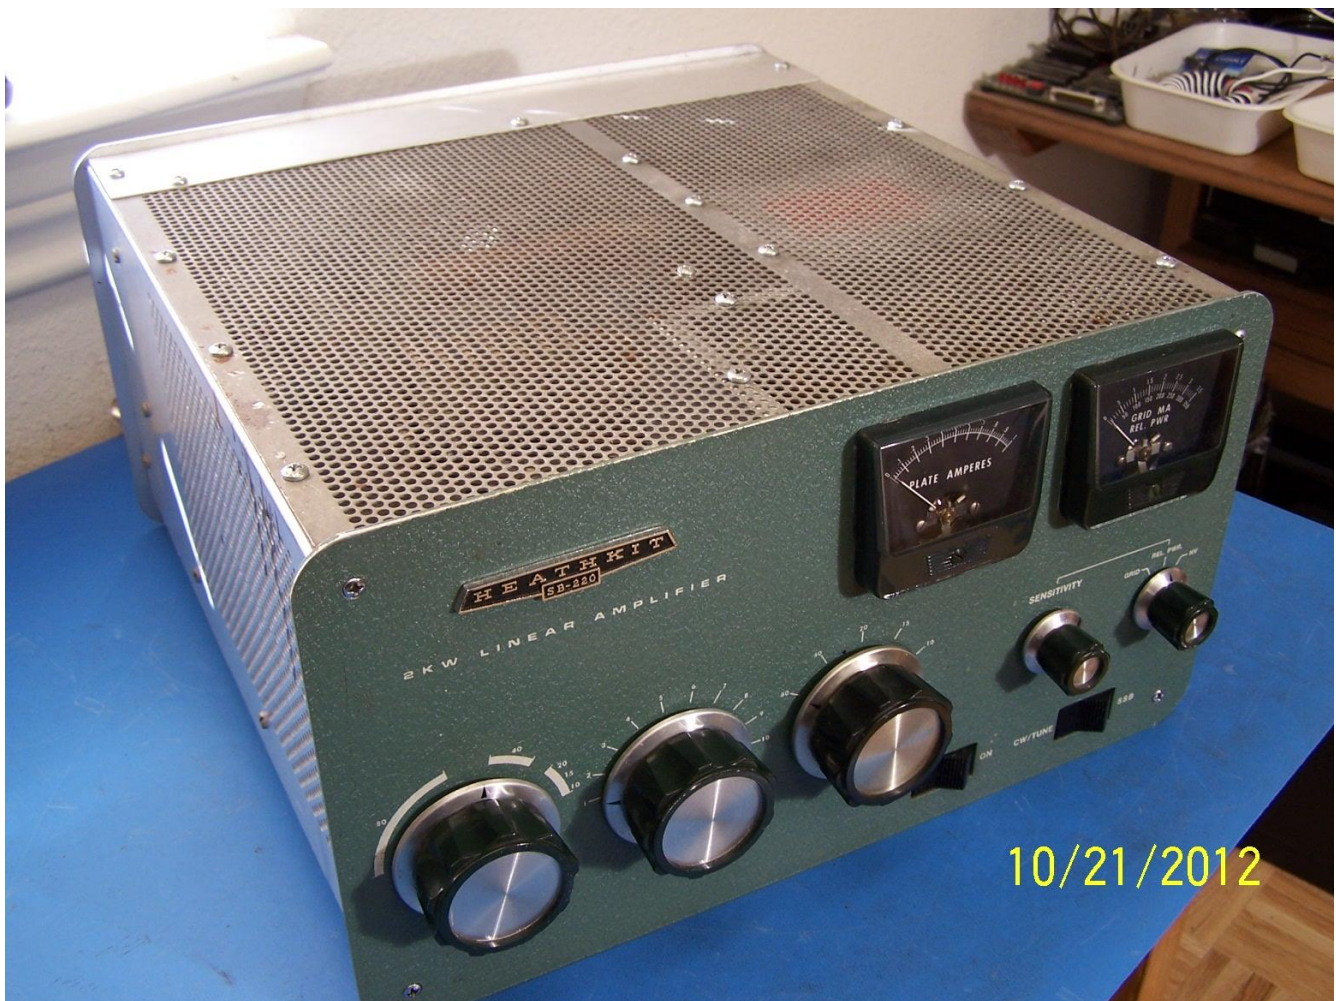
Photo 1. The Heath SB-220 at the beginning of the project. The outer enclosure has been removed.

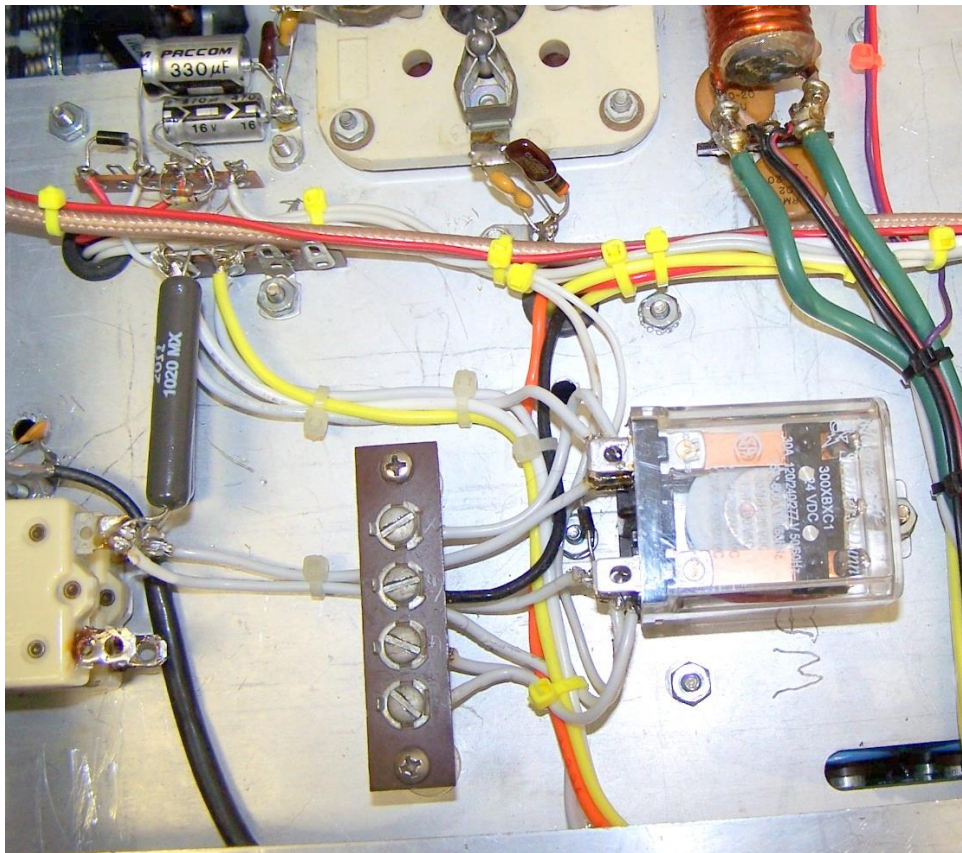
Photo 2. The components of the step-start circuit were located next to the circuit breakers and the power cord entry. The cord and voltage-select jumpers have not yet been installed.

Photo 2 shows the Magnecraft relay used to bypass each of the series resistors, which are located to the right and above the circuit breakers. The terminal strip to the left of the 3-500Z socket contains the 28 Volt rectifier and delay circuit. The transformer which powers this circuit was bolted to the side panel on the top of the chassis. It is shown in Photos 3 and 12. The final schematic includes the relay control circuit and 28 Volt power supply.

I chose the relay approach, shown in Photo 2 above, using a simple R-C and transistor timer. The start-up current requirement of an amplifier of this size can exceed the current ratings of the largest NTC thermistors, especially when the amp is operated at 120 Volts. The relay approach can be very reliable if the resistors and relay are selected carefully. After a two-second delay, two 15 Ohm, 5 Watt resistors in parallel in each leg of the incoming AC are removed, using a double-pole, 20 Amp relay. The component values allow the simple, 28-Volt delay circuit to operate properly at 120 and 240 Volts.

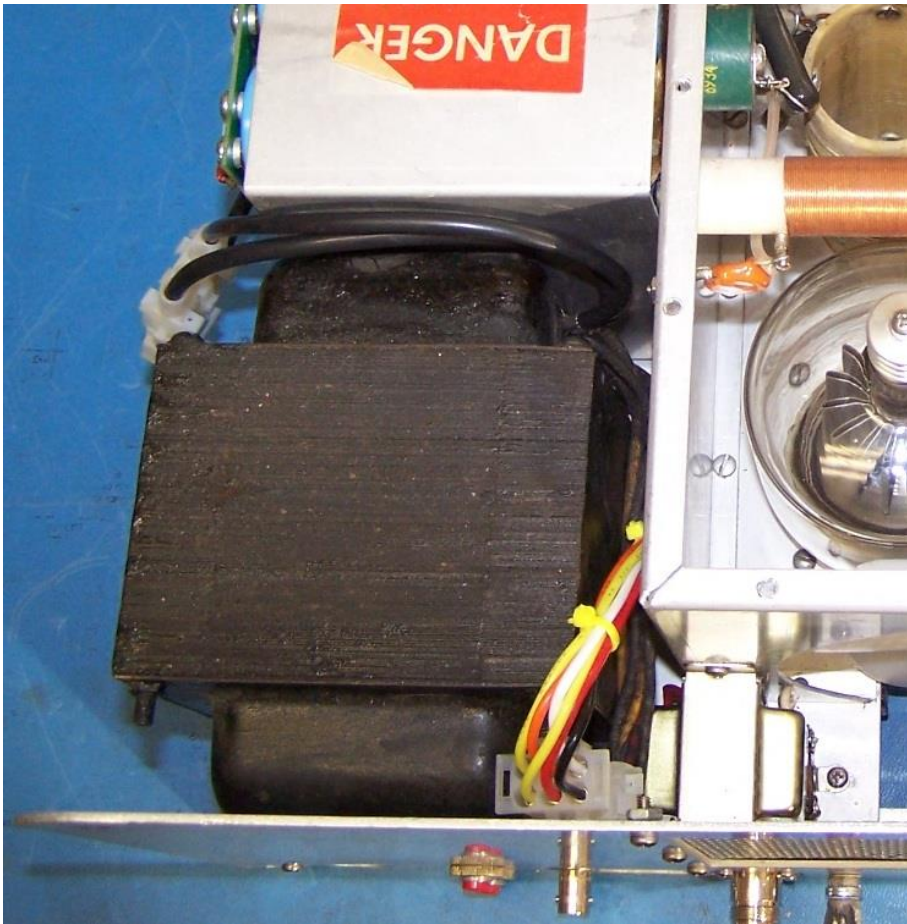
Photo 3. Molex connectors as installed at the high voltage power transformer. The connectors make it easier to remove the transformer for shipping. The original transformer was replaced with a Harbach/Peter W. Dahl unit, which increased the available high voltage from about 3200 to nearly 3500 Volts. This photo also shows the Alpha Wire sleeving which was installed on the transformer secondary leads. The breakdown rating of the sleeving is 8000 Volts.

1. Molex connectors were installed in the high voltage transformer leads and in the wiring to the front panel. These are shown in Photos 3 and 4. The primary connectors were Molex 50-84-1060 and 50-84-2060. The secondary connectors were Molex 50-84-1040 and 50-84-2040.

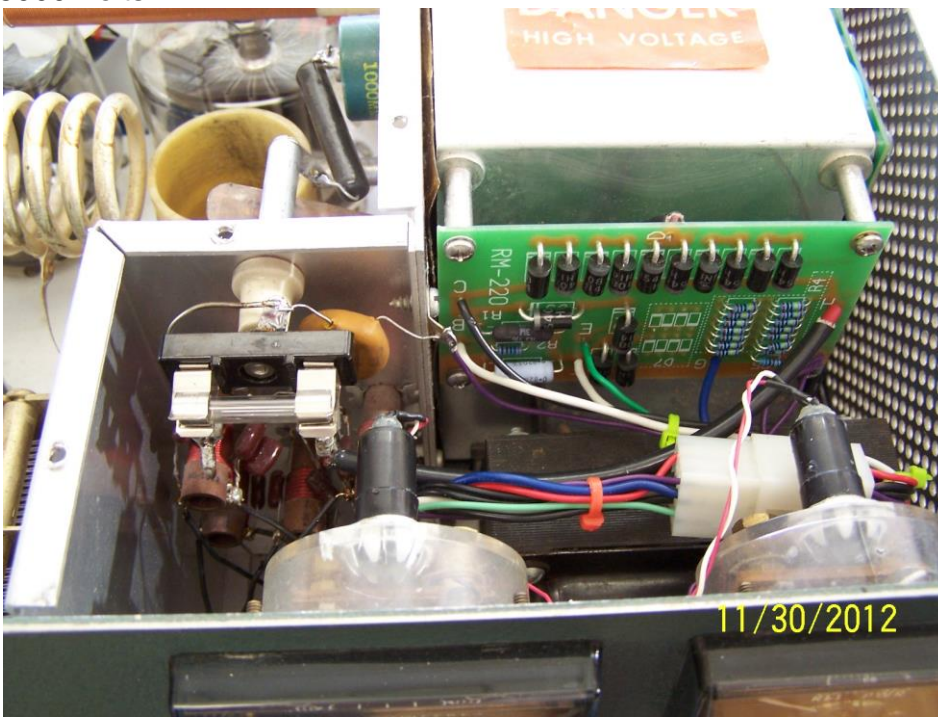
Photo 4. The Harbach diode board, which replaces the original voltage doubler board. The area of this board which contained the zener diode replacement is not populated because this function is performed by the W7RY QSK Board. Also visible in this photo is the Molex connector which allows detaching and removing the front panel. The fuse, visible

on the left side of the photo, protects the power supply and meters from tube flashovers. Not visible here is the diode recommended by W8JI to provide additional flashover protection for the meters. It has been soldered to the back of the diode board between terminal C and ground.

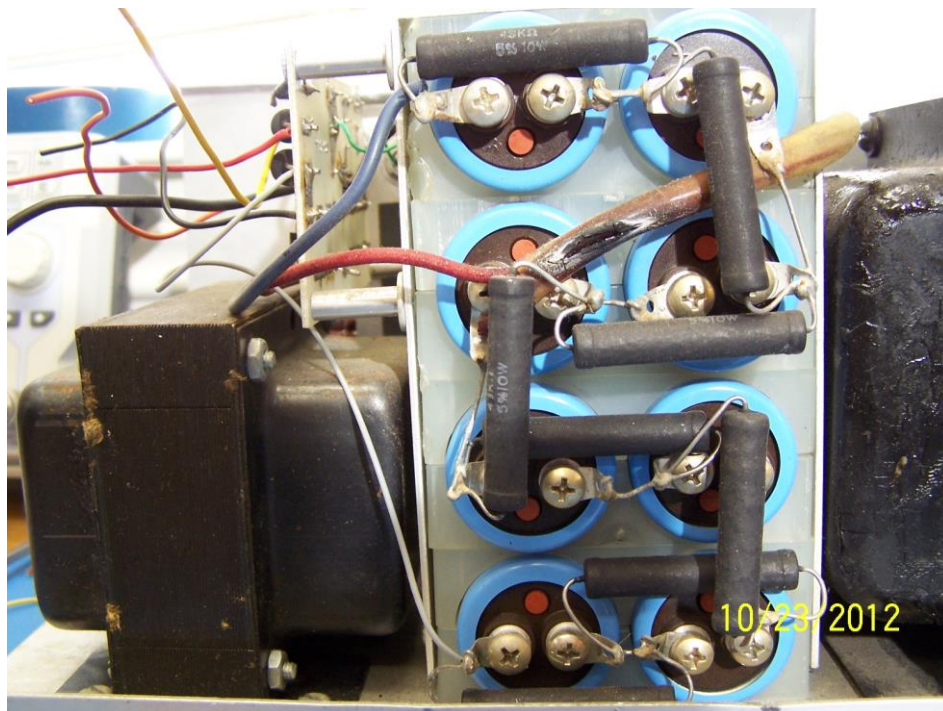
3. Harbach capacitor board was installed in the power supply. In addition to improving the appearance of the capacitor bank, the capacitor board includes new bleeder resistors and adds reverse diodes to protect the amplifier during tube flashovers. The old and new capacitor wiring are show in Photos 5 and 6. Notice the damage to the original transformer secondary lead from arcing through the insulating sleeving in Photo 5.

Photo 5. The original capacitor and diode board wiring. Notice the arc damage to the original transformer secondary wire and sleeving.

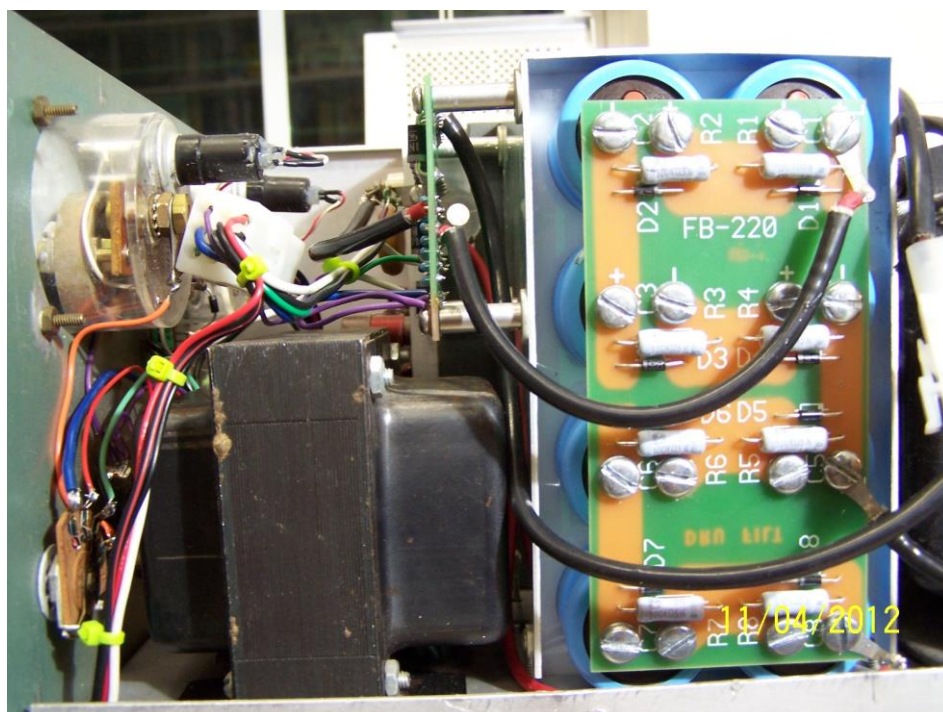
Photo 6. The Harbach capacitor and diode boards replaced the original wiring and PWB. Alpha Wire sleeving was used on all the high voltage wiring. The new front panel wiring and

white meter LEDs are also visible in this photo.

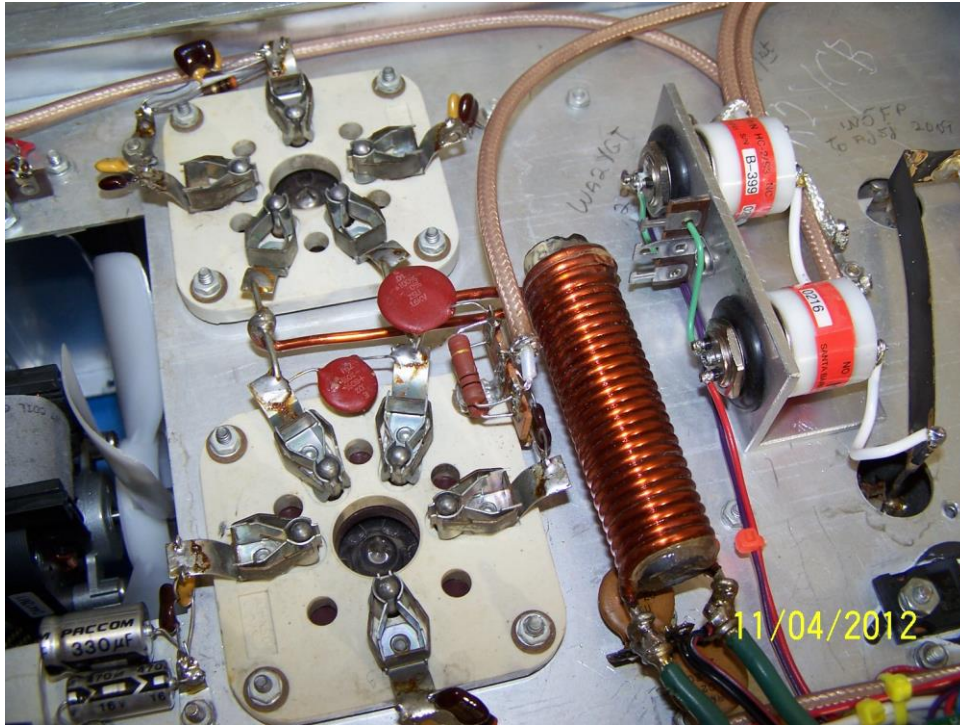
Photo 7. Kilovac HC-2 vacuum relays are shown in this photo. The resistor which sets current through the relays at 60 mA will be installed on the terminal strip between the relays.

The relays are mounted in rubber grommets (Mouser 534-750) to reduce mechanical switching noise. Also visible in this photo are the parallel 10 Ohm resistors in series with the coax and RF drive to the filaments. These reduce the Q of the bandswitch-to-tube wiring.

The first step in preventing this kind of damage is to abandon the practice of isolating the grids of the tubes from ground with chokes, resistors, or fuses. Photo 7 shows resistors installed between one of the grid terminals on each tube and each grid pin taken to RF ground with pairs of capacitors. These were replaced with buss wire connections to ground. The ground connection ensures that the grids can never be driven very positive in a flashover

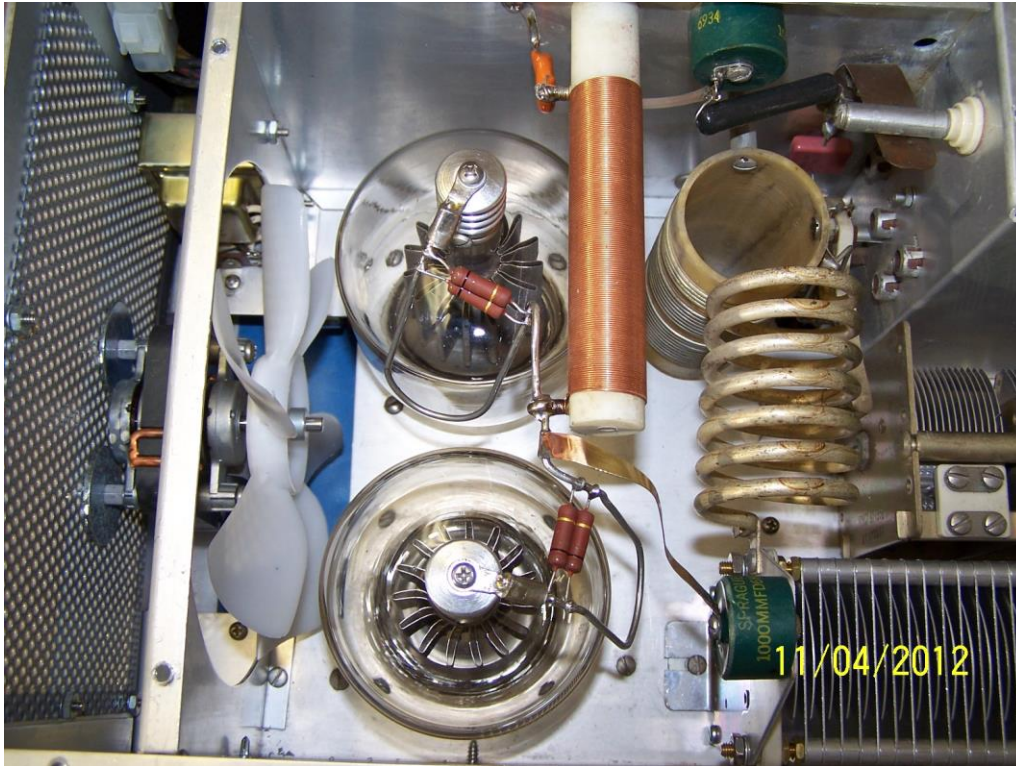
Photo 8. The hairpin parasitic chokes are supported by the plate choke. The Q-killer resistors are placed at the “bottom” of each choke. Notice the ceramic disc capacitor which was added at the base of the plate choke. The new fan and motor are visible to the left of the tubes. The mounting bolts were replaced with longer ones, which permitted using fender washers on the inside and outside surfaces of the intake grill. These reduced motor vibration. The small transformer above the fan motor was later moved to the opposite side of the fan because the space was needed for the larger Peter W. Dahl transformer.

Hairpin loops shunted by low-inductance resistors have self-resonant frequencies well above the VHF range and appear to work well as parasitic suppressors. The loops are typically just wide enough to allow the resistors to be soldered across the bases, and they are made somewhat longer than they are wide. I haven't seen the loop dimensions fully-defined yet, but Richard Measures, AG6K, gives a fairly complete description in his on-line paper on the TL-922 and the SB-220. (See the "Anode Circuit Modification" section of <http://www.somis.org/QSK922.html>.) Although Measures also recommends using nichrome wire for the loop, I have found 12-gauge, tinned buss wire to be satisfactory. Photo 8 shows the hairpin loops installed in this SB-220. Observing the output of the amp with a spectrum analyzer, I have found no tendency to oscillate, even under a variety of load conditions.

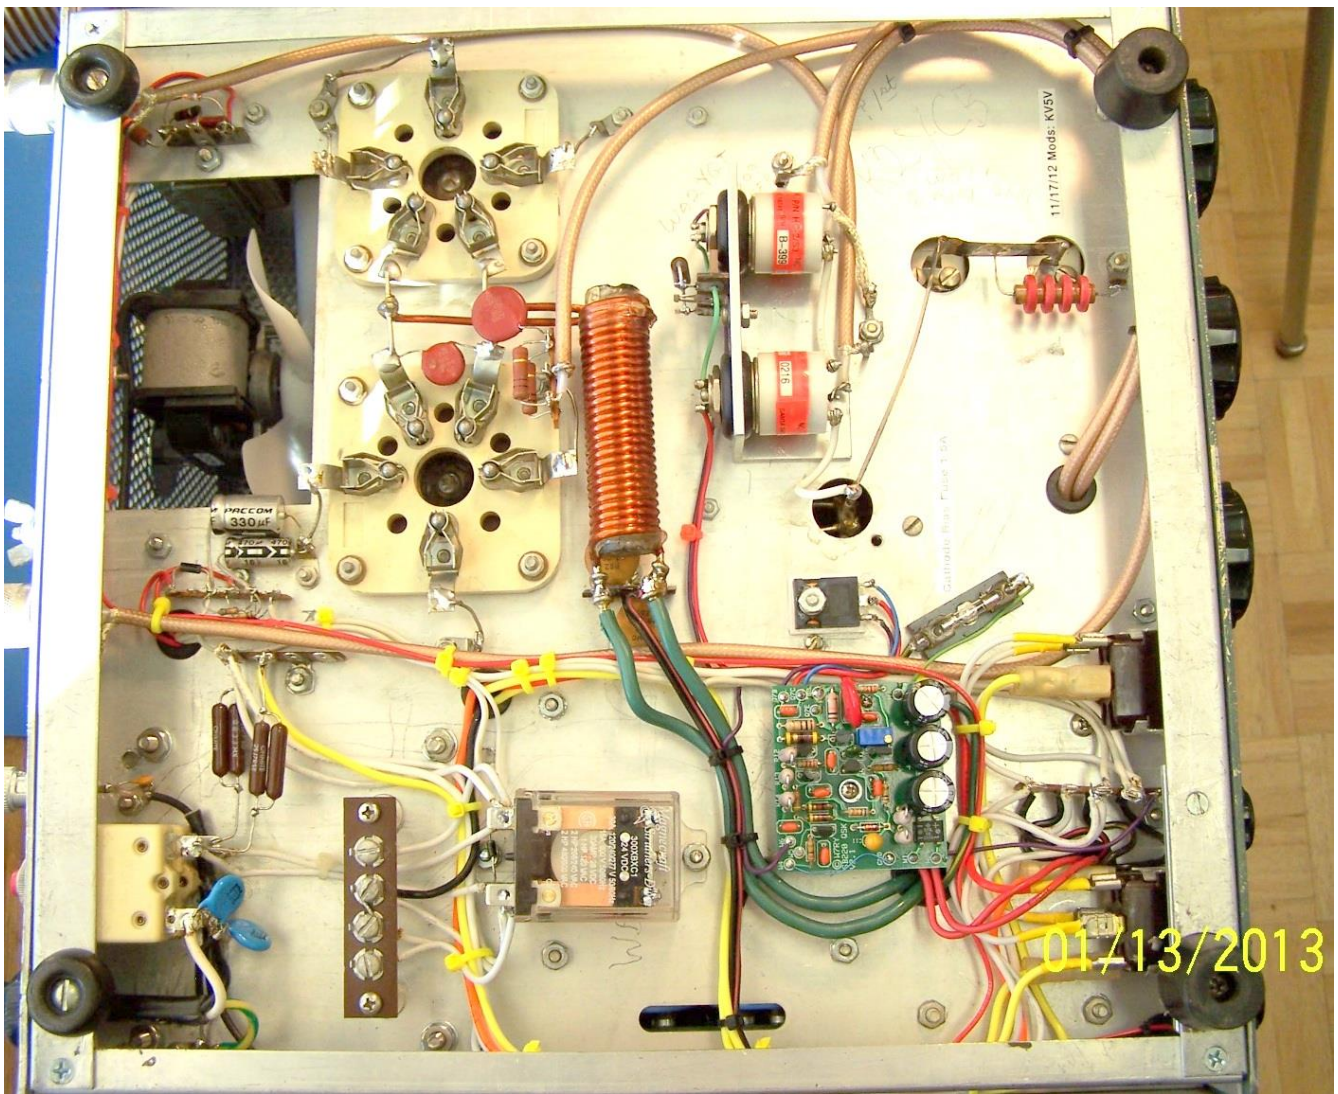
Photo 9. The finished underside of the amp. The QSK Board is on the lower-right in this photo. The Darlington bias-control transistor and filament center-tap fuse are mounted just above it, using available chassis holes.

The QSK Board has a role in preventing catastrophic failures in the SB-220, because a failure mode of the Zener diode which controls cathode bias in the original circuit is a short circuit. When the Zener fails in this manner, the tubes are turned fully on, and damage can result when excessive current flows. The QSK Board uses a TIP147 power transistor which is protected by an MOV (a Metal-Oxide Varistor). If the transistor should fail, the voltage across the varistor would rise to its 130 Volt avalanche rating, thus biasing the tubes into cut-off. The normal failure mode for an MOV is to go open, but this only occurs after the part has been driven into conduction many times. The scheme isn't completely failure-proof, but I believe it's less failure-prone than the original circuit. The installed board is shown in Photo 9.

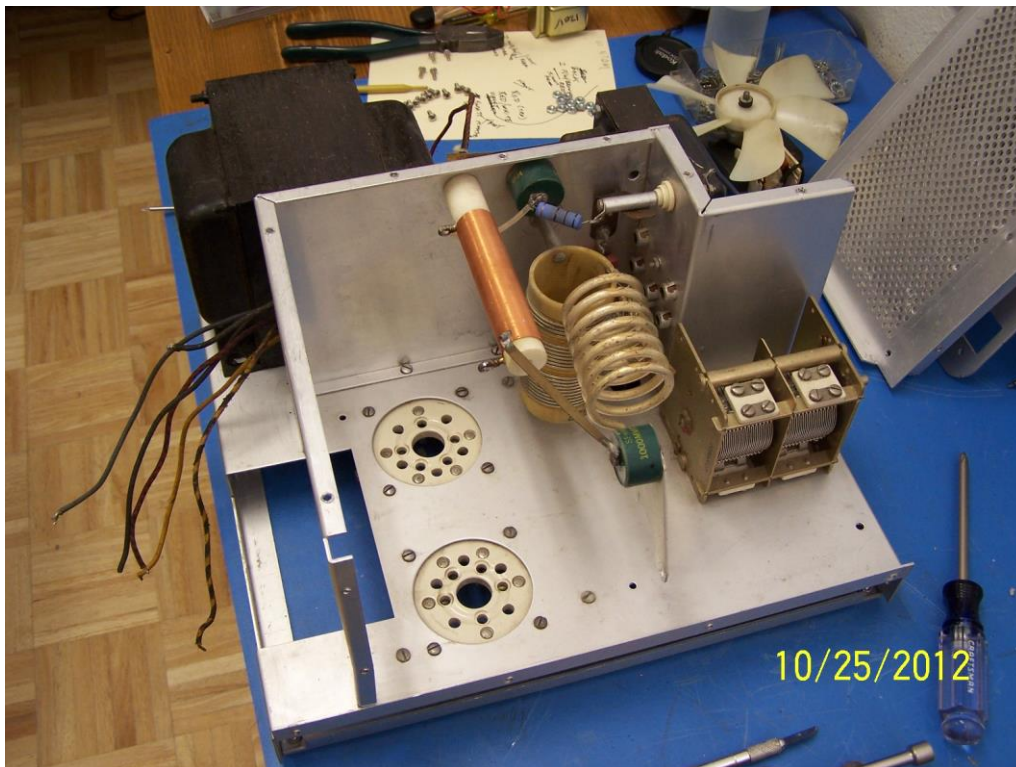
Photo 10. Most components have been removed so that the chassis can be cleaned and old hardware can be replaced. The resistor which feeds high voltage to the bypass capacitor and plate choke was also replaced.<sup>7</sup>

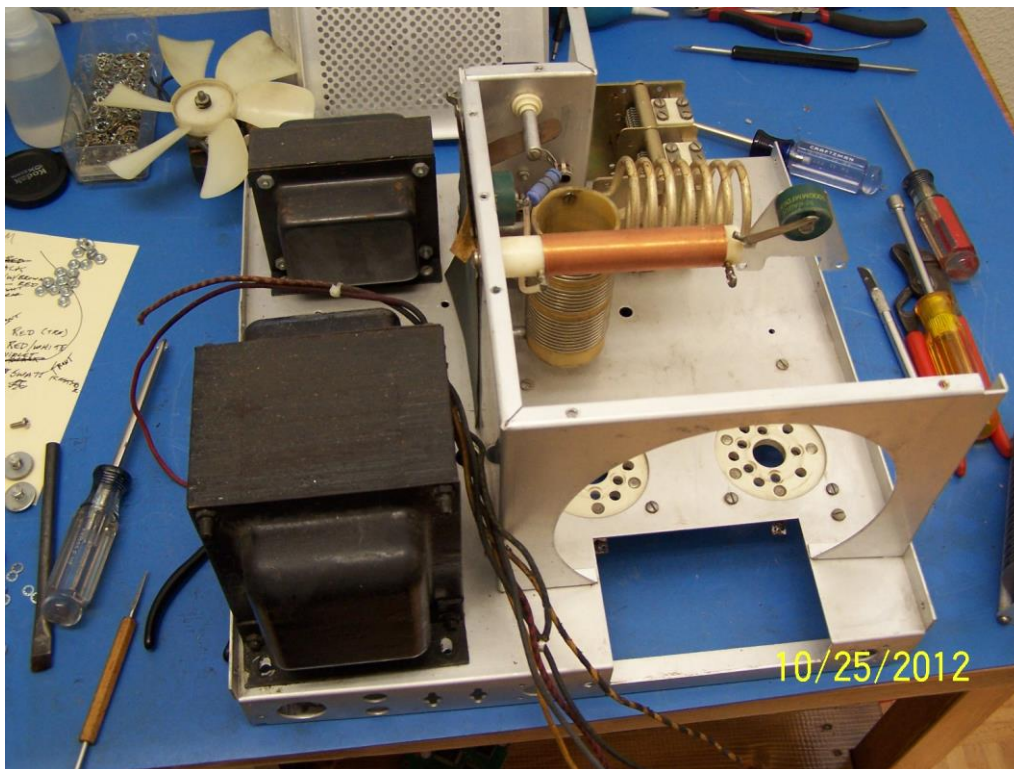
Photo 11. Another view of the chassis, ready for rewiring. One RCA connector on the rear of

the chassis was removed. The other was replaced with a BNC at the "Relay" input.

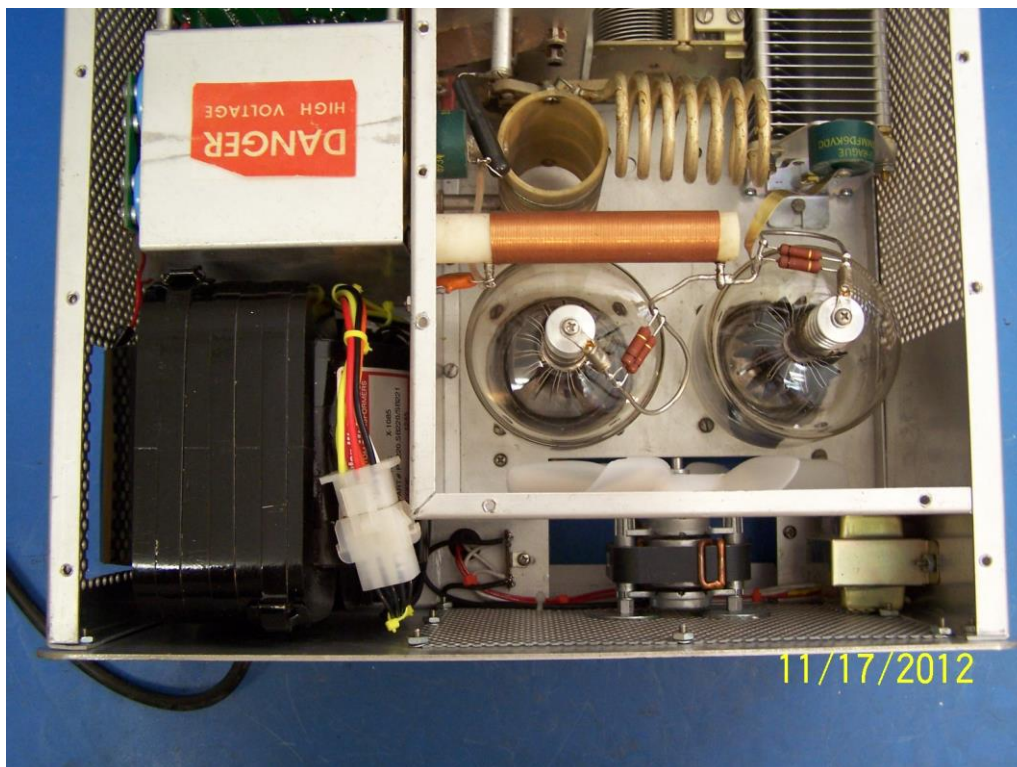
Photo 12. This view shows the Harbach/Peter Dahl HV transformer, which is slightly larger than the original transformer. The 24 Volt transformer which supplies power for the step-start circuit has been moved to the lower-right corner to make room for the Harbach.

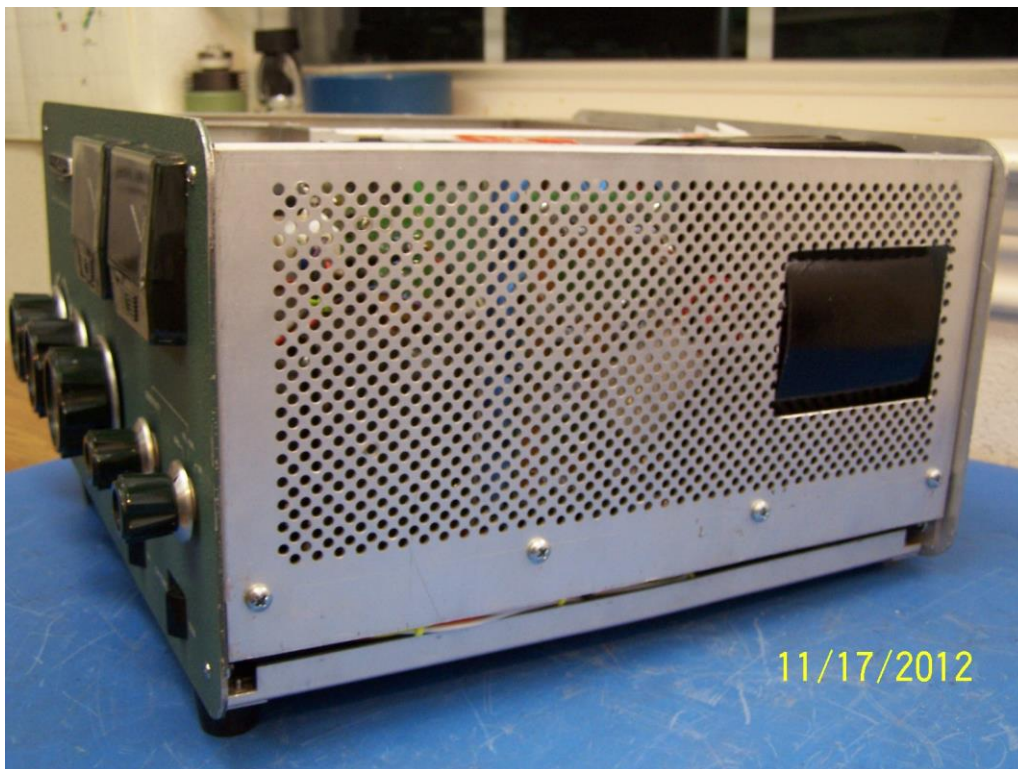
Photo 12. It was necessary to cut a rectangular hole in the right-side panel to make room for the Harbach transformer. The transformer will not interfere with the outer enclosure for the amp.
