Alinco EMR-400 Rotator Refurb – G1KOT

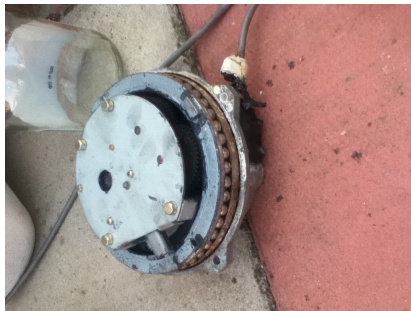
Once on the ground and not without trepidation I decided to remove all the 4 retaining bolt s underneath, and I was expecting a numerous amount of ball bearings and cogs to fall in my lap. But luckily and by design the top came away easily, revealing the internals, which looked surprising clean, (at first glance). Review Pic 1

On the Alinco EMR-400 rotator, a cog ring sits freely on top of the first set of ball bearings, and the 4 notches represent the direction of the rotator, one of the notches is larger than the others and the top housing holds a groove that sit's in this location only. This ensures that the stop leaver is also activated a the max south west and south east directions.. I found out by putting it all back together in the wrong order and only having a small amount of rotation being allowed!!...

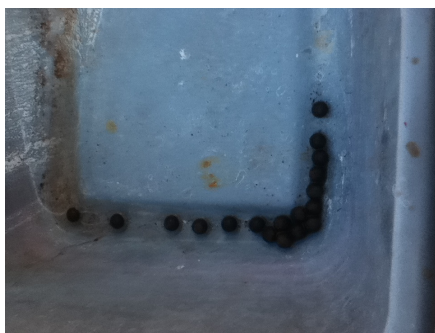
Pic 2

Once I have removed the cog ring and the top layer of ball bearings, I could see that rust was present at the underneath, looking for another means that the base was fixed proved false avenue, since a small amount of pressure caused the bottom section to fall away from the rest of the unit, a small rubber O-ring seems to provide this holding pressure.

The ball bearings in this section looked pretty poor by comparison to the others, and were completely rusty - review pic 2 & pic 3

Here you can see some of the removed ball bearings and the condition. Not a pretty sight. And the bottom housing that held these ball bearings in place, also coated in rust.

All the cogs inside and the top housing really surprised me on the good condition they where still in, so I set around cleaning all the lower ball bearings and housing with wet and dry paper and grease them all back up with some packing grease.

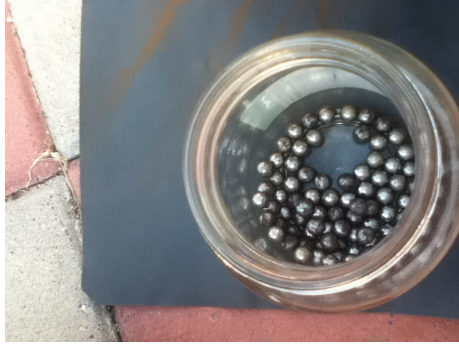
After about 2 hours work and very sore finger tips, luckily I do not have to use any fingerprint readers I managed to get the rusty ball bearings looking in a fairly decent condition, all 94 of them. See pic 4,

Although they still show some darkened colouring the hard rust was all removed and they were cleaned, a few times with wet and dry over the bottom mounting also made the ball bearing tracks a lot smoother.

Once they were all dried with paper towel it was time to repack all the ball bearings back into the lower mount. With care and plenty of grease I still managed to drop a ball bearing into the bottom of the rotator case, but with slight of hand and a handy old tooth brush, this was fished out and placed back into position. I also noticed that the rubber seal had some wear and cracking, so this was also liberally greased, with the idea of a possible replacement at some other future date. I must admit I took care when placing the lower mount into position; I really didn't want to break this seal.

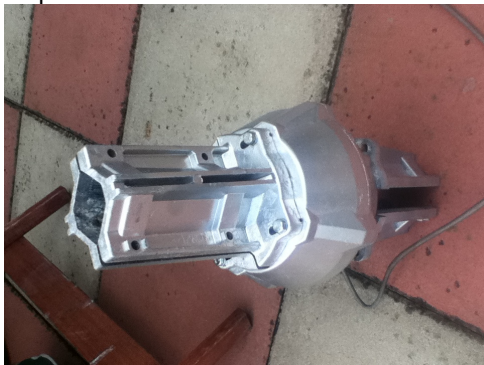
Once the bottom mount was being held in place by this rubber seal, all the cogs were given a once over with grease with the toothbrush, then the top bearings were also added and packed with grease with the top cog ring also greased up, this was mounted in the correct north position with the stop lever in the middle, at this point it was time to mount the top case back onto the unit and bolt it all back together, now with a quick spray of silver paint. And all new bolt and washers on the upper and lower clamps the final result

Powering up the unit provides a success, a smooth running unit giving full rotation and hopefully another 20 years plus of non-interrupted service..
