# VINTAGE RADIO

## A fault with a difference

**One intriguing aspect of vintage radio repairs is the number of obscure faults that one has to deal with from time to time. Few repairs are straightforward and there is often a hidden and challenging problem to solve.**

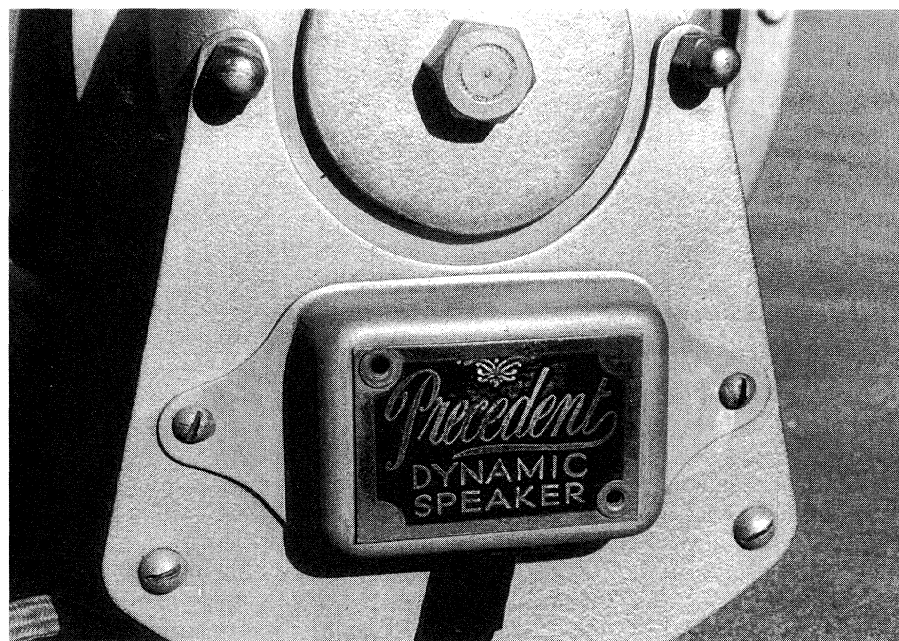
The large bolt head on this Precedent loudspeaker at top holds the central pole piece in place, making it easy to remove for repairs.

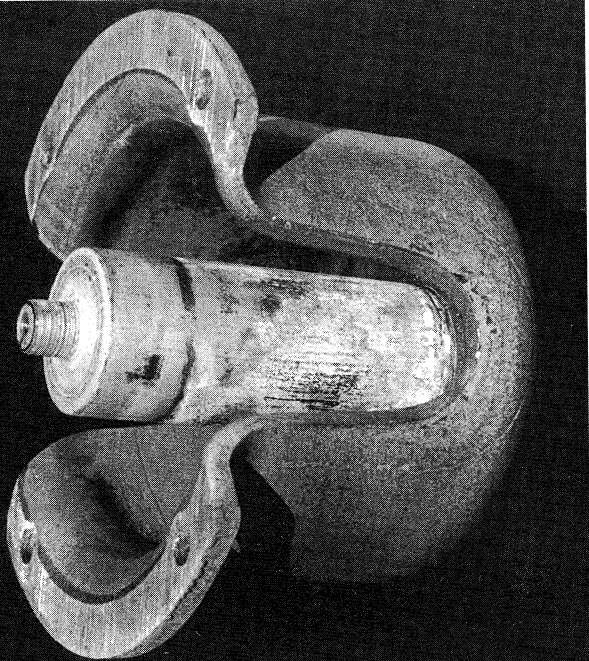
First, despite being plated, the pole piece was now very rusty. This had the effect of enlarging its diameter, thus reducing the clearance between it and the voice coil.

This pole piece shows obvious signs of damage. Note the scuff marks at the end where the voice coil has been rubbing against it.

After going through this routine often enough to realise that it wasn't going to work, the situation called for drastic measures. The pole piece was set up in a lathe and a quarter of a millimetre was turned off its diameter at the front where it fits into the voice coil.

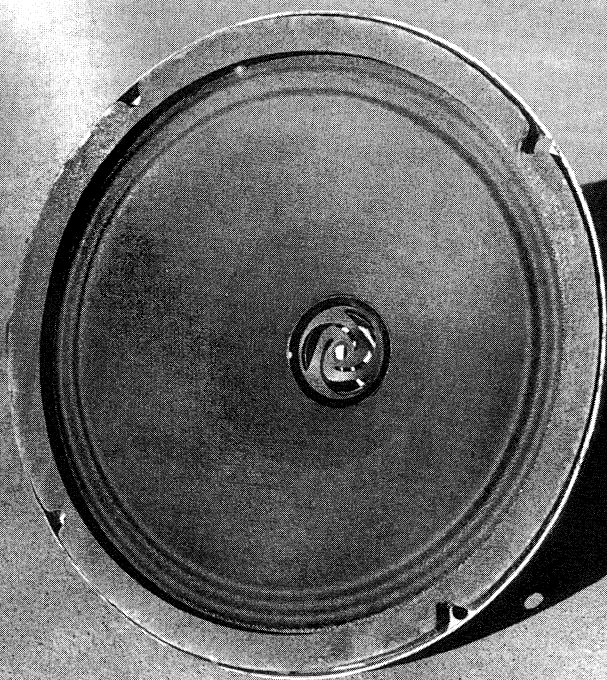
The speaker cone on this unit is still attached to the frame. Note the "spider" in the centre of this model, which is used to position the cone.

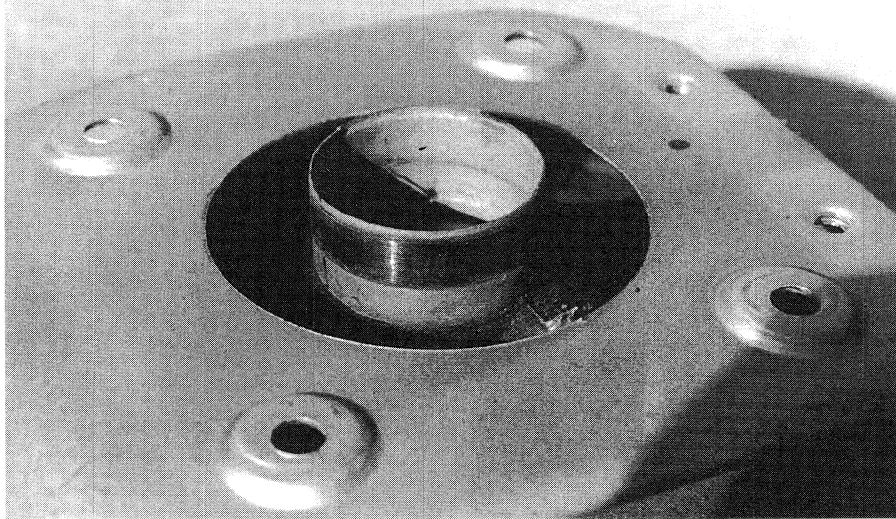
This back view shows the speaker frame and voice coil. The coil is wound on a thin cardboard former which often goes out of shape over the years, especially if the cone has sagged.

Because the voice coil is wound on a thin cardboard former, it is asking a lot to expect it to be perfectly round 50 or 60 years after it was made. Reducing the pole piece diameter is one way of compensating for an out-of-shape voice coil. A cone that sags and loses its form is one reason that voice coils go out of shape.

While on the subject of voice coils, remember that they are only glued to the speaker cone and a touch of lacquer to reinforce the area of attachment is highly recommended. If you have ever encountered a speaker with a loose voice coil or voice coil winding, you will appreciate the need to pay attention to that part of the speaker while it is accessible.

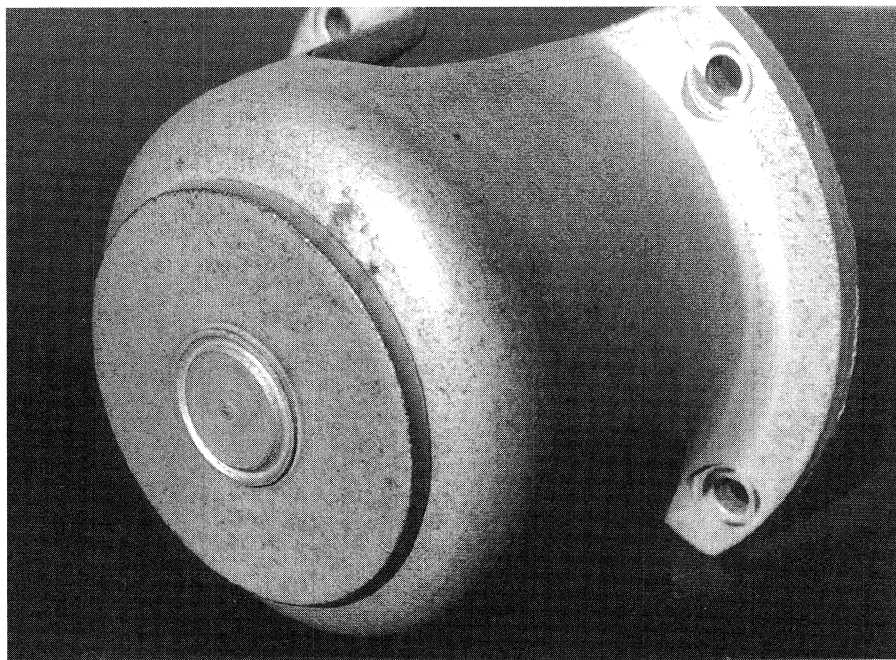
A typical field coil housing. Unlike the Precedent loudspeaker, this unit has the pole piece riveted in place which makes repairs more difficult.

One problem that would arise if doing a similar repair on this second speaker is the fact that the pole piece is riveted in place instead of being held by a bolt, as was the case with the Precedent speaker.

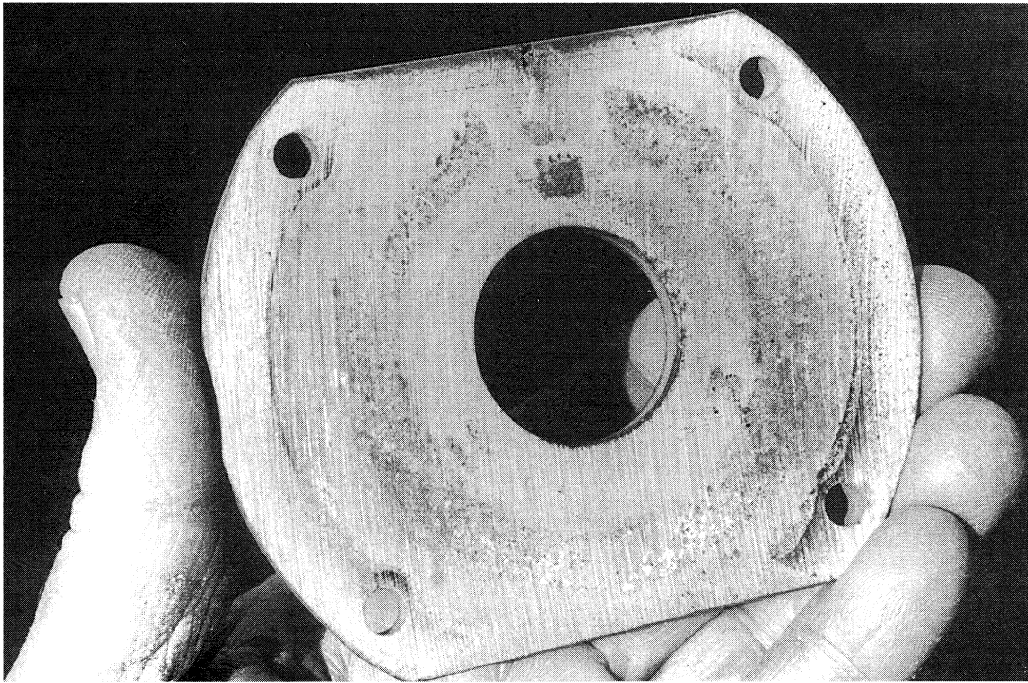
The hole in this backing plate is a neat fit around the voice coil. In some instances, this hole may require enlarging so as to clear a coil that has gone out of shape.

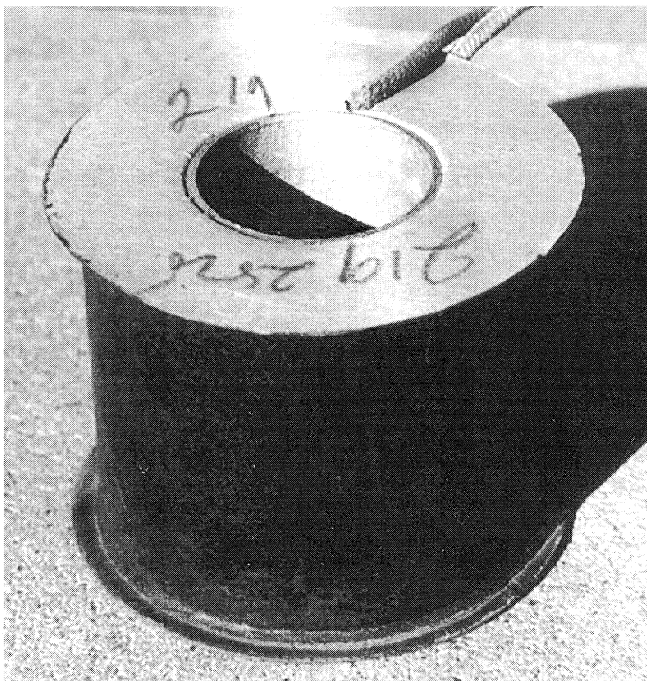
This 2.5kΩ field coil is wound on a cardboard former. Sealing the cardboard with lacquer will help to moisture-proof it.

The proposed repair for the Precedent loudspeaker was to clean up the pole piece and reposition it centrally in the voice coil. However, the job would not really be complete unless something was also done about the moisture absorbent cardboard. So, after leaving the spool out in the Sun

to dry for a few hours, it was given several coats of clear lacquer to seal it.

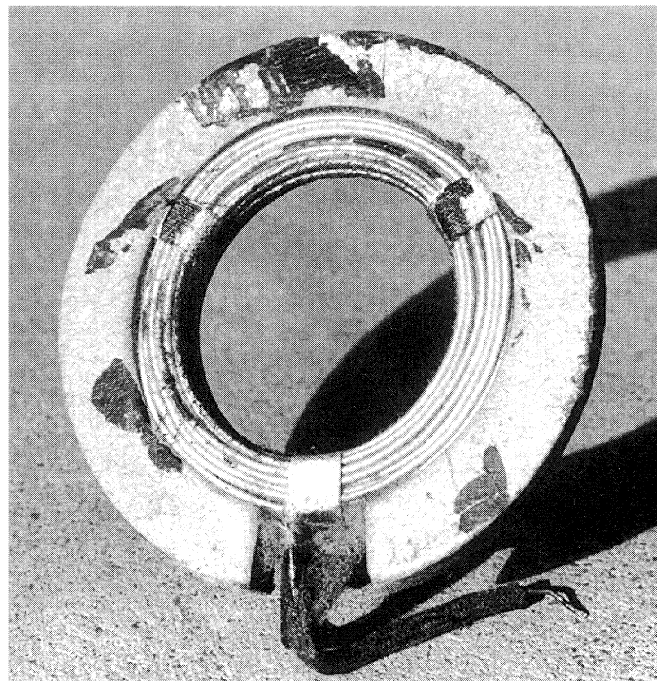
Most electrodynamic loudspeakers employed a hum-bucking coil which was used to neutralise hum induced by the field coil.
