## A PCR Restored!

**Michael Jones GW7BBY** not only covers the workings of these receivers but offers some history of their use.

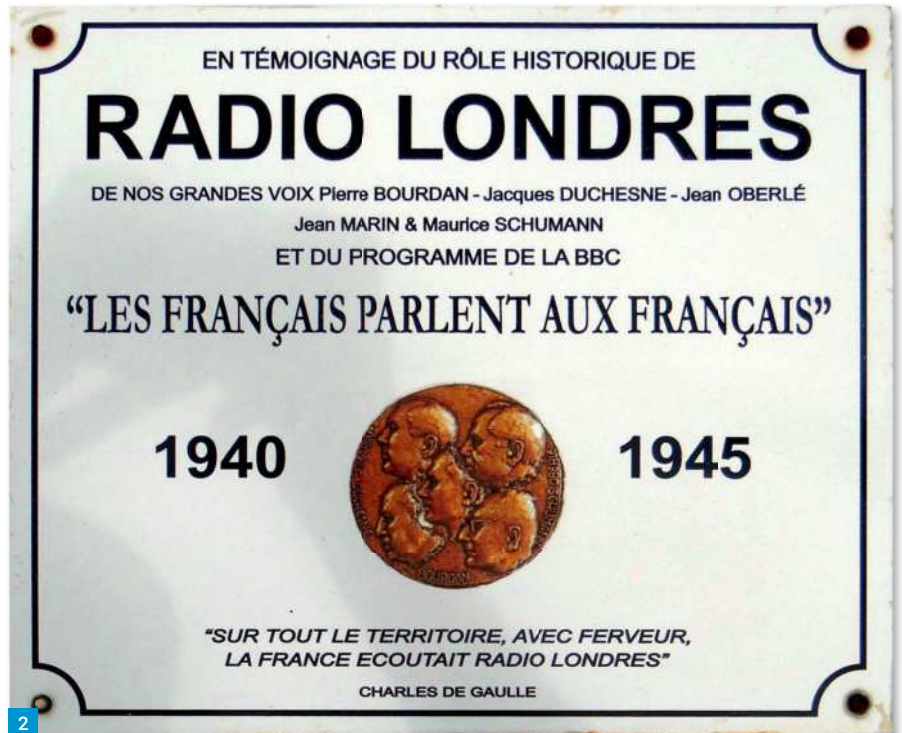
2

Fig. 1: PCR Receiver and its mains power supply.  
 Fig. 2: Plaque at the cemetery at Asnelles, in Normandy, commemorating the work of Radio Londres. Fig. 3: Circuit diagram of PCR1.  
 Fig. 4: Circuit diagram of mains power supply.  
 Fig. 5: Above chassis view showing space for modifications. Fig. 6: PSU showing wooden chest for fuses and spare bulbs. Fig. 7: Perished wiring to be replaced. Fig. 8: Lots of pictures were taken to ensure replacement components were correctly wired. Figs. 9 & 10: Below chassis view before and after replacing capacitors.

The PCR is a 6-valve superhet with an intermediate frequency (IF) of 465kHz. The circuit consists of a first RF amplifier (EF39/ARP34), mixer/oscillator (ECH35/ARTH2), two stages of IF amplification (EF39s/ARP34s), detector/audio amplifier (EBC33/AR21), audio output stage, PCR1: EL32(VT52), PCR2/3: 6V6G, Fig. 3 [2].

The three versions of the PCR: PCR (or PCR1), PCR2 and PCR3 are very similar. PCR is easily recognised as it has a built-in speaker. PCR2 and PCR3 relied on an external speaker or headphones. The other differences are in the frequency coverage. The PCR covers Long and Medium Waves plus 5.8 – 18MHz Short Wave, PCR2 has a different short-wave band: 6.0 – 22MHz. PCR3 dispenses with Long Wave and covers Medium Wave, plus two Short Wave bands: 2.3 – 7.3MHz and 7.0 – 23MHz.

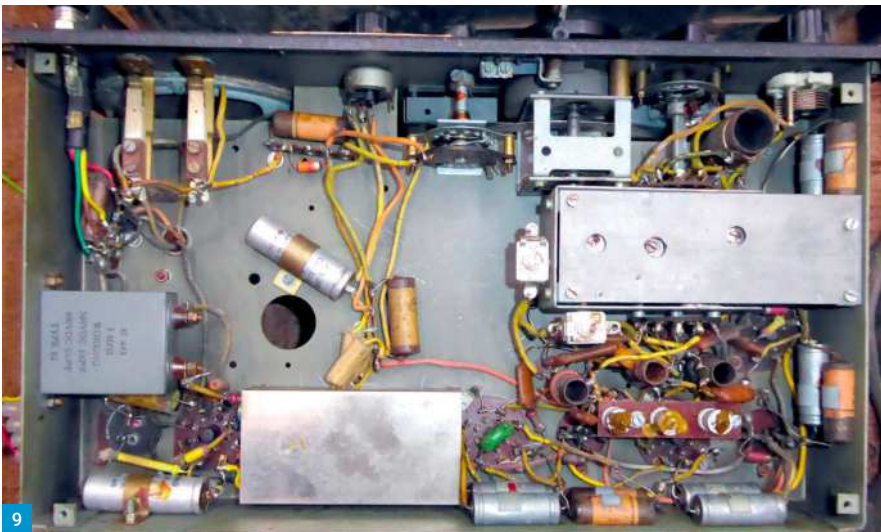
After ensuring that none of the perished wires were likely to cause trouble, I powered it up slowly with a Variac. If there were any seriously faulty capacitors, they would reveal themselves. All went well. The dial lights came on and after a short interval static could be heard, while with a short antenna Radio 4 could be heard faintly on Long Wave accompanied by some low frequency noise (motor-boating). There was no sign of activity on Medium Wave and Short Wave was completely dead. Poking around with the oscilloscope revealed the Local Oscillator (LO) signal on the grid of the Mixer Valve (V6: ECH35) on both Long and Medium Waves but nothing on Short Wave – possibly a dose of switch cleaner needed. I have a table of expected voltages on the valve bases and found some of these to be well out of specification. I also measured some of the wax paper and electrolytic capacitors: some were short and others of dubious value. A couple of the high value resistors were high.

All the perished wiring in the PSU and the radio was replaced, **Fig. 7**. I decided to replace all the wax paper capacitors: mostly 0.1  $\mu\text{F}$  or 0.01  $\mu\text{F}$  and a couple of 0.02  $\mu\text{F}$ . Two 12  $\mu\text{F}$  electrolytics were replaced with modern 10  $\mu\text{F}$  capacitors. Some high value resistors were also replaced, see **Figs. 8, 9 & 10**. Lots of pictures were taken to ensure that replacement parts were fitted correctly, **Fig. 8**. Upon powering up again all the voltages fell into place. Switch cleaner restored the LO on Short Wave. Attaching about 5m of wire to the antenna terminal brought
