The Bendix RA-1B aircraft radio receiver

Ulrich Fierz HB9AIK

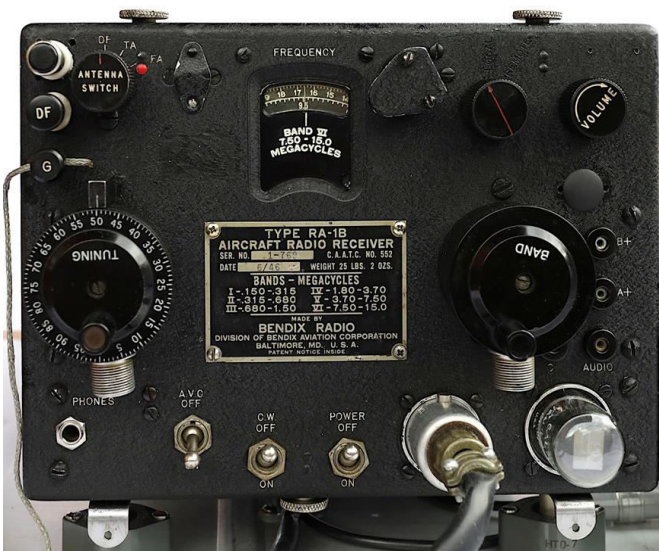
Figure 3. RA-1B front panel (refurbished radio)

The old EM87 sticking out was always somewhat vulnerable and too 'modern'. Initial thoughts leaned towards a 1629 indicator which was used in the ARC-5 command sets but, in the end, a shorter component was selected: the 6AL7GT. This is an indicator for AM/FM receivers with three rectangular sectors, used here with just one input. While not as attractive as the round magic eyes, it is compact and of the correct diameter to fit in the space of the remote connector (**Figure 3**, lower right-hand corner).

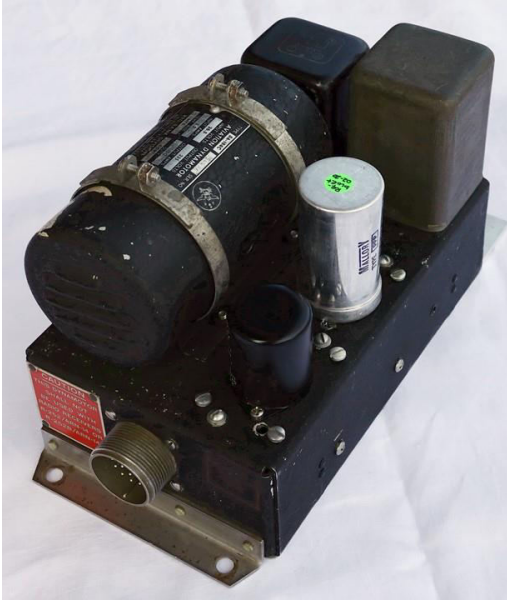
Figure 8. Dynamotor, topside (refurbished unit)

The B+ filter capacitor is now a dual unit and the resulting spare hole is occupied by the $600\ \Omega:8\ \Omega$ audio transformer. The outside was cleaned and the paint slightly touched up. The refurbished power supply is shown in **Figures 8 and 9**; the extended bracket is needed for the shock-mount used.

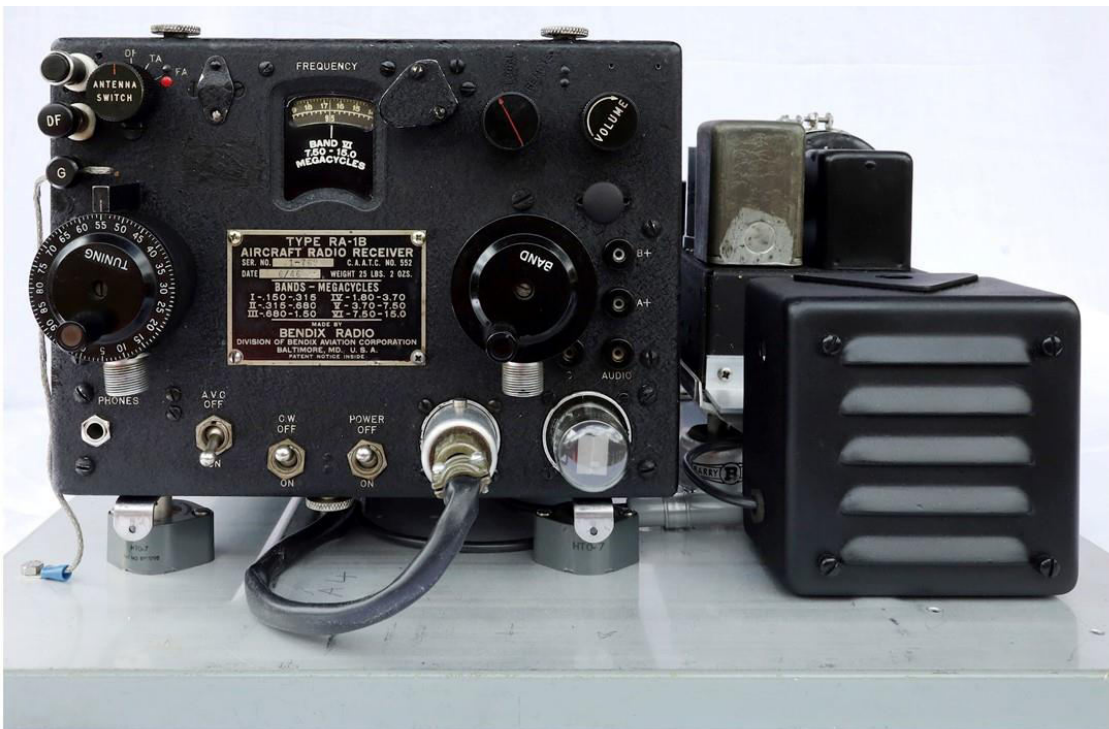
Figure 11. Layout of the RA-1B on an aluminium plinth for demonstration

In order to be able to display and demonstrate the receiver, an aluminium plinth was constructed to allow proper grounding of the components – similar to an aircraft installation (**Figure 11**).

The receiver was put on shock mounts that fit into the mounting rails of the receiver and the dynamotor was put on a suitable aircraft mount. All cables were made up using selected gauge PTFE-insulated wires for the required functions which were pulled into a silicone sleeve. As experience showed later, it would have been better also to include a shield braid to further reduce EMI.

The +28 VDC power input is filtered by a high-current 2 mH choke and a large 14,000 μ F computer-grade capacitor. A series resistor consisting of three 2.7 Ω resistors in parallel reduces the input voltage to approximately 26.5 V and, at the same time, limits the inrush current into the large capacitor. **Figure 10** shows the layout of the plinth. The choke and input resistor are behind the receiver.
