An 'SGC-230' autocoupler repair

Warren Stirling VK3XSW

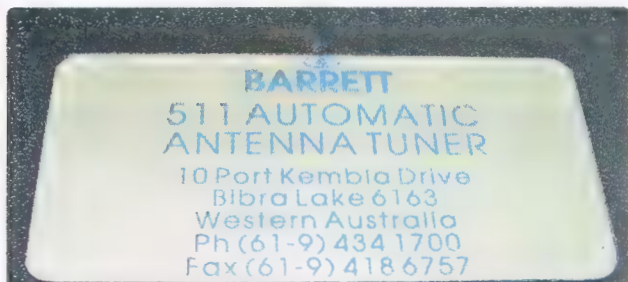
Photo 1: The 'SGC-230', showing the Barrett label.

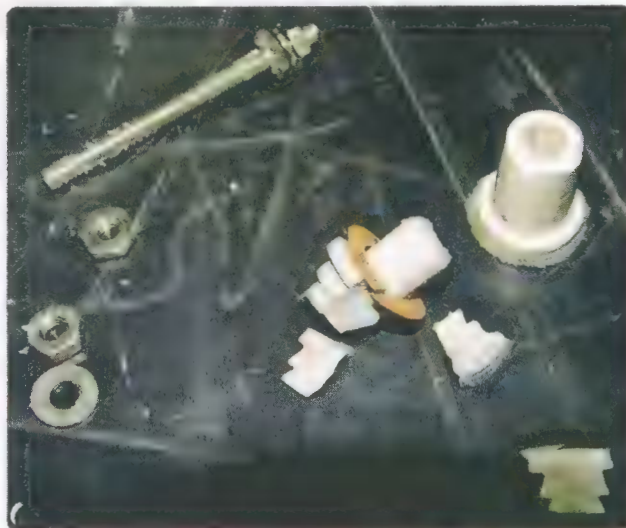
Photo 3: The broken feedthrough insulator.

The first thing to do was to gather some information about the unit so I downloaded the user manual, refer Reference 1, and also the troubleshooting guide, refer Reference 2, from SGC's website. The user guide does not contain any schematics, so I sent an email to SGC, describing the coupler including the internal panel. I also asked about a replacement for the broken ceramic feedthrough insulator

The new feedthrough insulator arrived and was fitted, so I started testing. The RS232 to TTL converter was connected to the SGC-230 and the SGC EPROM was replaced with the one I had programmed. A PC running Hyperterminal was connected and then the coupler was turned on. The result was a prompt from the test program in the EPROM which confirmed that at least the microprocessor in the SGC-230 was working, so it was onwards with further testing.
