Repairing the Traps on our Hygain TH7 Beam

Our tri-band beam, the venerable Hygain TH7, has served us well over the years.

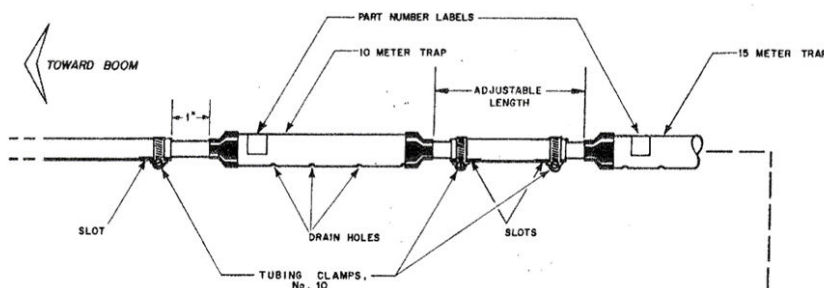
AO-0391-C-002-A

We recently experienced abnormal swr on all 3 bands, suggesting a trap failure in one

or more of the passive elements. It was not the first time.

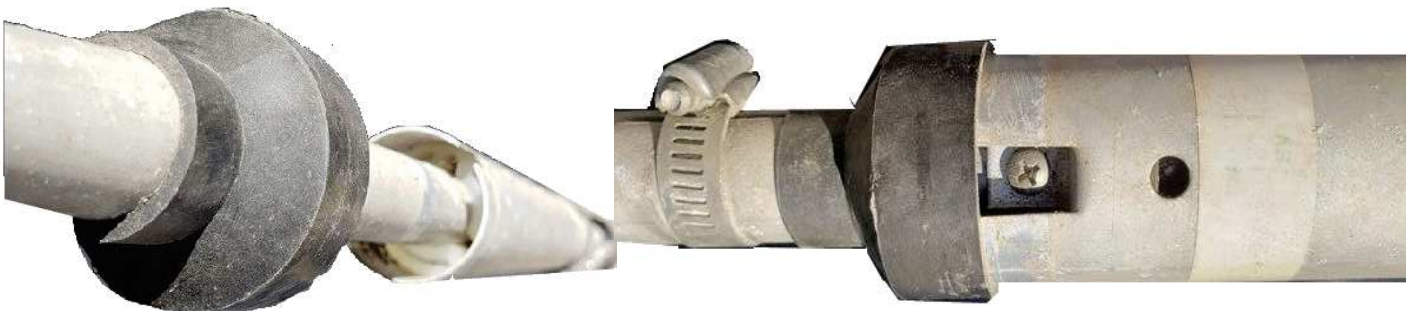
[4—Lower left] Outer end of trap shield (shown with protective boot slid away)

[5 - 0 Lower right] Inner end of Trap shield connected by screw to element and coil (shown with boot slid away). Tighten or replace screw.

Normally, R should be below 1 ohm in both instances. If R is above 1 ohm, removal of the plastic boot from the inner end of the trap and inspection of the connection is warranted. A loose or corroded sheet metal screw will likely be found at this point. Tightening the screw is one option, but the more permanent solution is to replace the existing 1/2" or 3/8" #8 screw

with a larger #10 stainless screw of the same length.
