PROPOSAL

MODIFICATION

OF

TAR-224 RADIO SET

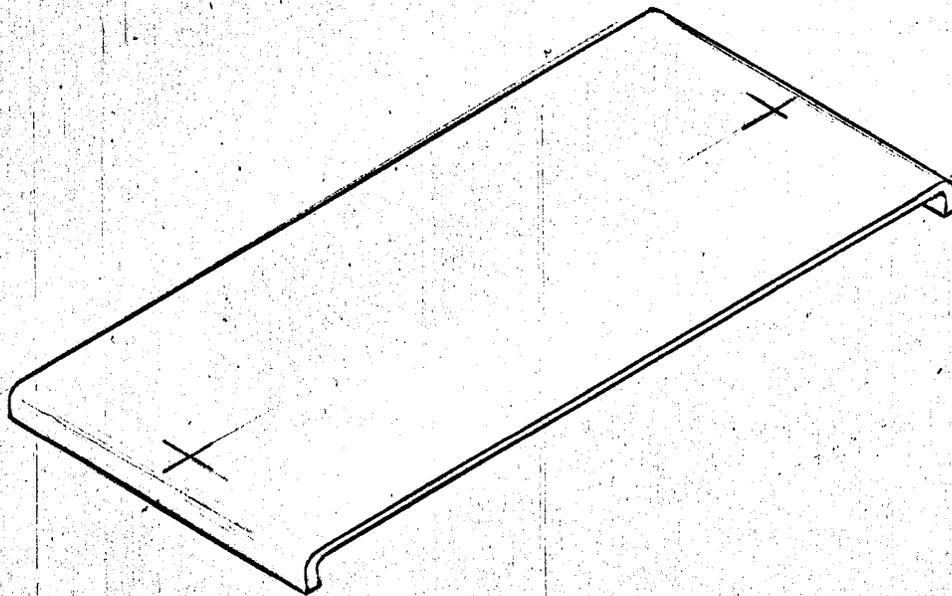
FIGURE 3. NEGATOR DIAL PLATE

2.1.2.a. WES Industries will procure a nylon dial tape bed plate (see Figure 3) of a new design. This plate will replace the original teflon plate whose shape contributed to excessive friction in the dial tape drive assembly. WES Industries will apply whatever final smoothing processes are necessary in order to minimize dial tape friction from this source.
