Some new findings about the AVO CT160A! Revision E5, 16 Feb 11

Valve Tester type 160A - Circuit Diagram ** Redrawn & Corrected!

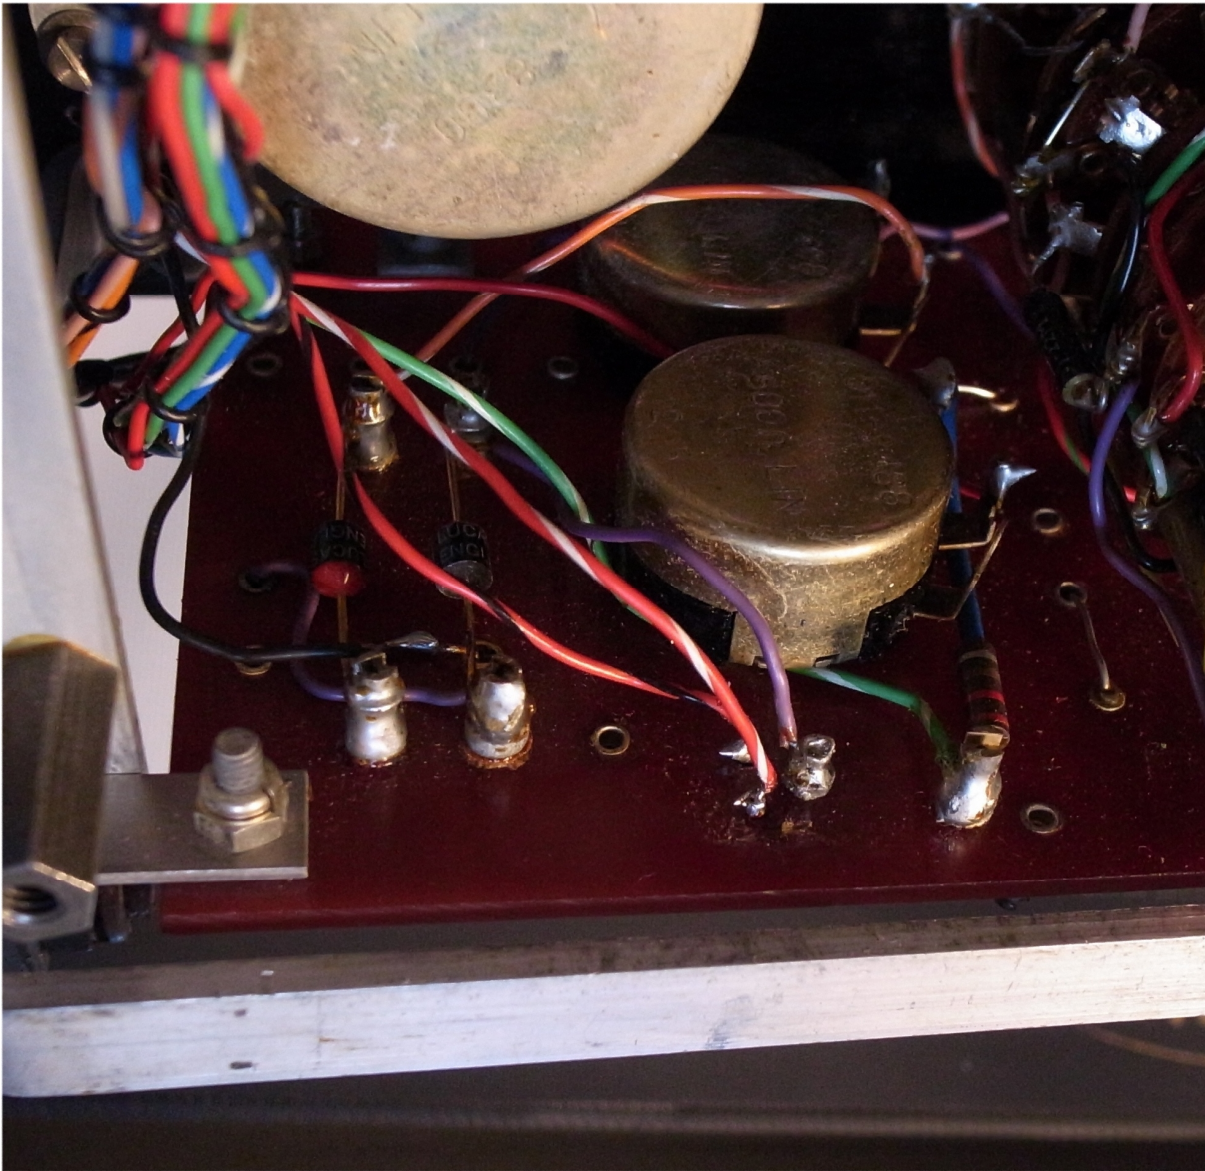
Photo 5: Different angle of components at the back of the PCB
