## CUSTOMER SERVICE BULLETIN

Subject: NCX-3 Suggestions &  
Operational Hints

## **CUSTOMER SERVICE BULLETIN**

NCX-3  
CSB 66-2

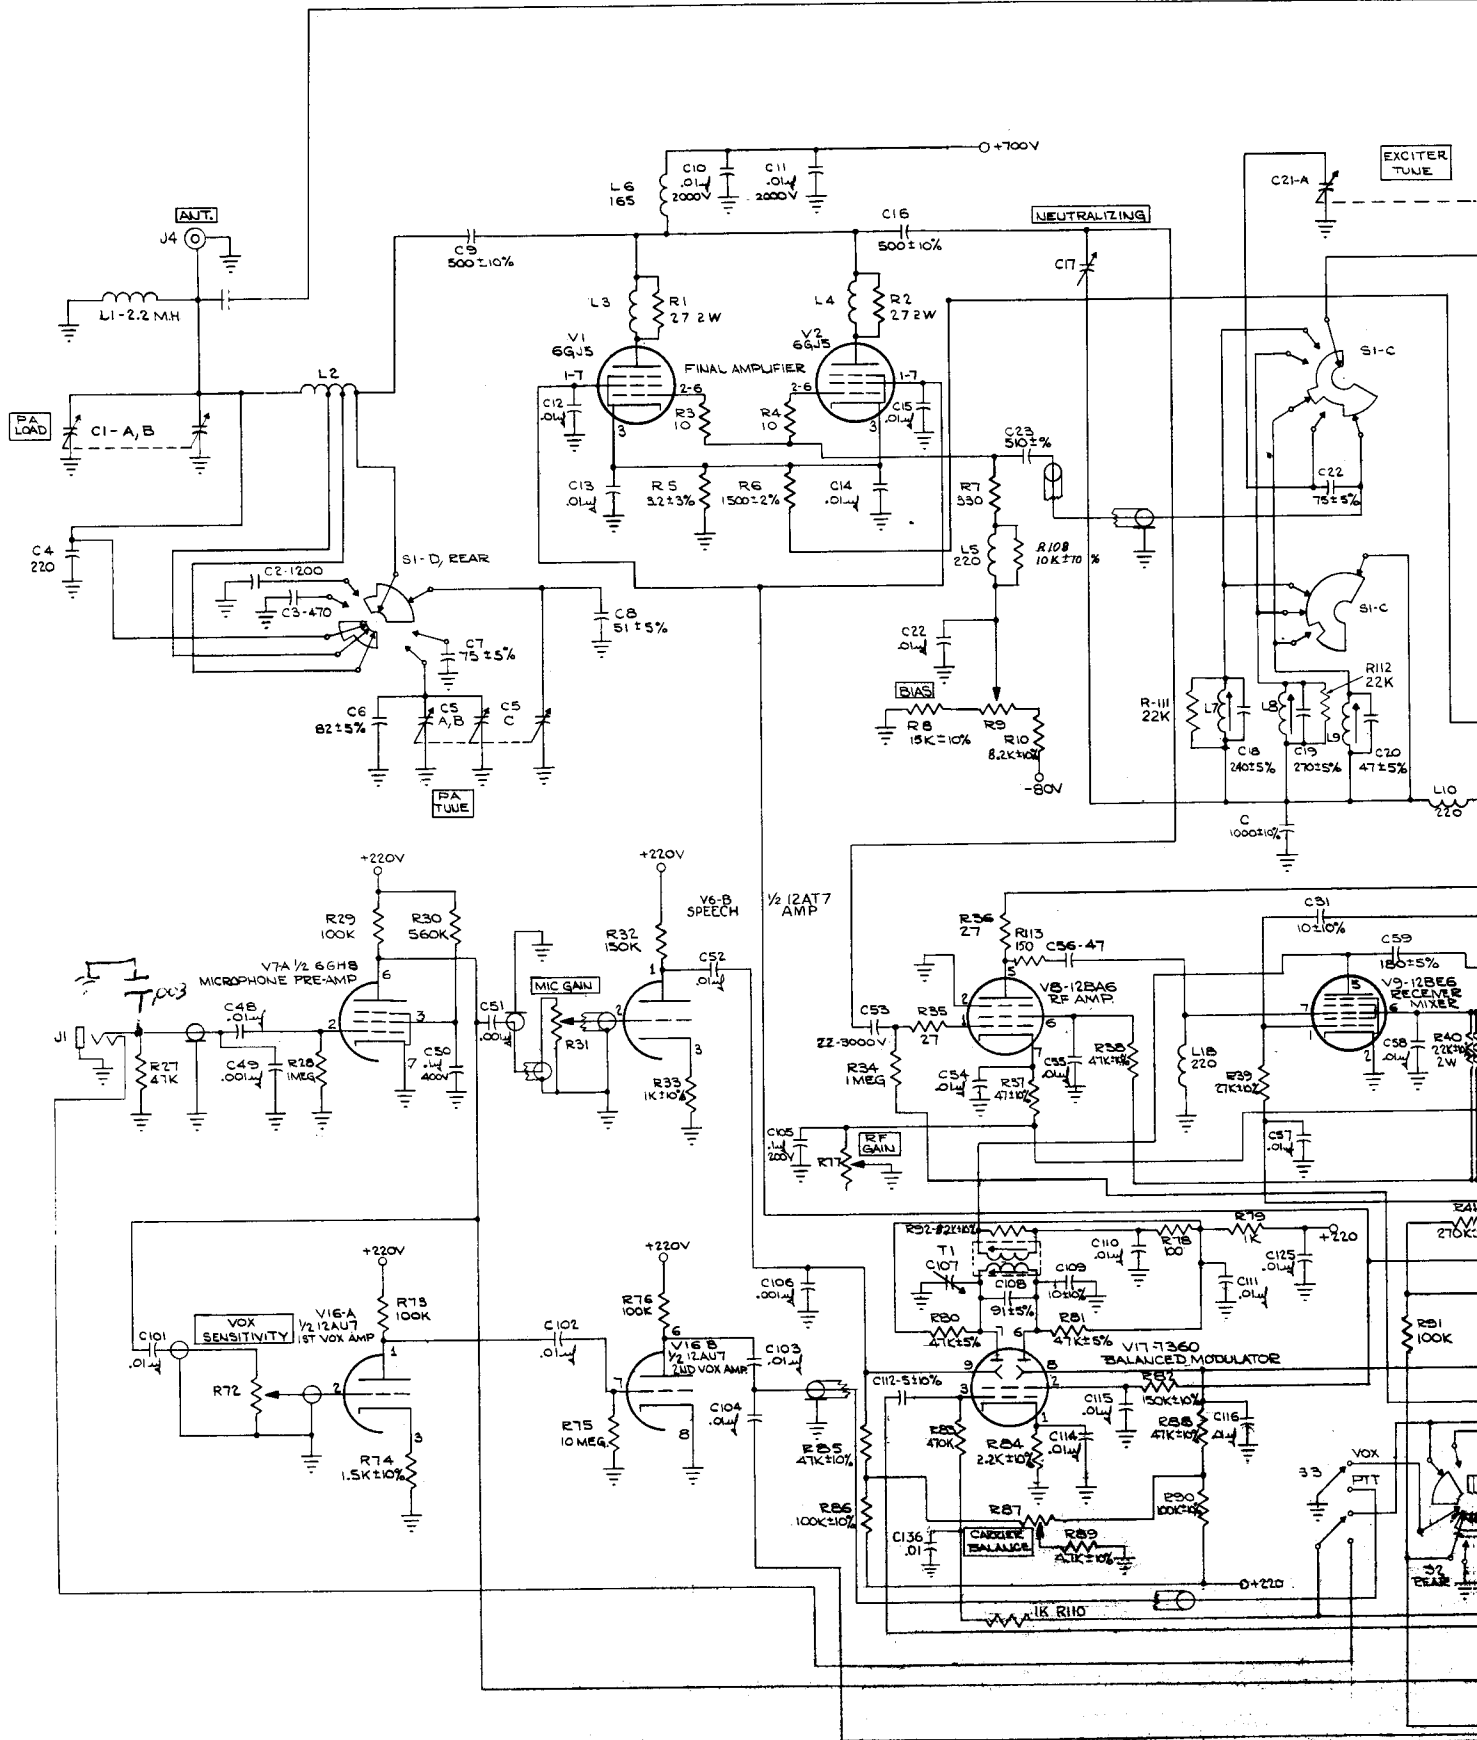
- NOTES:  
 1. BAND SWITCH (S-1) SHOWN  
 2. FUNCTION SWITCH (S-2) SHOWN  
 3. ALL CAPACITORS IN  $\mu\text{F}$  UNLESS OTHERWISE SPECIFIED  
 4. ALL RESISTORS 1/2 WATT UNLESS OTHERWISE SPECIFIED  
 5. ALL CHOKES IN  $\mu\text{H}$  UNLESS OTHERWISE SPECIFIED

\* R44 removed per letter from National

Remove R-44 at the screen grid of V-10. Do not replace.

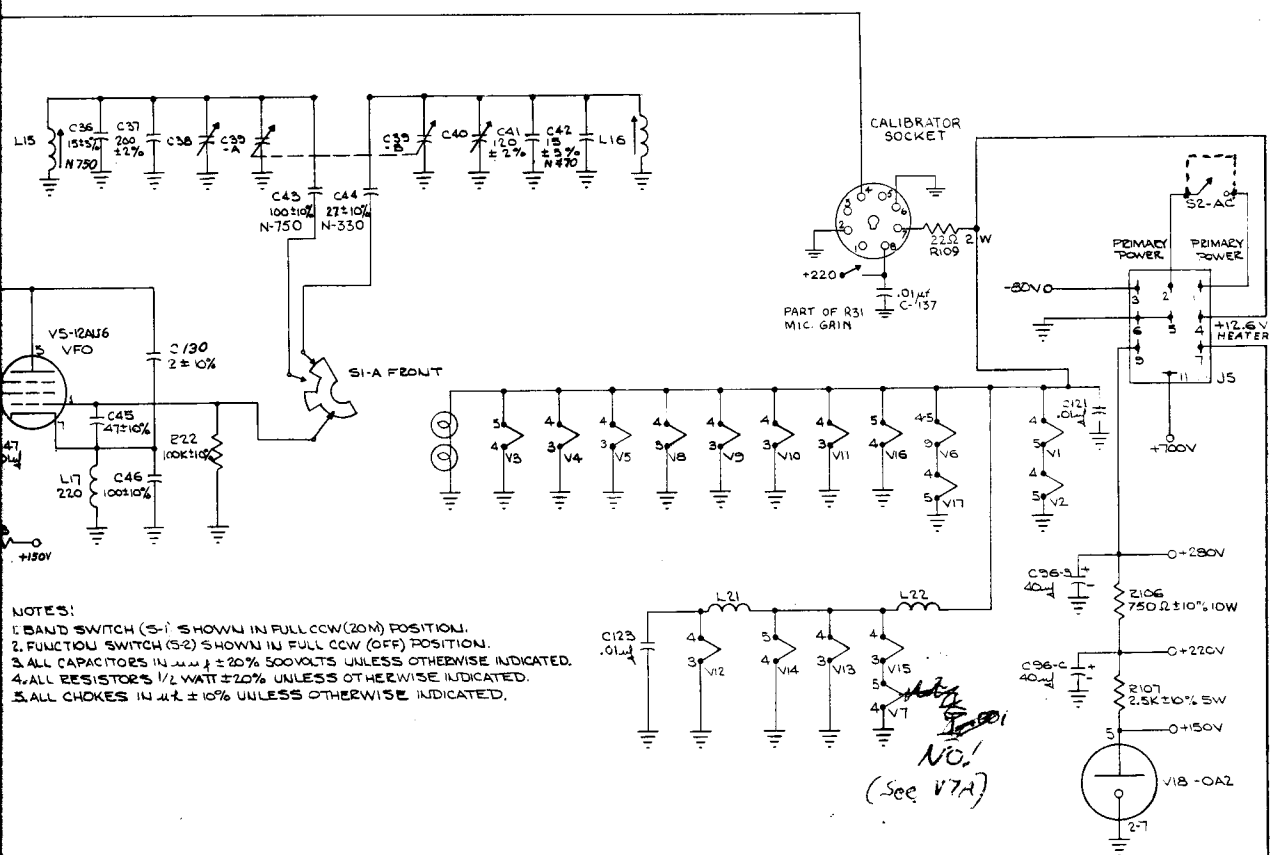
- NOTES:
1. BAND SWITCH (S-1) SHOWN IN FULL CCW (20M) POSITION.
  2. FUNCTION SWITCH (S-2) SHOWN IN FULL CCW (OFF) POSITION.
  3. ALL CAPACITORS IN μF ±20% 500VOLTS UNLESS OTHERWISE INDICATED.
  4. ALL RESISTORS 1/2 WATT ±20% UNLESS OTHERWISE INDICATED.
  5. ALL CHOKES IN μH ±10% UNLESS OTHERWISE INDICATED.

NO. 1  
(See V7A)

\* Energized on Rcv

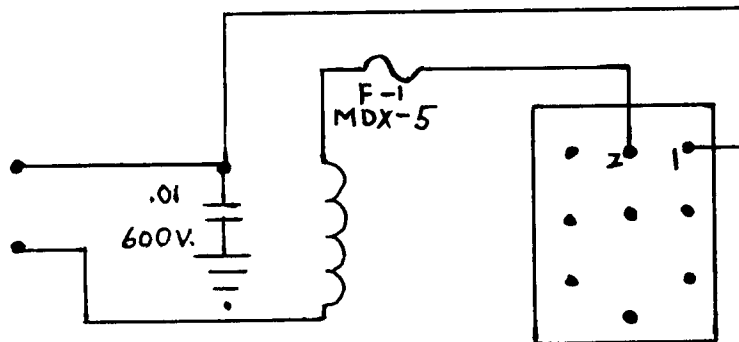
1. Resistor R7 has been changed from  $1000 \Omega \pm 10\%$  to  $1800 \Omega \pm 10\%$ .
2. A 0.01 uf 600 volt capacitor from one side of the AC line to chassis is not indicated on the schematic.
3. A revised primary power schematic is shown below:

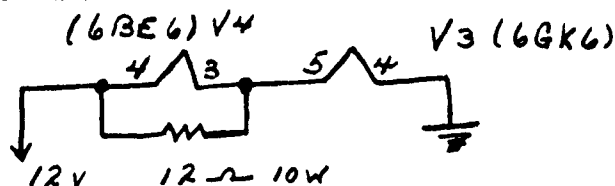
We have found that changing the driver tube from 12BY7 to 6GK6 results in improved reliability and greater drive. The following changes are necessary in order to substitute the 6GK6:

- a.) Change R-11 to 100 ohms 1 watt.
- b.) Change R-13 to 100K ohms 1/2 watt.
- c.) Change V-4 to a 6BE6.
- d.) Remove the ground from Pin 3 of V-4.
- e.) Locate the brown wire going from Pin 4 of V-4 to Pin 5 of V-3. Remove from Pin 4 of V-4 and reconnect to Pin 3 of V-4. Connect a 12 ohm 10 watt resistor from Pin 4 of V-4 to Pin 5 of V-3.

- f.) It will be necessary to repeak all driver and mixer coils.
